Safety Bulletin

Date: September 2024

Mobile plant used for pulling create line-of-fire hazard

Safety Bulletin SB24-07

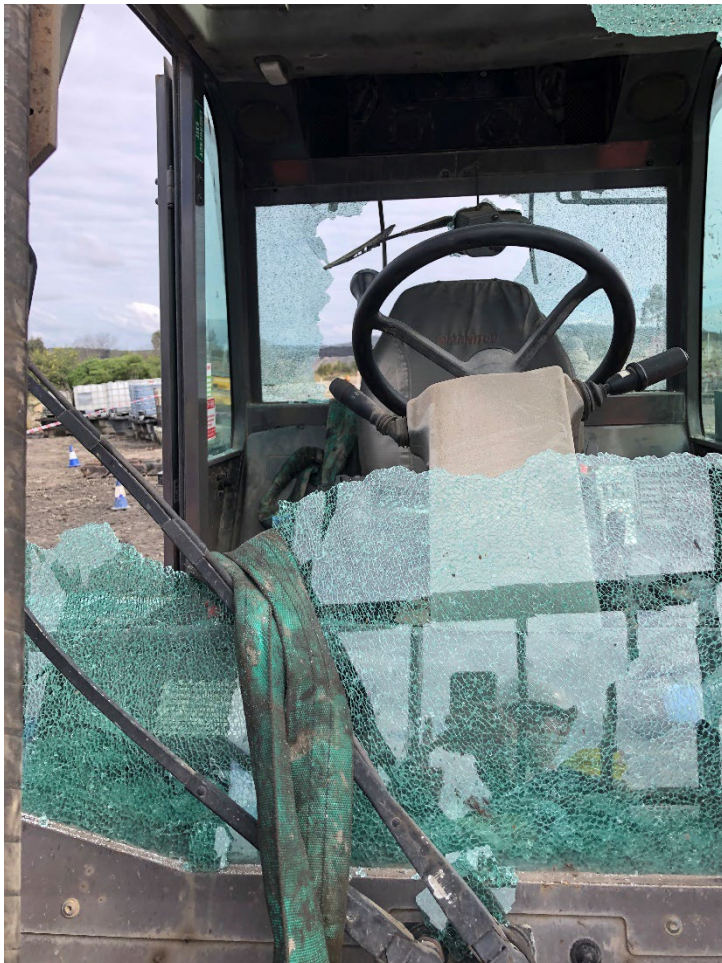
Figure 1 – Forklift with shattered rear and front windscreens after the M36 nut projectile narrowly missed the operator

Many pins had been extracted by this method the previous day, and 2 pins immediately before the incident. The pin in the incident required several attempts with increasing intensity while trying to jolt it free. The last attempt resulted in failure of the weld between the nut and pin, causing the M36 nut, weighing 425 grams, to recoil under tension of the slings. The nut, shackle, and slings shattered the rear window of the forklift, narrowly missing the operator, before shattering the front windscreen and coming to rest entangled in the mast. The forklift operator suffered only minor grazing to their back from the broken glass.

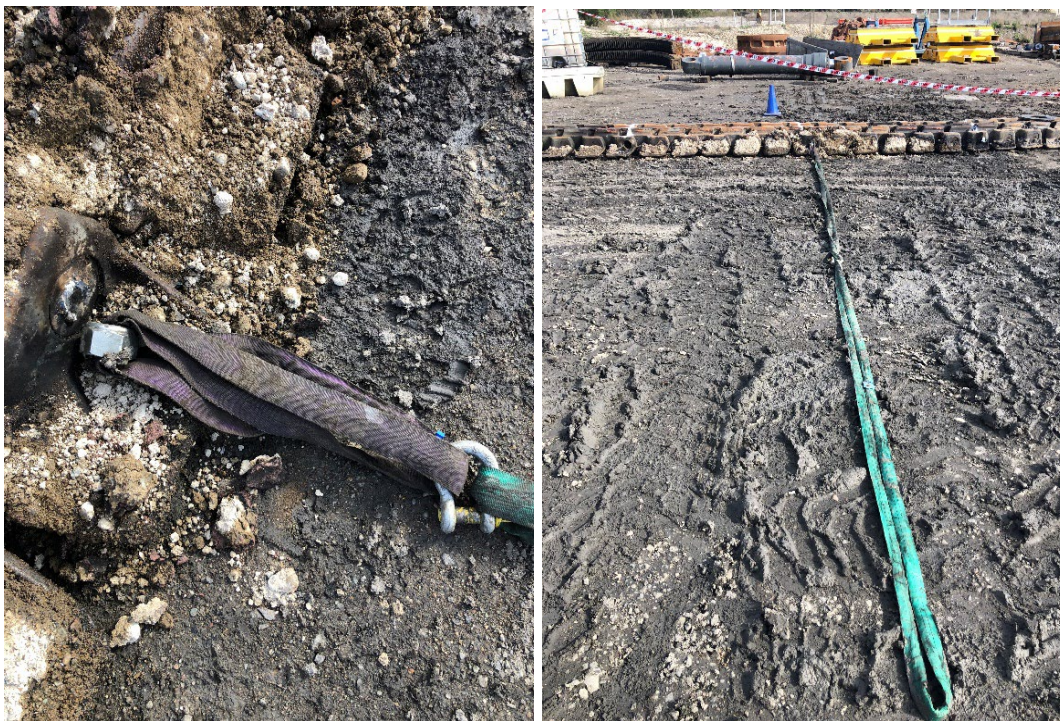
On Friday 16 August 2024, contract mine workers were removing pins from a length of excavator track on a shutdown pad. A nyloc nut was welded to the end of the pin to act as a connection point for pulling (snigging). A series of slings and shackles were then connected between the tow hitch of an all-terrain forklift and the nut welded to the pin. The forklift was then driven forward to give a slight jolt for the pin to come out.

Figure 2 – Sling connection to forklift was re-enacted after the incident

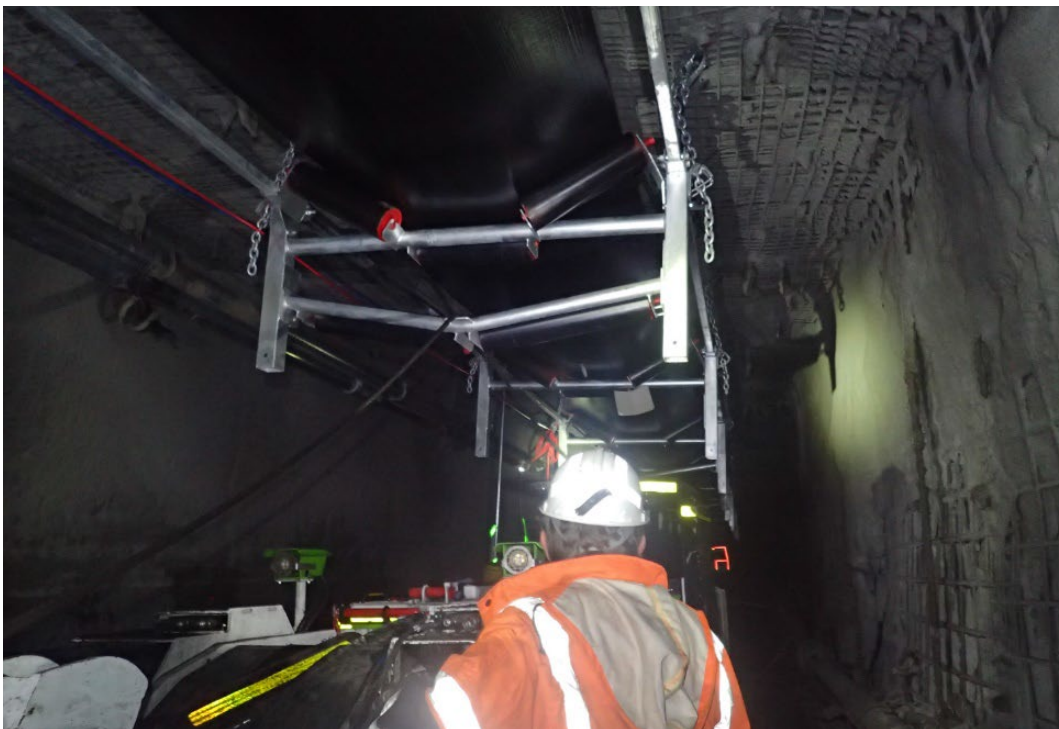
About 1am, a knot occurred in the rope when pulling rope from the spool. As the LHD moved forward the knot became stuck in the conveyor structure. The end of the rope was fitted with a metal eyelet weighing approximately 1 kilogram, and was simply looped over the front handrail of the work platform as shown in figure 4. Tension in the rope developed and became sufficient to overcome the securing method. The rope and the eyelet recoiled past the workers in the QDS workbasket, the LHD operator, and landed approximately 50 metres behind the LHD.

Figure 3 – Re-enactment of rope pulling through conveyor structure

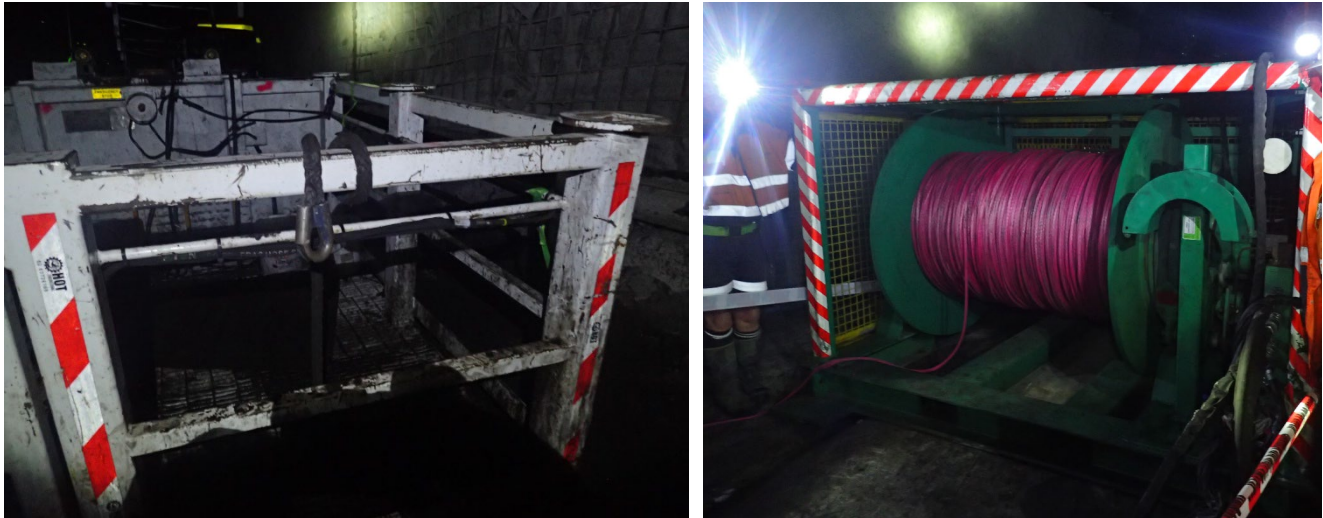
Figure 1 - Rope looped over workbasket handrail (left), and rope spool at conveyor tail (right)
