Weekly incident summary

Week ending 20 September 2024

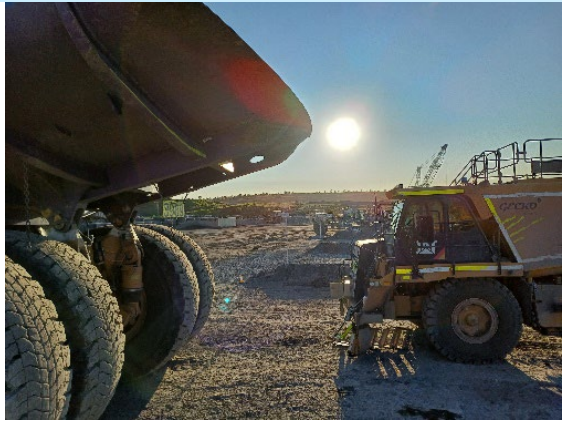
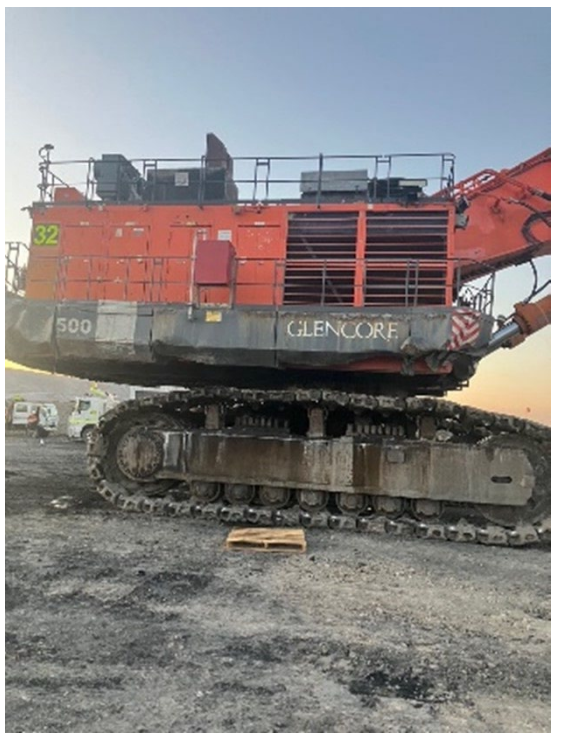
<p data-bbox="113 638 411 772">Dangerous incident IncNot0047678 Open cut coal mine</p>	<p data-bbox="411 638 975 750">A wooden pallet was dropped from the top deck of an excavator, breaking a worker's arm.</p> <p data-bbox="411 772 975 1030">Following a service on the excavator, a worker on the top deck checked the ground area to see if it was clear then dropped a pallet over the guardrail. The pallet weighed 19.12 kg and fell about 7m from the excavator, hitting the worker below on the forearm and hand.</p>

<p data-bbox="975 638 1477 739">Fit-for-purpose equipment should be used to lift service items up and down from excavators.</p> <p data-bbox="975 761 1477 828">Under no circumstances should items be dropped from such a height.</p> <p data-bbox="975 851 1477 1064">Visual inspection in such circumstances is not an adequate risk control and this incident should be communicated to workers to highlight the risks involved in undertaking such actions.</p>
