# Weekly incident summary

## Week ending 30 August 2024

## Weekly incident summary week ending 30 Aug 2024

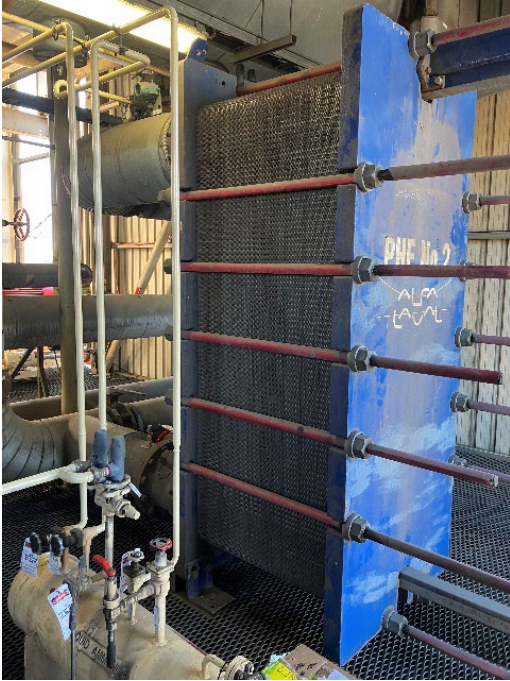
| Incident type | Summary | Comments to industry |
|--|--|--|
| Dangerous incident<br>IncNot0047567<br>Underground metals mine | A maintenance contractor was conducting commissioning checks (for about 30 minutes) on an ammonia plant for the mine's bulk air cooler that feeds cool air into the mine shaft. The bulk air | When maintenance commissioning activities can have inadvertent or unintentional safety or health ramifications it is recommend a specific risk assessment be carried out to |

| Incident type | Summary | Comments to industry |
|---|--|--|
| | <p>cooler was being recommissioned in preparation for the summer season. During the commissioning, a leak occurred between the ammonia system and the water-cooling system, allowing ammonia to bleed across a failed gasket. Some ammonia passed into the mine air cooling water and ammonia was smelt in the ventilation underground. The intake airway sensor recorded no detection of ammonia. The underground workers were sent to refuge chambers.</p> | <p>identify what can go wrong and implement relevant controls prior to the commissioning activities. Where plant has been decommissioned for a period of time, consideration should also be given to potential degradation of components from age and being idle.</p> |
