# Weekly incident summary

## Week ending 11 October 2024

Document control	
ISSN:	2982-1010 (online)
CM9 reference	RDOC24/191178
Mine safety reference	ISR24-xx
Date published	18 October 2024
Authorised by	Deputy Chief Inspector Office of the Chief Inspector

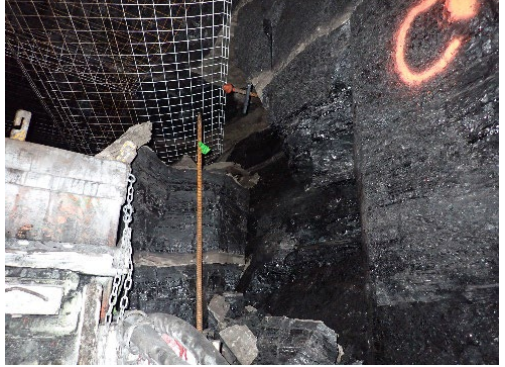
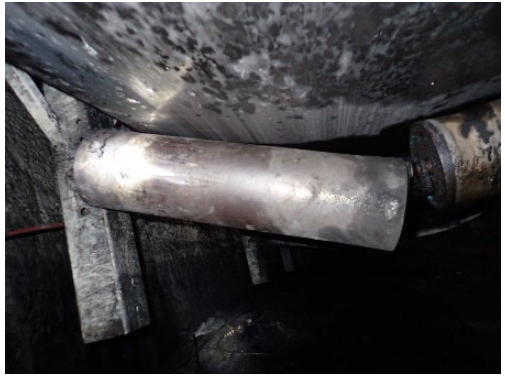
Incident type	Summary	Comments to industry
<p data-bbox="124 589 371 797">           Dangerous incident            IncNot0047811            Underground coal mine            Fire or explosion         </p>

<p data-bbox="416 589 898 808">           Heating occurred on an underground conveyor from a failed roller. While undertaking conveyor inspections, a deputy smelt something burning and found 2 x 5 mm glowing embers under the belt.         </p> <p data-bbox="416 831 927 976">           The roller bearings had catastrophically failed, allowing the roller shell to run on the shaft, creating excessive friction and heat.         </p>

<p data-bbox="954 589 1469 958">           Mine operators must have systems to identify and change-out defective conveyor rollers. Workers conducting conveyor inspections must be aware of the increased risk of roller failure at high tension areas of conveyors. They must also diligently inspect for fire risks such as accumulation of material, failing or collapsed idlers and contact between conveyor belts and fixed structures.         </p>

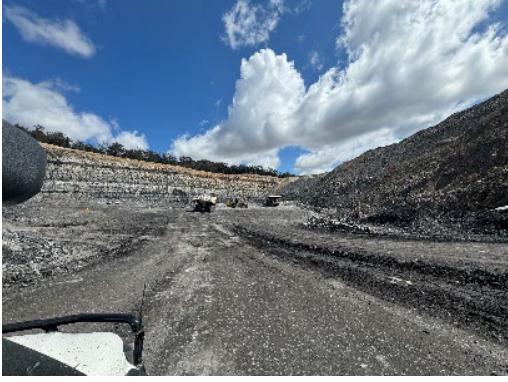
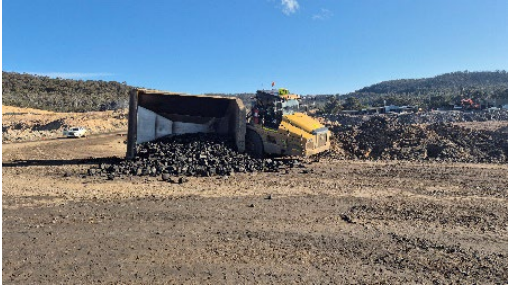
<p>Dangerous incident IncNot0047789 Open cut coal mine Roads or other vehicle operating areas</p>

<p>An articulated truck rolled its dump body while negotiating a bend. The cabin remained upright, and no one was injured.</p>

<p>Articulated truck rollovers continue to be a cause for concern on mine sites. The stability of articulated vehicles is a known risk that needs to be managed.</p> <p>When operating articulated equipment workers must drive at appropriate speeds, particularly when negotiating corners and turning the machine around.</p>
