Weekly incident summary

Week ending 27 September 2024

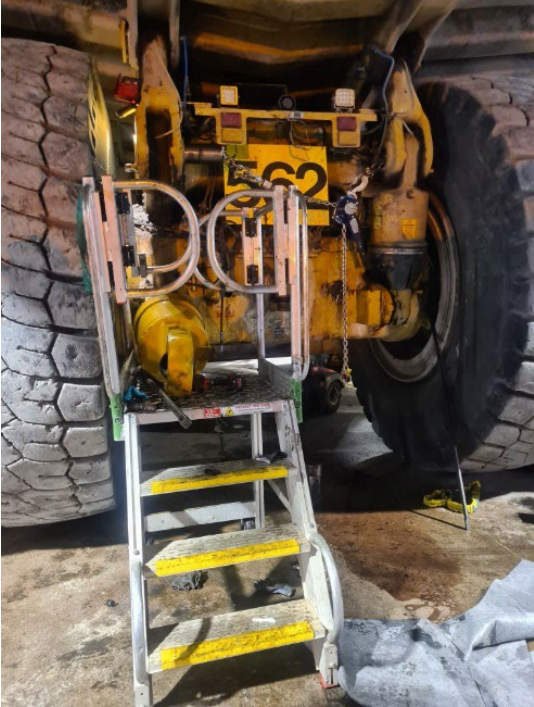
Incident type	Summary	Comments to industry
Serious injury IncNot0047697 Open cut coal mine	<p>A worker was fitting the upper pin to the left-hand rear strut of a haul truck and thought it was secured in place.</p> <p>Workers detached the sling and removed the forklift and jib, which were being used to support the strut.</p> <p>They were in the process of realigning the cylinder with the mounting boss to allow the pin to fully engage when the cylinder fell/rotated back onto the worker, grazing the worker's abdomen, and seriously lacerating the worker's leg.</p>	<p>The potential for this incident to have a fatal outcome cannot be understated.</p> <p>It is vital that the hazards and risks associated with removing and replacing rear strut cylinders on haul trucks be fully assessed and documented with appropriate controls developed and implemented.</p> <p>Particular attention needs to be given to the robust restraint of suspended or partially suspended loads that could fall, slide or pivot.</p> <p>Ensure that clear and detailed directions for the methods of restraining strut cylinders are included in procedures and are communicated to the relevant workforce.</p>

<p>Consider developing or purchasing task-specific lifting jigs to assist in controlling the hazard of falling, sliding, slewing or pivoting components.</p>
<p>Serious injury IncNot0047722 Underground coal mine</p>	<p>A worker lost consciousness following an incident while installing a ventilation tube. The worker's fingers became sucked in between the flexi duct and a ventilation tube but he eventually managed to free himself.</p> <p>Following the incident, the worker went into shock and was in and out of consciousness for about a minute.</p>	<p>Control measures and procedures in relation to installing ventilation tubes while auxiliary fans are in operation should include identifying:</p> <ul style="list-style-type: none"> • safe operating ranges for workers installing ventilation tubes • the sequence of steps to take to safely add ducting inline • guards on the most inbye tube, to minimise the risk of workers being sucked into or against the ducting while working adjacent to it (e.g. on continuous miner platforms). <p>Refer to: SA20-05 Worker sucked into auxiliary fan ventilation tube</p>
