Investigation report

Worker seriously injured during lifting activity

November 2024

Published by the Department of Primary Industries and Regional Development

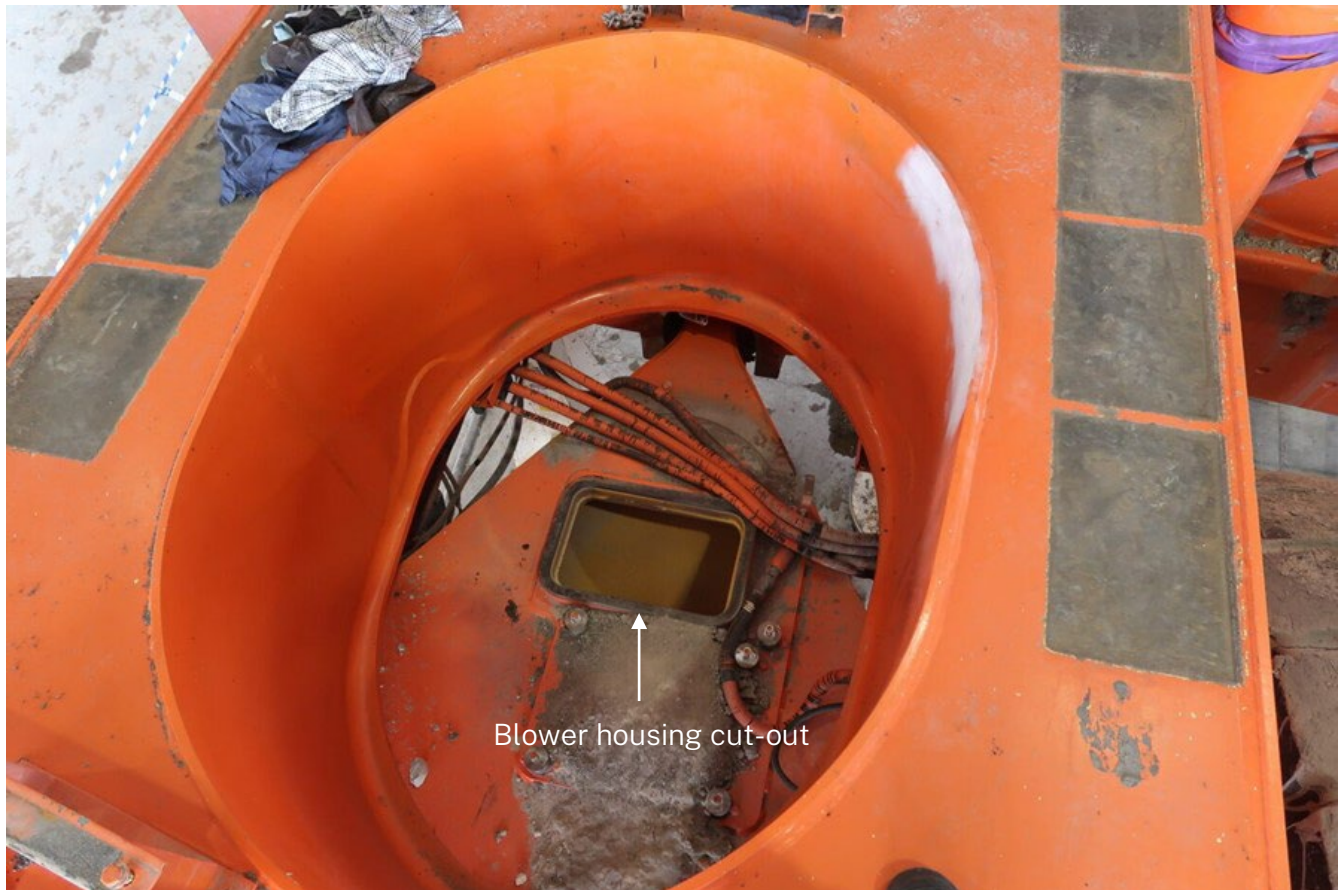
After becoming uncomfortable in the crouched position, the worker released his grip on the plate and set the remote control aside to reposition himself. As the worker repositioned, the crane continued moving and the plate snagged on the edge of the cut-out. The momentum caused the plate to pull through the cut-out, catapulting it onto the platform next to the truck's operator cabin. As it released and propelled clear from the cut-out edge, it hit the worker's lower left leg resulting in a compound fracture.

Figure 1: The work area and blower housing cut-out that the worker was attempting to manually manoeuvre the lifting plate through

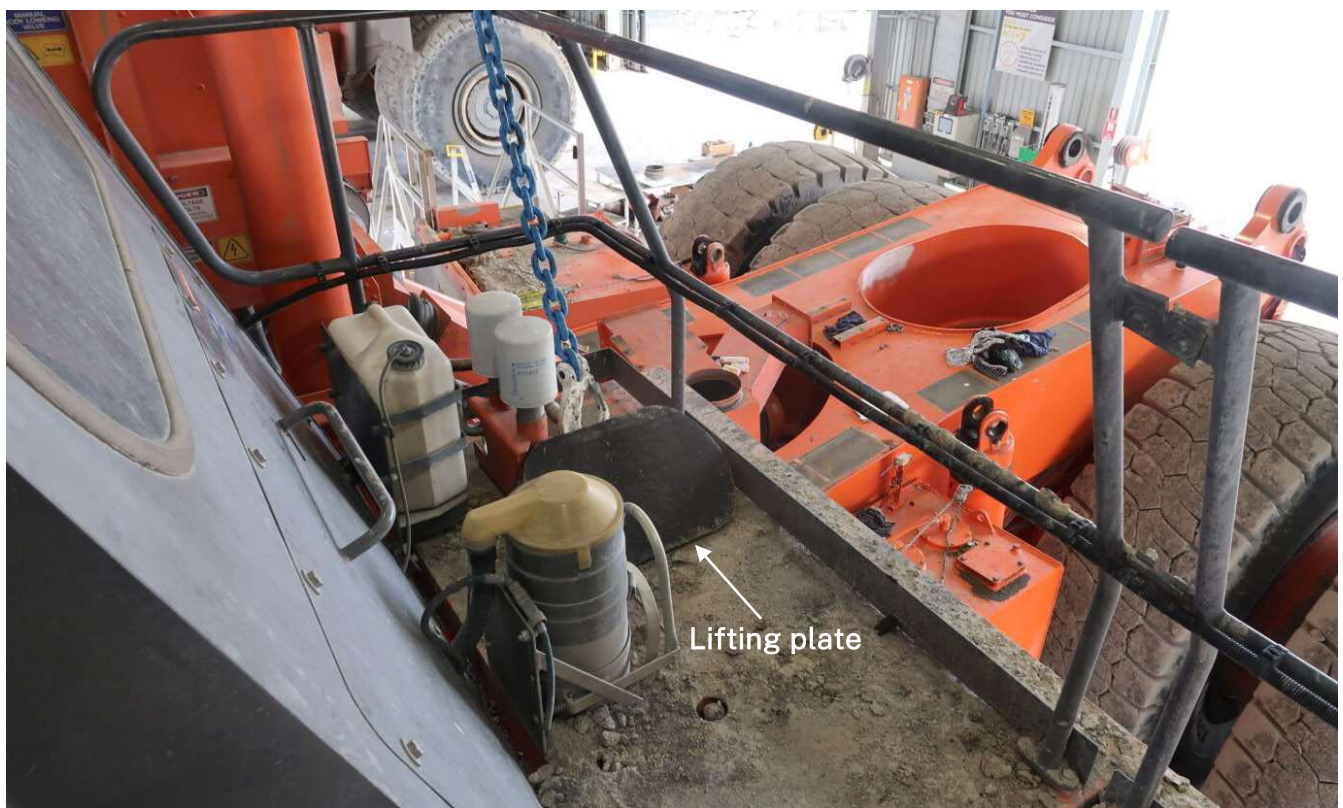
Figure 2: Location of the lifting plate after uncontrolled release

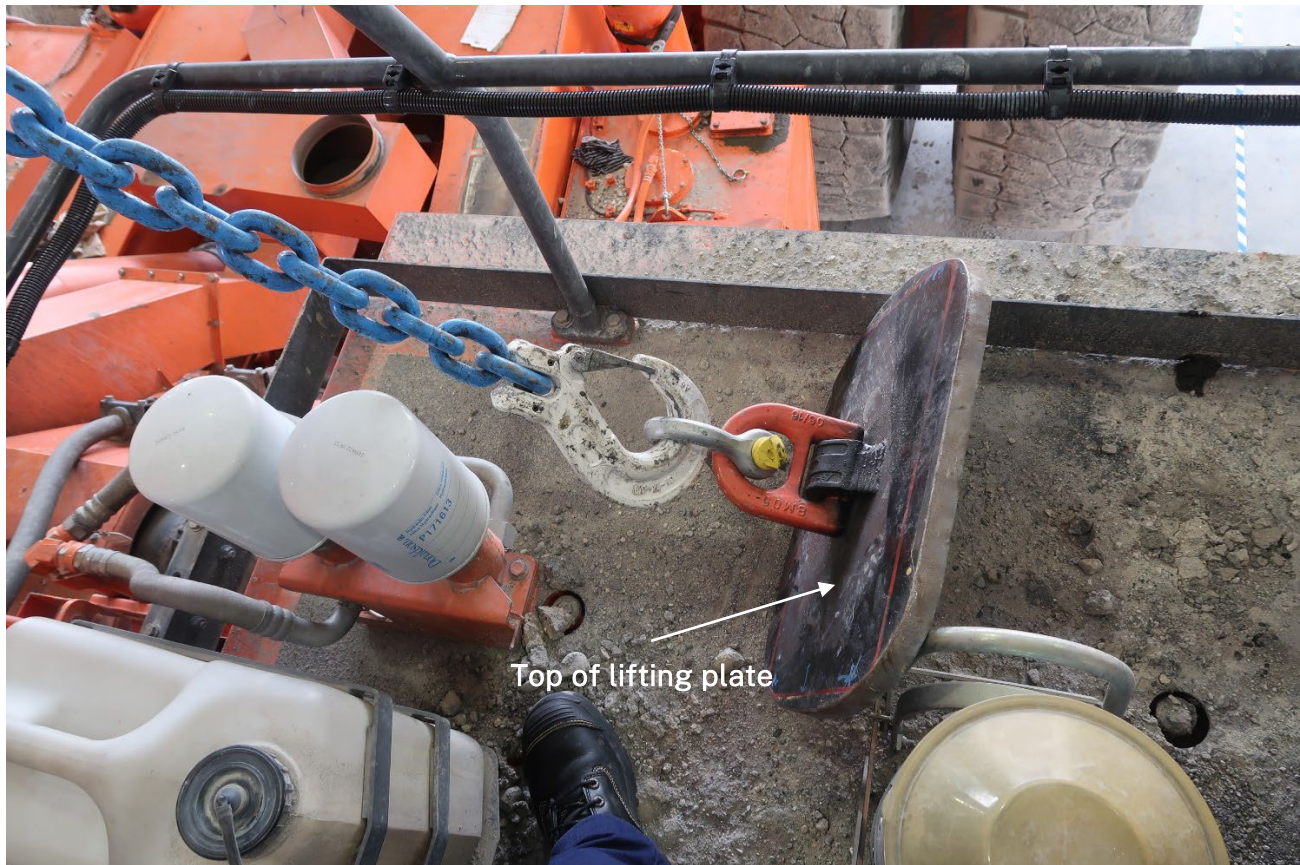
Figure 3: The top of the lifting plate has red markings to indicate its correct positioning inside the axle box, relative to the blower housing cut-out

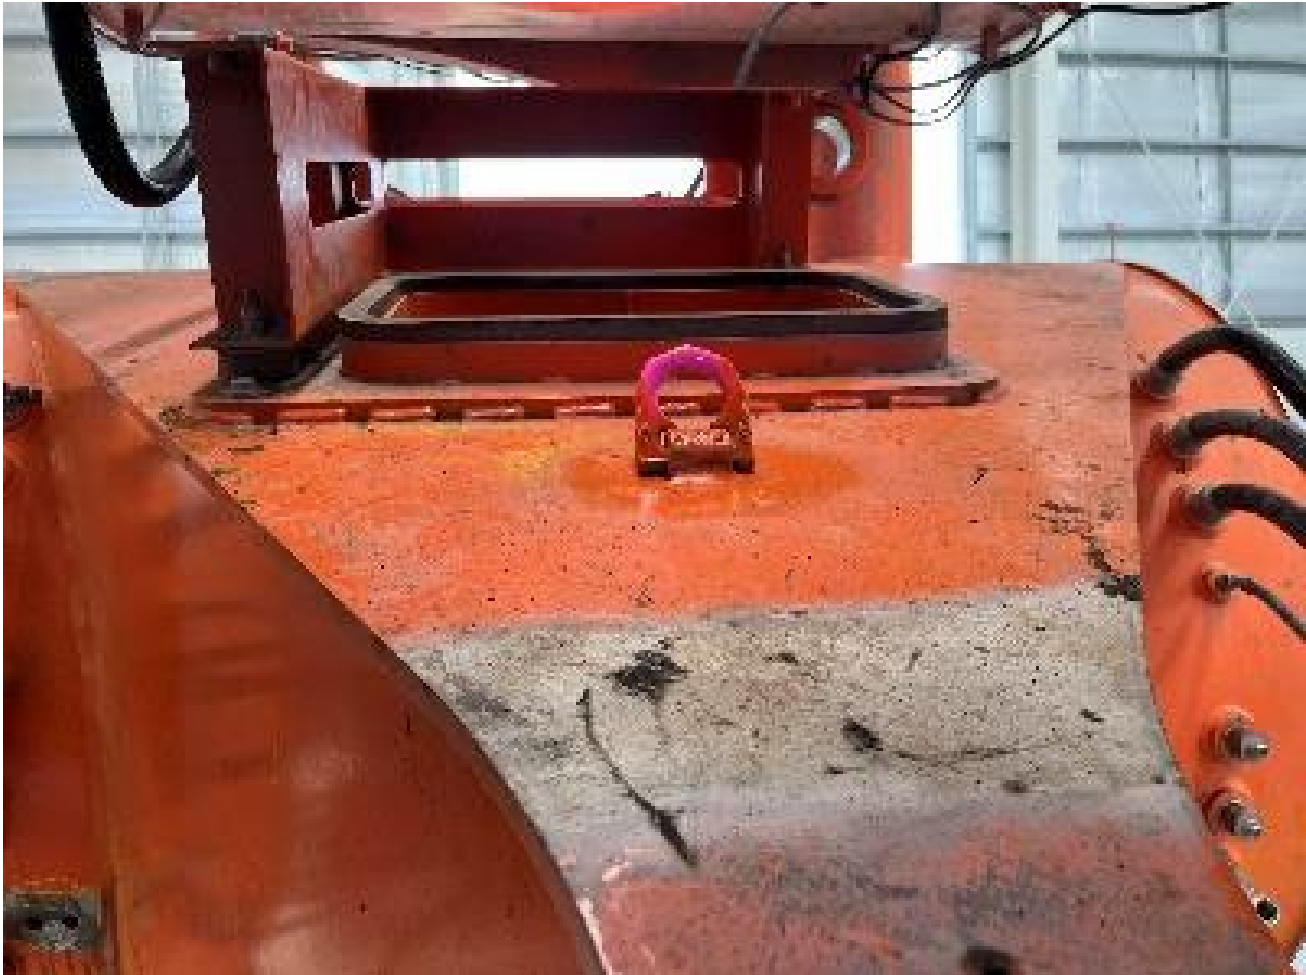
Figure 4: 4T - VLBS load ring welded to the axle box as an alternative to use of the plate

- a. installing a lifting lug directly onto the axle box assembly whereby the crane could be directly connected and/or disconnected to the axle box while it was not in operation, without workers having to reach below platform/working level, handle heavy componentry or remain in line of fire while engaging or removing a lifting plate. This

method was implemented post-incident at the mine as depicted in figure 4 below.
