Weekly incident summary

Week ending 1 November 2024

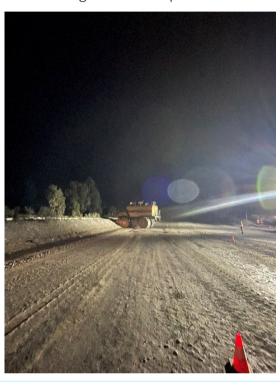
A water cart lost steering as it was negotiating a bend in the haul road. The water cart collided with a windrow while attempting an emergency stop.

The failure was caused by low hydraulic oil level due to an undetected leak. The design did not include a low hydraulic oil reservoir level warning to alert the operator.

This incident highlights the importance of stringent monitoring and quality control of maintenance and repair activities.

After doing maintenance and repairing mobile plant, the plant should be inspected, tested and verified as fit-for-purpose before being returned to service.

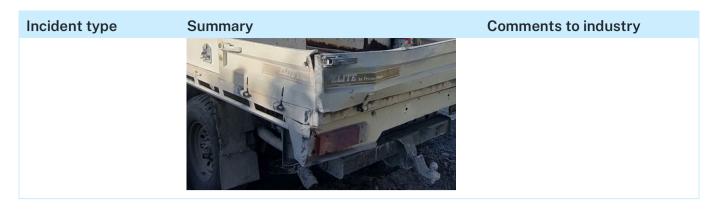
A technician who was operating a light vehicle was rushing to arm barriers for a tele remote system and failed to park the vehicle correctly before exiting it. The vehicle immediately rolled backwards about 13 metres before hitting a wall.

The technician had applied the handbrake but left the vehicle running, not in gear and not parked into the wall.

During the incident, the technician ran to the vehicle and tried to re-enter the cabin, but it was moving too fast.

When implementing controls for safe parking, mine operators should follow the hierarchy of controls. Engineering controls should be considered before resorting to lower level controls. Regardless of the engineering controls fitted, workers should always park fundamentally stable.

Under no circumstances should a worker ever attempt to reenter a moving vehicle.
