Weekly incident summary

Week ending 9 November 2024

Weekly incident summary week ending 9 November 2024

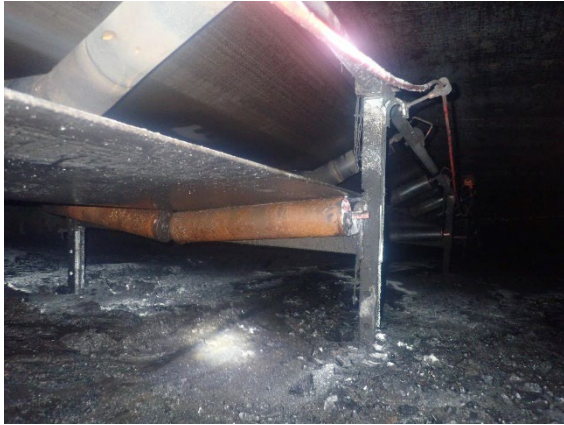
<p>A deputy discovered a collapsed return roller on a panel conveyor belt at an underground coal mine. The deputy stopped the belt, applied a fire extinguisher and isolated the area with a fire watch in place. A preliminary investigation was initiated, and the incident was reported to the Regulator. Immediate corrective actions included replacing damaged structure legs and rollers and conducting a full review of the conveyor risk assessments and fire management plan.</p> <p>Three days later, smoke and embers were detected on the conveyor directly outbye the earlier incident. This was caused by the belt making contact with a restrained grease line. The conveyor had</p>	<p>Risks and effective risk controls associated with conveyor systems are well known.</p> <p>Mine operators must ensure appropriate risk controls are implemented and maintained.</p> <p>Inspection systems should be designed to identify defects, with a strategy to address identified defects, i.e. with the use of a defect register/database.</p> <p>Wander switches should be commissioned to ensure this control measure will be effective during the operation of conveyors.</p>

Incident type	Summary	Comments to industry
	<p>wandered beyond its intended path, with wander switches failing to trip. All belts were shut down, and a full inspection was ordered. The incident prompted a detailed audit of conveyor systems, investigation of wander switch functionality, and a review of installation procedures.</p>
