Weekly incident summary

Week ending 22 November 2024

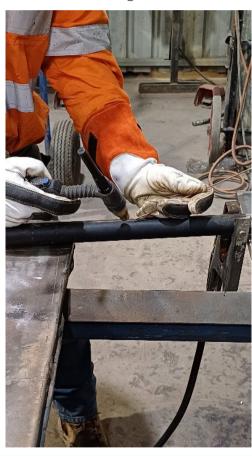
High potential incident IncNot0048026 Open cut coal mine

A boilermaker was welding a handrail when the worker suffered an electric shock.

The boilermaker made contact with the welder handpiece while leaning on the bench completing the welding task.

The welder was a Tig welder.

Workers involved with welding activities should remain insulated from the welding job. Welding gloves are not electrical insulators. Damp gloves and clothing can increase the likelihood of suffering an electric shock.
