Weekly incident summary

Week ending 13 December 2024

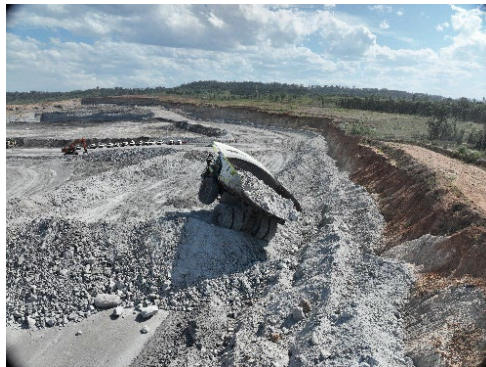
Incident type	Summary	Comments to industry
Dangerous incident IncNot0048197 Open cut coal mine Roads or other vehicle operating areas	During the process of tipping a load, the position 5 and 6 wheels of a haul truck slumped, causing the position 1 wheel to raise about 1.5 metres off the ground.	Dumping operations should conform to design and operational parameters that ensure stability and safe tipping operations. Mine operators must ensure a system is in place to monitor the compliance to these parameters at all times. Operators involved in dumping operations must be competent to do so, and have the knowledge and ability to raise timely compliance concerns when dump construction and/or operations are non-compliant.

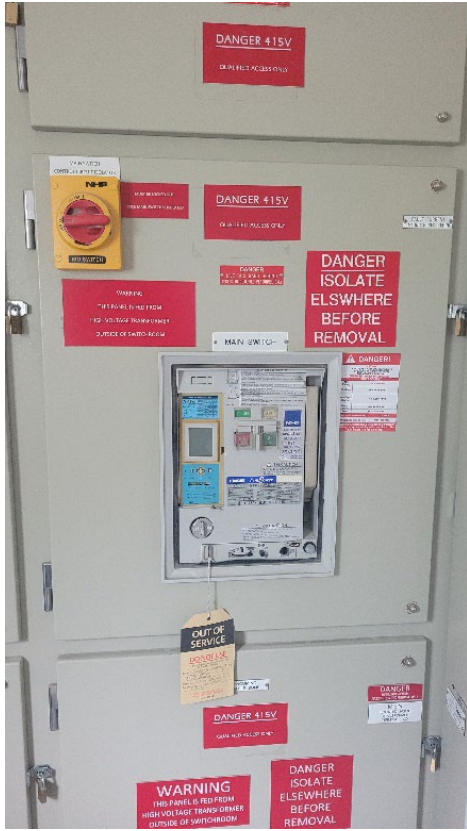
Incident type	Summary	Comments to industry
<p data-bbox="113 185 411 235">Dangerous incident IncNot0048178</p> <p data-bbox="113 297 411 369">Construction materials</p>	<p data-bbox="411 185 938 369">An electrician suffered an electric shock from a 240V source while working within an isolated (main switch) distribution board in a switch room.</p> <p data-bbox="411 369 938 593">While the electrician followed the correct isolation process for the 415V power circuit, they did not identify that there was a second, 240V control supply into the switchboard cabinet, and had not isolated the control circuit.</p>

<p data-bbox="938 185 1481 369">Mine operators must ensure that electrical panel labelling includes all supply sources in order to inform the electrician of the isolation requirements.</p> <p data-bbox="938 369 1481 492">Residual current device (RCD) protection should be installed on all 240V control circuits.</p> <p data-bbox="938 492 1481 616">When changes are made to circuitry, wiring diagrams must be updated accordingly.</p>
