Weekly incident summary

Week ending 29 November 2024

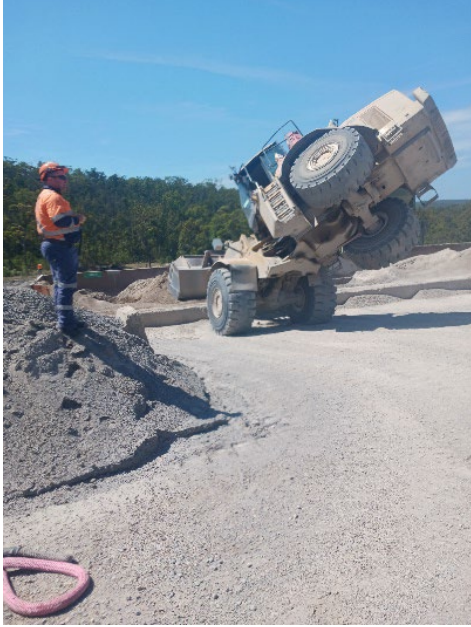
Incident type	Summary	Comments to industry
Dangerous incident IncNot0048090 Construction materials Roads or other vehicle operating areas	<p>A laden load haul dump (LHD) machine's rear wheels left the ground while the machine was being operated. The operator was removed from the cab of the machine with the assistance of an elevated work platform.</p> <p>A slight slope leading to the bins, that had built up over time, may have contributed to the vehicle tipping forward.</p>	<p>Mine supervisors should undertake frequent physical inspections of mine roadways to ensure there are no impediments to the safe operation of vehicles and that roadways remain as designed.</p> <p>Equipment operators must remain situationally aware and understand the effects of heavy loads on the tipping point of an articulated vehicle.</p>

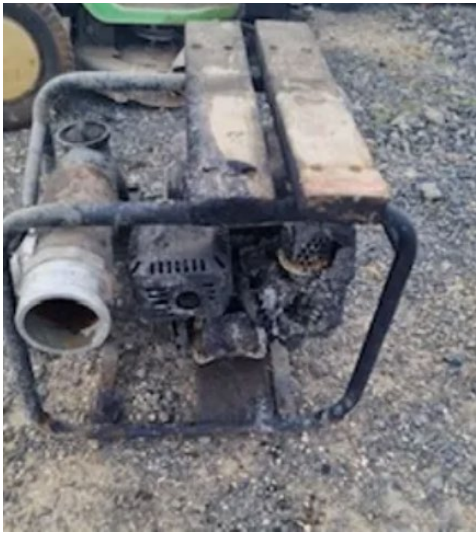
<p data-bbox="124 842 371 920">Dangerous incident IncNot0048096</p> <p data-bbox="124 938 288 1005">Construction materials</p>	<p data-bbox="429 842 874 916">A worker suffered burns to his hand when refuelling a water pump.</p> <p data-bbox="429 938 922 1120">A 20 litre drum was used instead of a 10 litre drum and the fuel spout disconnected from the drum causing uncontrolled flow of fuel onto the hot surface of the pump.</p>

<p data-bbox="954 842 1453 1066">This is the second incident involving a water pump in the past month. Mine operators should have documented safe work procedures for refuelling petrol engines and workers trained in those procedures.</p> <p data-bbox="954 1088 1465 1232">Mine operators that have petrol-powered pumps onsite should ensure that the below information is passed to workers to prevent any further incidents.</p> <p data-bbox="954 1254 1465 1435">Hot engine exhausts are a well-known ignition source. As a minimum, petrol-powered pumps should be turned off and allowed to cool down before any refuelling activities.</p> <p data-bbox="954 1458 1458 1525">Consideration should be given to using diesel engines in place of petrol engines.</p>

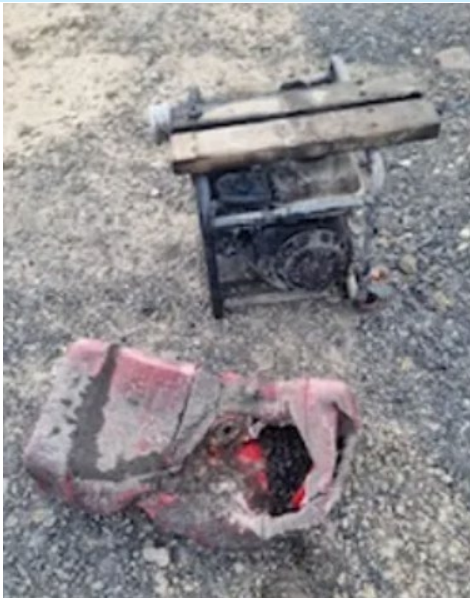
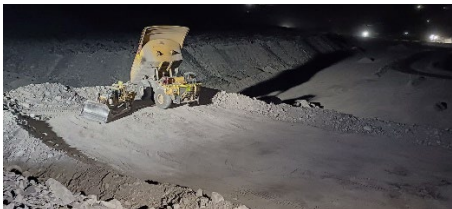
<p data-bbox="124 813 368 1059"> Dangerous incident IncNot0048108 Open cut coal mine Roads or other vehicle operating areas </p>

<p data-bbox="429 813 919 994"> A dozer and dump truck collided despite the dozer operator identifying the presence of the truck just before impact, and attempted to track forward to avoid a collision. </p> <p data-bbox="429 1019 919 1160"> The dozer was side cutting a narrow dump when the dump truck entered the dump without establishing positive communication. </p>

<p data-bbox="951 813 1430 994"> The Resources Regulator has noticed with some considerable concern, an increasing trend in vehicle interactions over the past 6 months throughout all sectors of the mining industry in NSW. </p> <p data-bbox="951 1019 1414 1160"> Mine operators must take note of the recommendations in safety bulletin: SB24-08 Recent increase in vehicle interactions </p> <p data-bbox="951 1184 1461 1290"> There have been 46 vehicle interaction notifications reported to the Regulator in the past 6 months. </p> <p data-bbox="951 1314 1461 1532"> A review of these incidents indicated that the predominant causes have been a lack of, or inadequate, communication between people involved in the incidents, as well as a lack of situational awareness on the part of operators. </p>
