Weekly incident summary

Week ending 6 December 2024

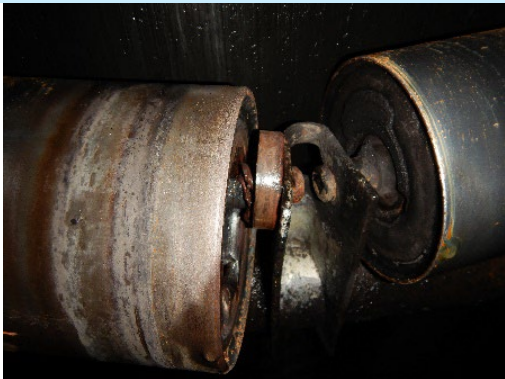
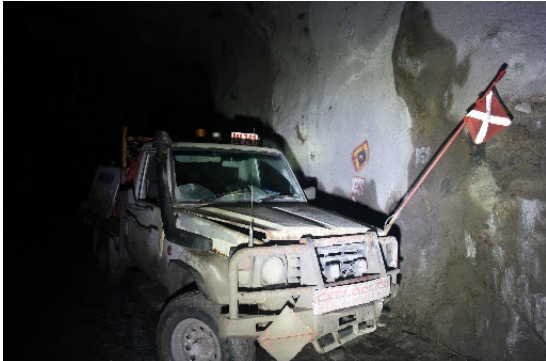
Incident type	Summary	Comments to industry
<p>High potential incident IncNot0048167 Underground metals mine Roads or other vehicle operating areas</p>

<p>A worker alighted from a light vehicle in an underground area and went to the upside of the vehicle, leaving it unattended. The light vehicle rolled away about 20 metres before colliding with the wall of the opposite drive. The operator then drove the vehicle back up the drive.</p>

<p>Vehicles must at all times be safely parked as to eliminate the risk of roll away or unplanned movements.</p> <p>Following any incident where a vehicle rolls away, under no circumstances should the vehicle be driven until the issue has been diagnosed and remedied. If the vehicle needs to be moved for repairs, adequate controls are to be implemented to move the vehicle to a safe place.</p>
