# Weekly incident summary

## Week ending 17 January 2025

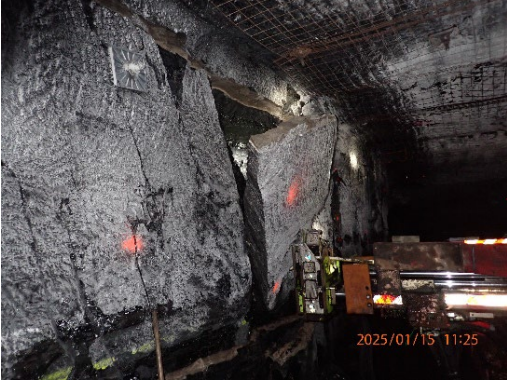
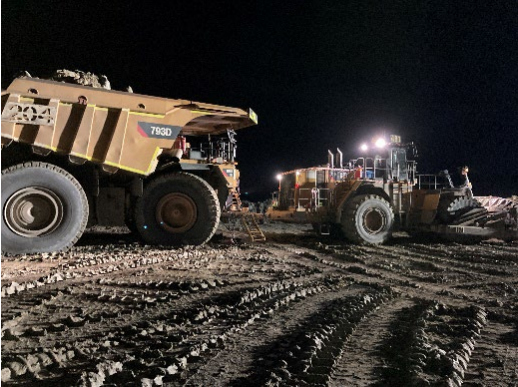
Incident type	Summary	Comments to industry
<p data-bbox="124 607 368 853">           Dangerous incident            IncNot0048381            Open cut coal mine            Roads or other            vehicle operating            areas         </p>

<p data-bbox="419 607 916 880">           A wheel dozer was working on a dump when it reversed 30 metres and collided with the front of a stationary haul truck. The truck operator was waiting for direction from the wheel dozer operator. The wheel dozer operator did not look behind him while reversing.         </p>

<p data-bbox="967 607 1463 752">           Workers have a duty to take reasonable care for themselves and others while in the workplace. Operators should always check their path when reversing.         </p> <p data-bbox="967 775 1463 954">           Mine operators should prioritise segregation between dozers and haul trucks on dumps over lower order controls such as positive communications and work procedures.         </p>
