# Quarterly safety report

October to December 2024

[resources.nsw.gov.au](https://resources.nsw.gov.au)

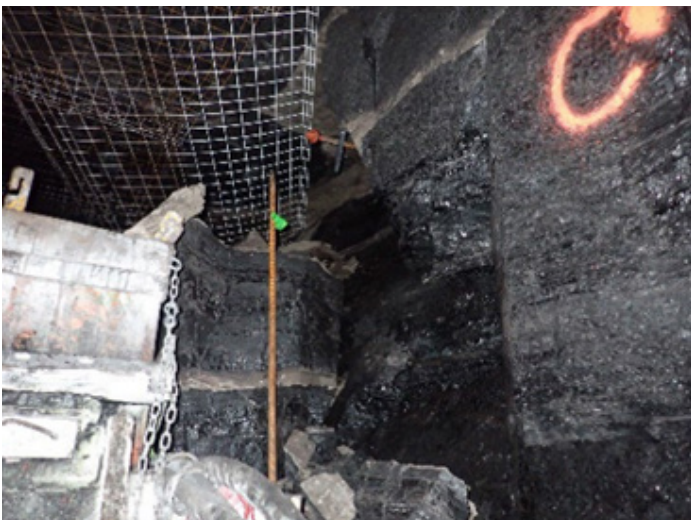
Picture 1.  
Rib fall in panel

### Dangerous incident | IncNot0047788 – Rib fall in mains panel

**Summary:** A large rib fall of about 5 m long x 3.1 m high x 1.2 m deep occurred when cutting in a herringbone mains panel. No one was present on the side of the continuous miner where the fall occurred, although a worker was on the opposite side platform. It did not appear to be a lubricated fault (greasy back). Rib support consisted of 1.2 m bolts at about 2.2-2.4 m above the floor.

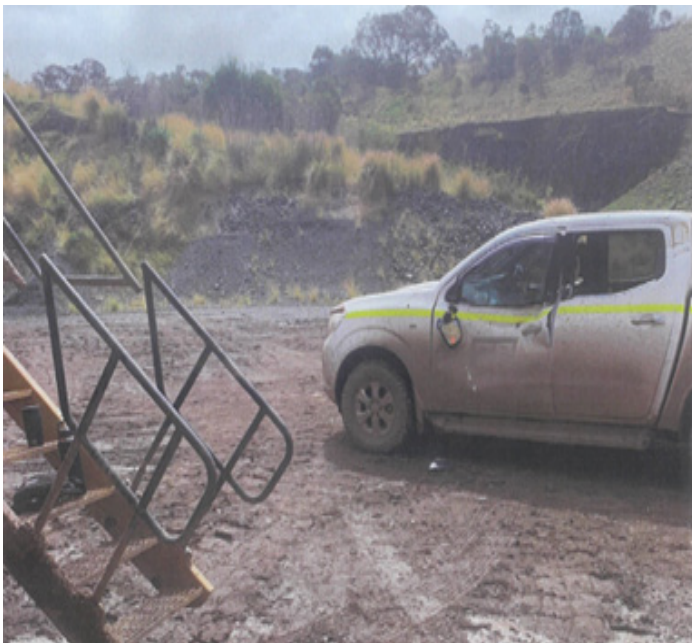
Picture 2.  
Truck ladder and damaged light vehicle

### Dangerous incident | IncNot0047769 – Haul truck and light vehicle collision

**Summary:** A supervisor pulled up near a stationary haul truck to pick up the operator. The operator, unaware of the nearby light vehicle, moved the truck forward several metres to realign it, contacting the light vehicle with the ladder, which was in the lowered position. The supervisor assumed the truck was parked up when he stopped in front of it.

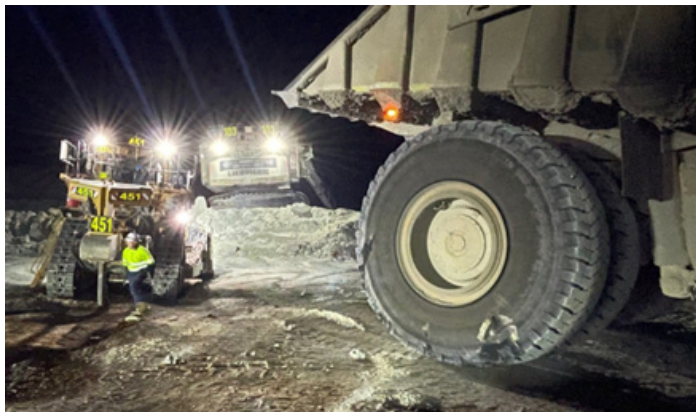
Picture 3.  
Dozer and truck interaction showing tyre scuff marks

**Summary:** A dozer was cleaning up around a dig face when a haul truck reversed into place. The truck contacted the dozer on the drivers offside. The truck driver breached the mine’s procedure by positioning the rear of the truck towards the loading unit prior to the bucket being presented.

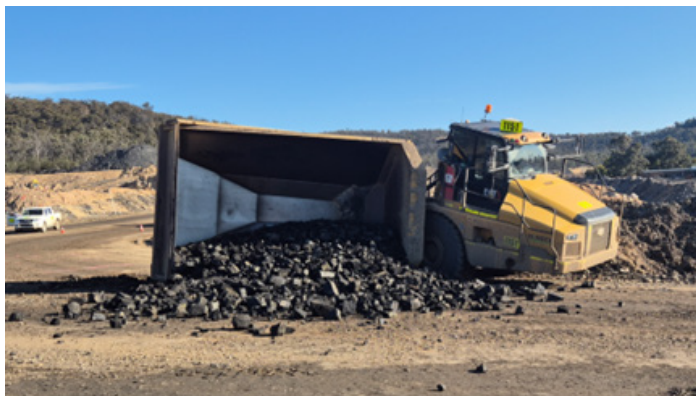
Picture 4.  
Rolled articulated dump body with spilled material

**Summary:** An articulated truck rolled its dump body while negotiating a bend. The cabin remained upright, and no one was injured.

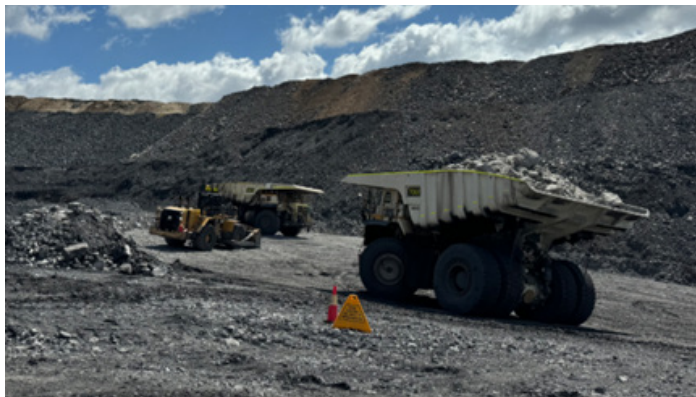
Picture 5.  
Laden haul truck stopping position

**Summary:** A loaded haul truck exceeded its retard window while descending an 8% ramp. The truck reached a speed of 60 kph before the operator made an emergency application of the service brake. The truck stopped within an estimated distance of 300 m. A working wheel dozer was positioned about 30-40 m from where the haul truck stopped.

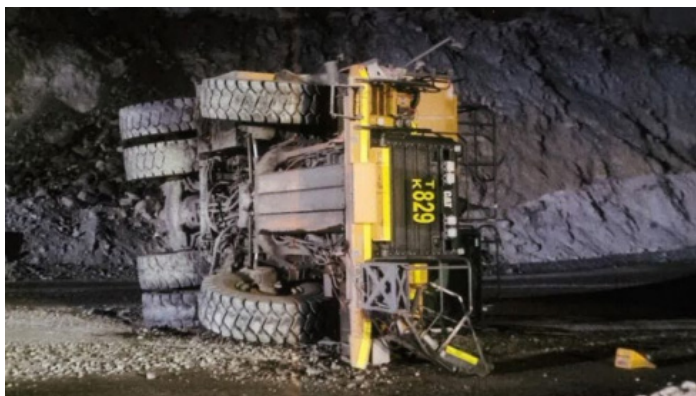
Picture 6.  
Overturned service cart

**Summary:** A service cart overturned when completing a U-turn. The cart transitioned from a wet to a dry line and overturned onto its left side. There were no injuries to the operator. Speed has been established as a major contributing factor.

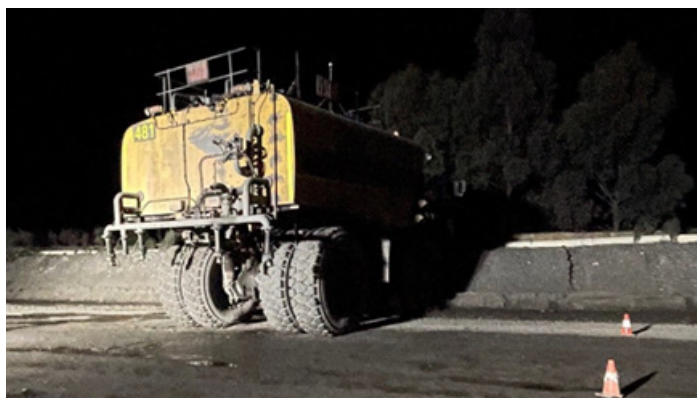
Picture 7.  
Water cart stopped on windrow

**Summary:** A water cart lost steering as it was negotiating a bend in the haul road. The water cart collided with a windrow while attempting an emergency stop. The failure was caused by low hydraulic oil level due to an undetected leak. The design did not include a low hydraulic oil reservoir level warning to alert the operator.

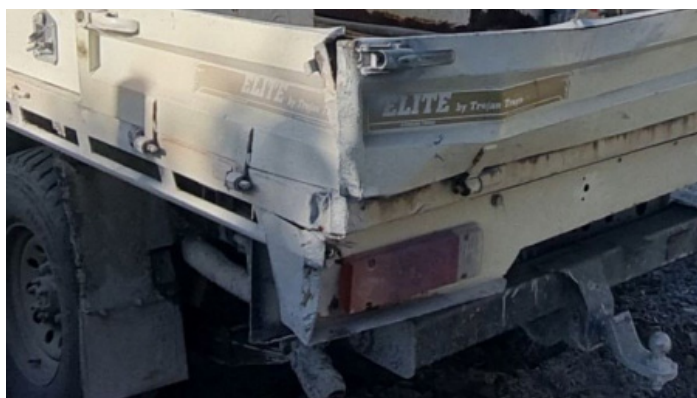
Picture 8.  
Damage to rear of light vehicle

**Summary:** A technician who was operating a light vehicle was rushing to arm barriers for a tele-remote system and failed to park the vehicle correctly before exiting it. The vehicle immediately rolled backwards about 13 metres before hitting a wall. The technician had applied the handbrake but left the vehicle running, not in gear and not parked into the wall. During the incident, the technician ran to the vehicle and tried to re-enter the cabin, but it was moving too fast.

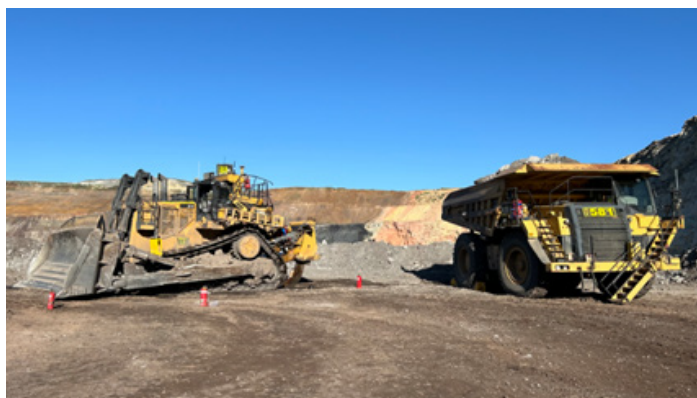
Picture 9.  
Vehicles parked after collision

**Summary:** A laden dump truck and a dozer collided while both were reversing on a dump. The offside rear corner of the dump truck dovetail collided with the left-hand, rear corner of the dozer. Both operators were uninjured in the incident.

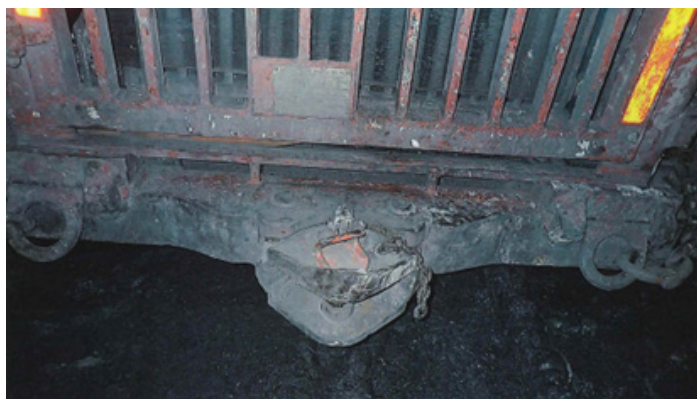
Picture 10.  
LHD collision damage

**Summary:** Two load-haul-dump machines (LHDs) collided underground. The first LHD, heading outbye, stopped at 56 cut-through to allow another vehicle to shunt past. The second LHD, in third gear and carrying a concrete kibble, failed to notice the parked LHD and collided into its rear. The scene was not preserved immediately. The operator of the first LHD, which was hit, experienced minor discomfort and was treated on site.

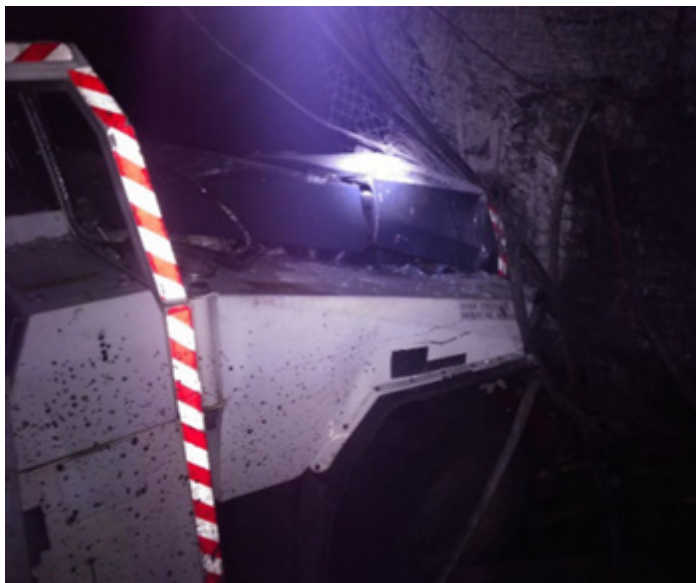
Picture 11.  
Collision damage at intersection

**Summary:** A worker was driving in an underground mine vehicle when he had a micro sleep. He woke up just before there was a collision, but when he went to brake, his foot missed the brake pedal. The vehicle collided with the corner of an intersection he was approaching. It was the worker's second night shift in 3 months.

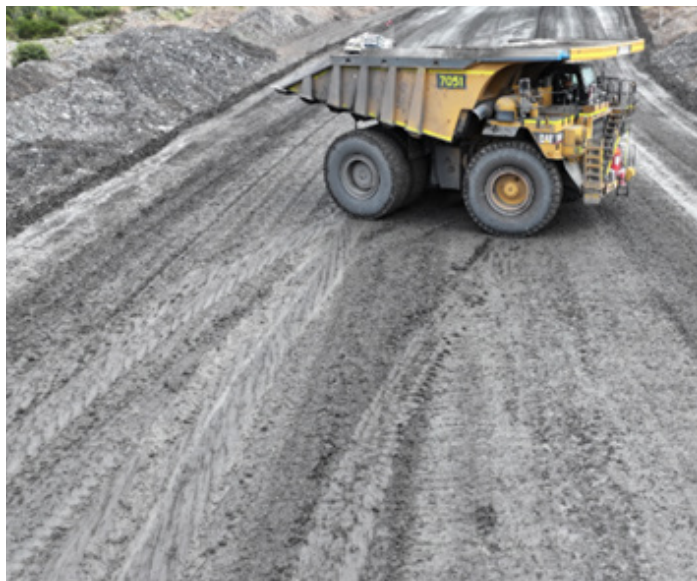
Picture 12.  
Dump truck spun on wet road

**Summary:** An empty rear dump truck slid 90 degrees clockwise while descending a ramp following wet weather. Rainfall on the previous night had resulted in a wet haul road surface. The wet weather trigger action response plan (TARP) was implemented limiting speed to a maximum of 30kph. After hauling laden onto the dump, the operator commenced the return run. On descent of a short section on the access road, the truck lost traction. It slid at low speed for about 50 metres before rotating clockwise and stopping in the middle of the road. The truck crossed the centre line of the road at this point.

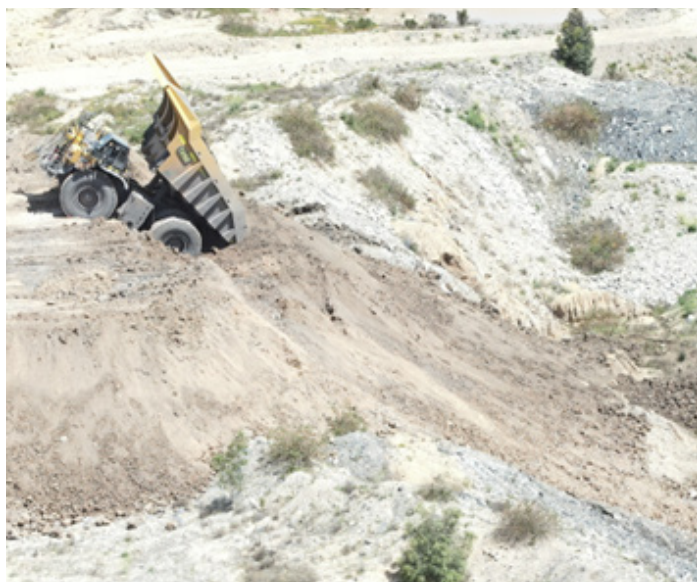
Picture 13.  
Slumped material and truck

**Summary:** A rear dump truck reversed up to a tip head and began discharging its load when the tip edge slumped, causing the rear of the truck to sink with the slumped material. The dump slumped at a slow rate. The operator exited the vehicle and was uninjured.

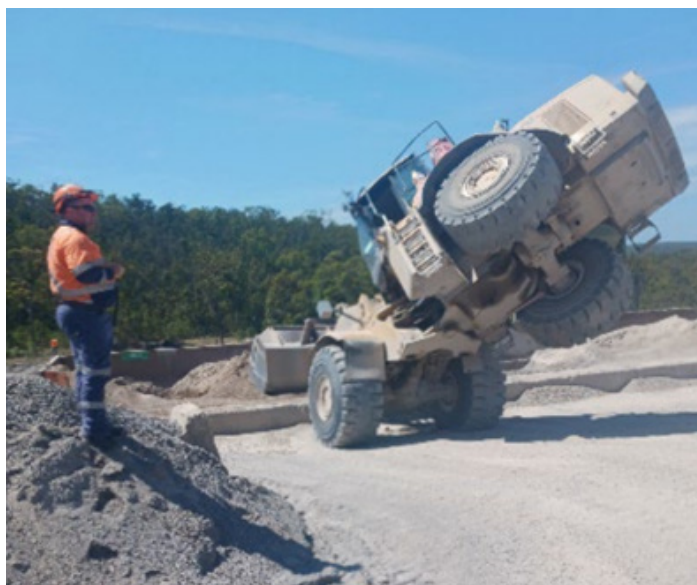
Picture 14.  
Stricken LHD with rear wheels off the ground

**Summary:** A laden load haul dump (LHD) machine's rear wheels left the ground while the machine was being operated. The operator was removed from the cab of the machine with the assistance of an elevated work platform. A slight slope leading to the bins, that had built up over time, may have contributed to the vehicle tipping forward.

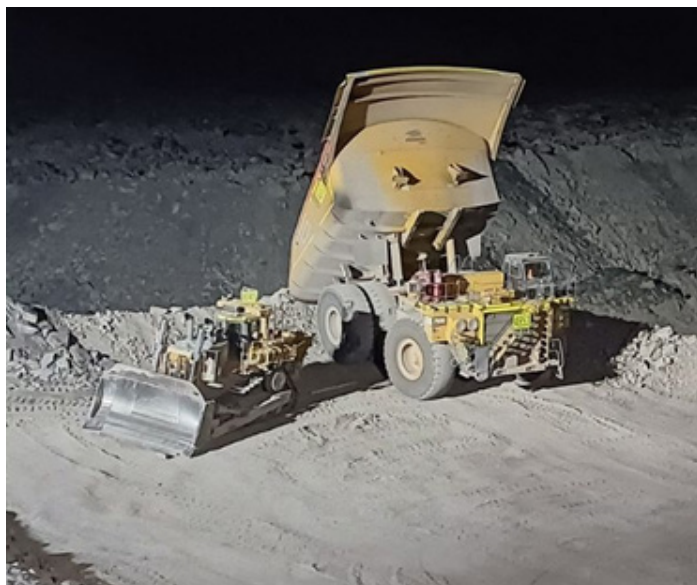
Picture 15.  
Scene of location and vehicles involved

**Summary:** A dozer and dump truck collided despite the dozer operator identifying the presence of the truck just before impact and attempting to track forward to avoid a collision. The dozer was side cutting a narrow dump when the dump truck entered the dump without establishing positive communication.

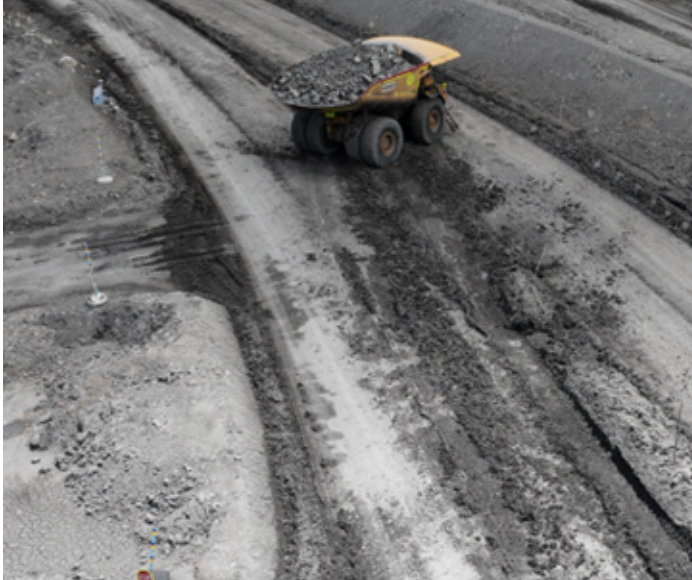
Picture 16.  
Drone view of truck after incident

**Summary:** A loaded haul truck drove into mud in the centre of a road and lost control before making contact with a centre bund and crossing the centreline of a road. The truck, being driven by a trainee operator, was travelling down a ramp of about 6% at 46 kmh when the incident occurred.

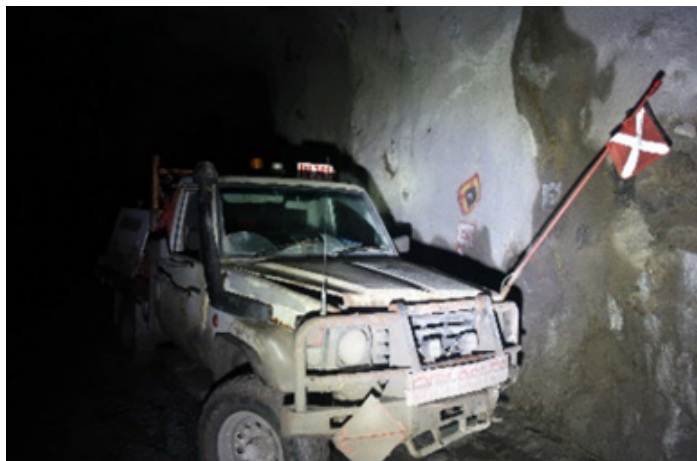
Picture 17.  
Light vehicle at wall

**Summary:** A worker alighted from a light vehicle in an underground area and went to the upside of the vehicle, leaving it unattended. The light vehicle rolled away about 20 metres before colliding with the wall of the opposite drive. The operator then drove the vehicle back up the drive.

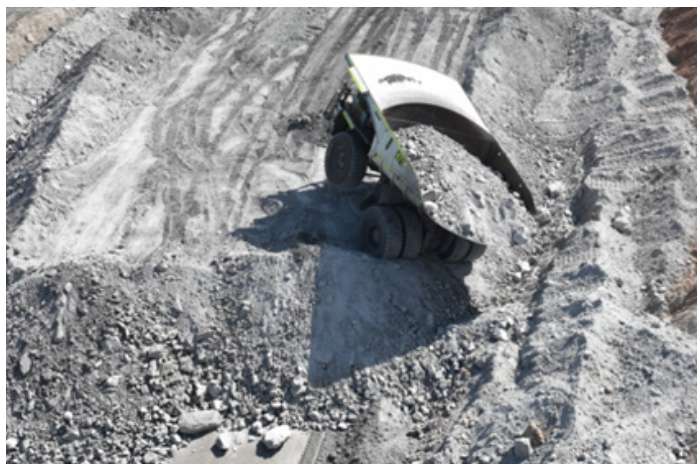
Picture 18.  
Slumped truck with raised wheel

**Summary:** During the process of tipping a load, the position 5 and 6 wheels of a haul truck slumped, causing the position 1 wheel to raise about 1.5 metres off the ground.

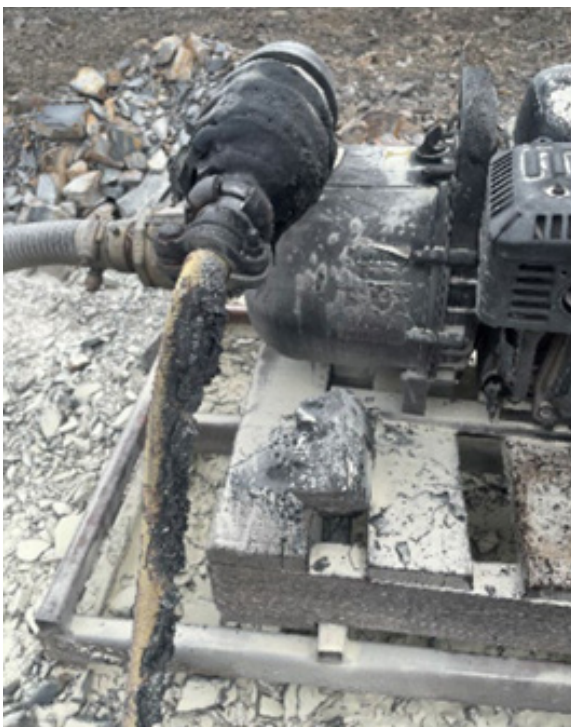
Picture 19.  
Charred pump after ignition incident

### Serious injury | IncNot0047878 – Serious burns as petrol-powered pump ignited

**Summary:** A worker suffered serious burns when the fuel being used to refill a petrol-powered pump ignited.

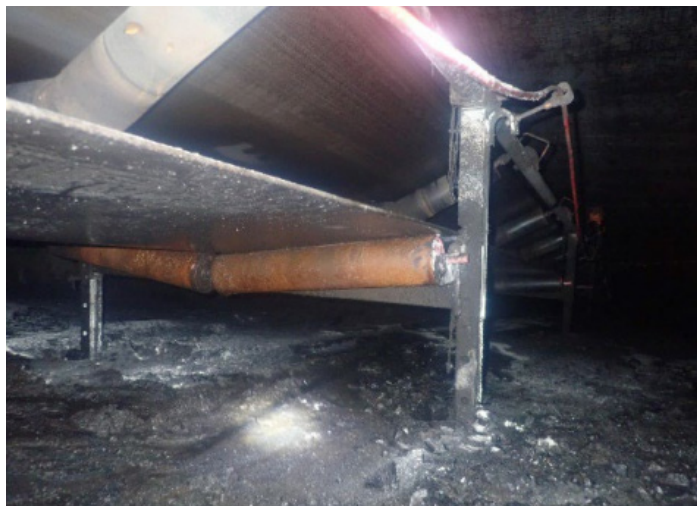
Picture 20.  
Smoke damage on conveyor structure

**Summary:** A deputy discovered a collapsed return roller on a panel conveyor belt at an underground coal mine. The deputy stopped the belt, applied a fire extinguisher and isolated the area with a fire watch in place. A preliminary investigation was initiated, and the incident was reported to the Regulator. Immediate corrective actions included replacing damaged structure legs and rollers and conducting a full review of the conveyor risk assessments and fire management plan. Three days later, smoke and embers were detected on the conveyor directly outbye the earlier incident. This was caused by the belt making contact with a restrained grease line. The conveyor had wandered beyond its intended path, with wander switches failing to trip. All belts were shut down, and a full inspection was ordered. The incident prompted a detailed audit of conveyor systems, investigation of wander switch functionality, and a review of installation procedures.

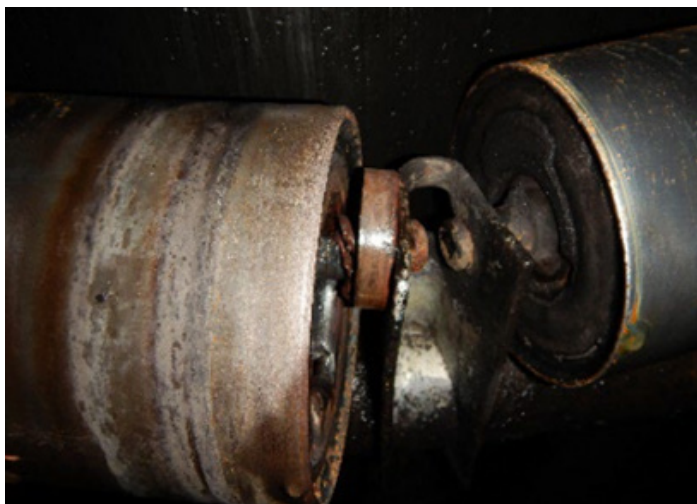
Picture 21.  
Defective roller involved in fire incident

**Summary:** A work crew was travelling inbye at a shift change when they noticed sparking from a return roller. The work crew stopped the belt, and the roller produced a visible flame for a short time before being extinguished.

**Comments to industry:** Mine operators must have systems to identify and change-out defective conveyor rollers. Workers conducting conveyor inspections must be aware of the increased risk of roller failure at high tension areas of conveyors. Mine operators must also diligently inspect for fire risks such as accumulation of material, failing or collapsed idlers and contact between conveyor belts and fixed structures.
