# Weekly incident summary

## Week ending 14 February 2025

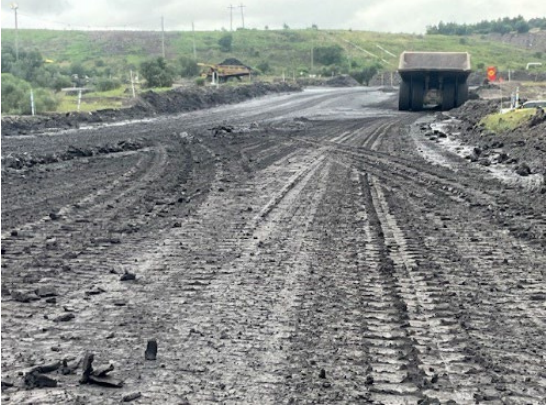
<p data-bbox="124 1480 368 1727">           Dangerous incident            IncNot0048564            Open cut coal mine            Roads or other            vehicle operating            areas         </p>  	<p data-bbox="411 1480 946 1592">           A new-to-industry trainee was operating a haul truck when the trainee felt a loss of traction.         </p> <p data-bbox="411 1615 946 1794">           The operator attempted to correct the loss of traction but oversteered and crossed the centreline of the road before correcting the steering sharply and stopping against a windrow.         </p>	<p data-bbox="986 1480 1457 1628">           Wet weather training for new truck operators must be undertaken and the driver deemed competent before driving in wet conditions.         </p> <p data-bbox="986 1650 1457 1798">           Mine operators should ensure that all truck operators have the requisite skills before they commence operating on site.         </p> <p data-bbox="986 1821 1457 1933">           When road surfaces are degraded after rain, they must be remediated as a priority.         </p>

<p>Workers must operate vehicles at a speed that is appropriate to the prevailing conditions.</p>
