Weekly incident summary

Week ending 21 February 2025

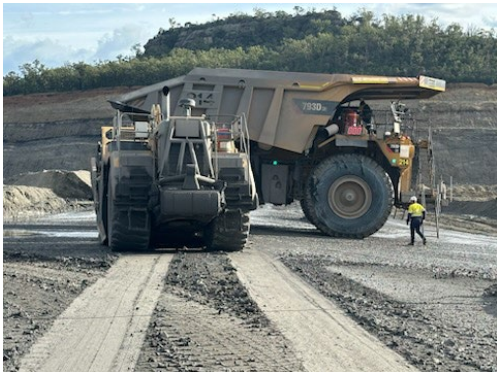
Incident type	Summary	Comments to industry
Dangerous incident IncNot0048571 Open cut coal mine Roads or other vehicle operating areas	<p>A scraper collided with a haul truck at the intersection of the main pit and a haul road.</p> <p>The scraper was operating under hierarchy conditions. The scraper slid approximately 57 metres before colliding with the haul truck.</p>

<p>When operating machinery, particularly on wet surfaces, the driver's primary focus must remain on the operation and control of the vehicle.</p> <p>Low speeds are critical in such conditions and drivers must operate vehicles at a speed that is appropriate to the prevailing conditions.</p> <p>Engineering controls that minimise the risk of loss of control should be considered, including using speed-limiting devices, speed monitoring and alarms.</p> <p>Mobile plant operating characteristics, including stopping distances, manoeuvrability and speeds must be considered when developing control measures to manage the risks of operating vehicles.</p>
