# Weekly incident summary

# Week ending 14 March 2025

This incident summary provides information on reportable incidents and safety advice for the NSW mining industry. To report an incident to the Resources Regulator: phone 1300 814 609 24 hours a day, 7 days a week.

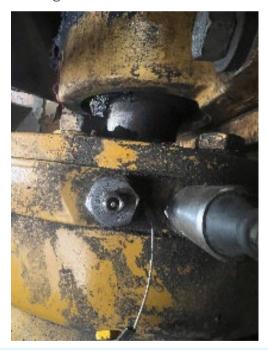
# Dangerous incident IncNot0048716 Open cut coal mine

A fourth year auto electrical apprentice was fault finding on an electrical pressure sensor on the right-hand front strut of a CAT 775G service truck.

After finding no fault on the electrical pressure sensor, a supervisor directed him to test the strut's internal pressure at the charge valve.

Rather than attaching the original equipment manufacturer (OEM)-recommended pressure-measuring assembly, the apprentice unscrewed the charge valve, resulting in the forcible ejection of the valve and the contents of the strut, including nitrogen and hydraulic oil. The worker was covered with oil from the valve port.

Under the weight of the truck, the strut retracted allowing the truck to fall about 200 mm and pushing the worker from the step ladder from which he was working.

Supervisors have a duty to ensure that workers under their care are not exposed to dangerous situations. Supervisors should be trained to recognise the potential hazards associated with all energy sources and should assess the risks involved when working with pressurised systems and have appropriate controls in place to manage the risk.

Mine operators should have documented safe systems of work for the maintenance or repair of wheel strut charge valves with the documentation being readily available to those undertaking such tasks. OEM recommendations must be considered when developing procedures for tasks.
