Weekly incident summary

Week ending 21 March 2025

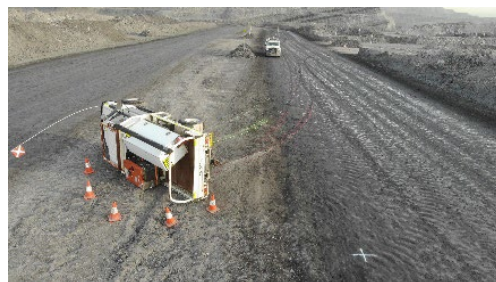
Incident type	Summary	Comments to industry
Dangerous incident IncNot0048782 Underground metals mine Roads or other vehicle operating areas	<p>A light vehicle operator was travelling on a haul road when they lost control of the vehicle and rolled it onto its left side. The driver was the single occupant in the vehicle.</p> <p>The road was flat and straight and was watered to the mine's standard at the time.</p> <p>The vehicle had worn tyres, which contributed to the loss of traction.</p>	<p>Multiple incidents of this nature have been notified recently. Mine operators should communicate this with workers and reinforce relevant controls.</p> <p>Tyre condition is crucial to maintaining stability on wet roads. When operators report defects or concerns, thorough inspections should be conducted to ensure vehicles are safe to operate. Where vehicles are found not to be safe to operate they are to be removed from service until repaired.</p> <p>Engineering controls that minimise the risk of loss of control should be considered, including using speed-limiting devices, speed monitoring and alarms.</p>

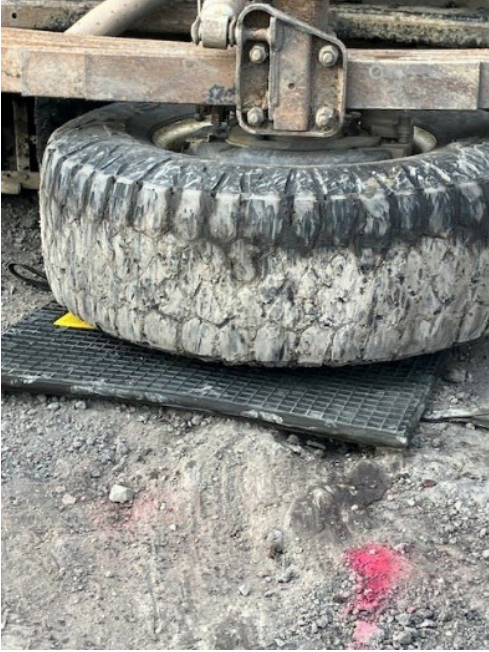
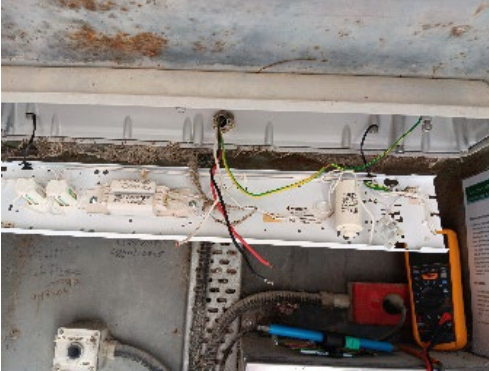
<p>Dangerous Incident IncNot0048795 Industrial minerals</p>	<p>A fourth year electrician suffered an electric shock while changing a fluorescent light. The light circuit was isolated and tested under supervision before the work began. The apprentice was exposed to a live circuit within the casing when changing the light.</p> <p>There were 2 power sources to the light fitting from 2 separate circuit breakers. Drawings for the electrical installation were not up to date.</p>

<p>Mine operators must ensure that fit-for-purpose electrical installations are maintained in a state without risk to workers.</p> <p>The Resources Regulator is concerned with a recent trend of electrical apprentices suffering shocks. Mine operators should have robust systems in place for supervising at-risk workers such as apprentices.</p> <p>At a minimum, mine operators should ensure that:</p>

<ul style="list-style-type: none">• circuit board diagrams are up to date• redundant equipment is removed• circuit breakers are the correct sizes• the purpose of each circuit breaker is clearly identified with labels• there are no loose terminations• all supervisors can identify the skills and training levels of apprentices to ensure safe task allocation and supervision levels. <p>For further information read the safety bulletin:</p> <p><u>SB20-03 Electric shocks in the mining industry</u></p>
