Investigation information release

Worker seriously injured after roof collapse engulfs drill rig at gold mine

Incident date: 9 March 2025

Investigation information release IIR25-04

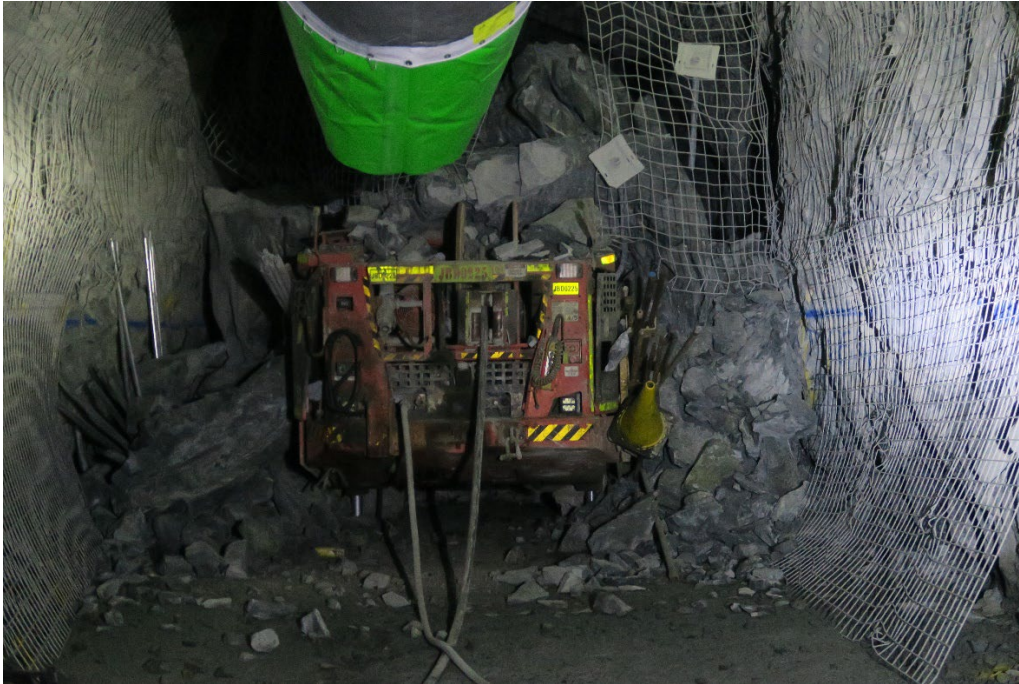
During operations, a significant roof collapse occurred. The collapsed roof was estimated to be about 10.9 metres in length by 4.4 metres tapering in towards the rear of the drive, with a wedge shape extending to an apex of about 2.7 metres. The jumbo, including the operator's cabin, was engulfed and partially buried by the material. The operator suffered a laceration while extricating

Figure 1: The jumbo drill rig partially buried by the roof collapse
