Weekly incident summary

Week ending 28 March 2025

Weekly incident summary week ending 28 March 2025

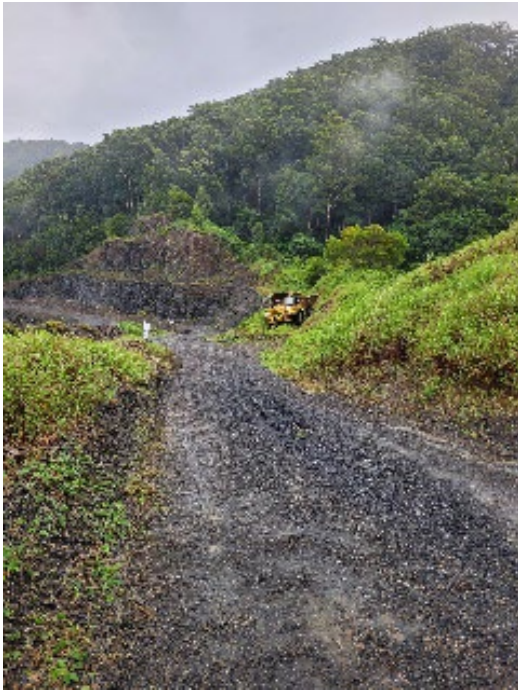
<p>A haul truck lost power on a ramp and rolled 30 metres backwards before coming to rest on a bench.</p> <p>The operator had stopped on the ramp with the motor running, waiting for another task to be completed. When the task was completed, the operator put the truck in gear, released the handbrake and took his foot off the footbrake to accelerate.</p> <p>The engine cut out and the truck began rolling backward. The operator pumped the footbrake and pulled the retarder up and down multiple times with no result. He couldn't use the secondary retarder as he was trying to steer the truck.</p> <p>He managed to steer the truck over a water diversion bund and bring it to a halt.</p>	<p>Mine operators must have systems in place to ensure the regular review and effectiveness of fit-for-purpose safety critical components over their lifecycle. This includes driving, braking, steering and emergency systems.</p> <p>Further information may be published later.</p>

Incident type	Summary	Comments to industry
	<p>The cause of the failure is being investigated.</p>

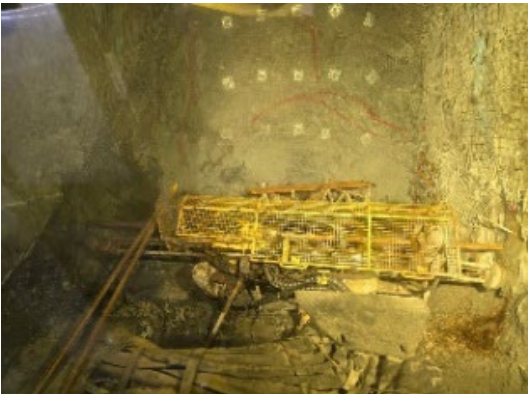
<p>Dangerous incident IncNot0048838 Underground metals mine</p>	<p>A diamond drill offsider was hit in the abdomen and pinned against a wall by the rear of a drill string.</p> <p>The offsider was walking past the back of the drill string, where there was minimal space, when the drill operator selected the rod pulling option instead of the rod feeding option, resulting in the offsider being hit and trapped when the joystick was engaged.</p> <p>The offsider was taken to hospital to assess his injuries.</p>

<p>Drill operators need to remain aware of their offsider's location when pushing and pulling rods. The carriage should not be moved if you are not aware of their position in relation to the rig.</p> <p>Positive communications should be established to confirm the offsider's location and to alert them when the drill is about to be activated.</p> <p>Mine operators should reinforce the application of drilling procedures, including the need for positive communications.</p>
