Weekly incident summary

Week ending 4 April 2025

This incident summary provides information on reportable incidents and safety advice for the NSW mining industry. To report an incident to the Resources Regulator: phone 1300 814 609 24 hours a day, 7 days a week.

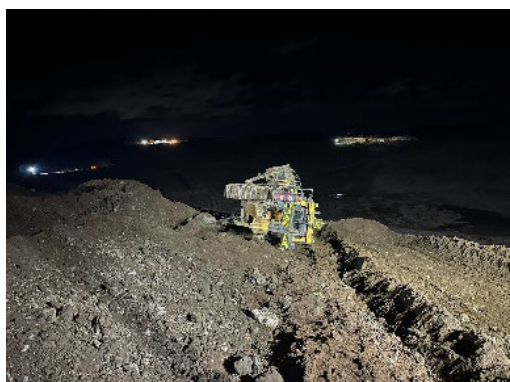
Incident type	Summary	Comments to industry
Dangerous incident IncNot0048853 Open cut coal mine Roads or other vehicle operating areas	<p>A dozer rolled onto its side when travelling over wet material on one track and mounted a large rock with the other track.</p> <p>The operator was able to exit the dozer and was unharmed.</p>

<p>Pre-task inspections of work areas should be undertaken to identify and manage hazards. This includes confirming lighting is adequate for the tasks being conducted. Dozer operators should remain situationally aware while the dozer is in motion and continually assess the work area for hazards. Pre-task inspections of work areas must be monitored and confirmed by supervisors. Refer to the safety bulletins:</p> <p><u>SB19-01 Rise in dozer incident putting operators at risk</u></p> <p><u>SB19-10 Dozer incidents increase despite warnings</u></p>
Dangerous Incident IncNot0048854	<p>While dumping a load at a tip head, the ground gave way beneath haul truck,</p>	<p>Tip heads and dumps must have suitable inspection regimes in place. Changes in conditions, such as wet</p>

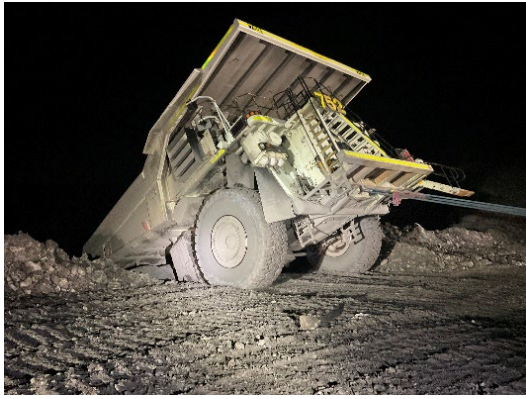
<p>causing the back of the truck to sink up to the axle.</p>

<p>weather, should trigger an increase in inspection frequency.</p> <p>Design of dumps and catch bunds should consider areas where water can accumulate.</p> <p>When dumping near bodies of water or mud, strict controls should be implemented based on robust risk assessment processes.</p> <p>Refer to the safety bulletin: <u>SB20-01 Failure of highwalls, low walls and dumps.</u></p>
<p>Dangerous incident IncNot0048860 Underground coal mine</p>	<p>The operator of a load haul dump (LHD) machine carrying a concrete kibble applied the park brake so that a worker could operate the controls on the kibble to empty out the concrete.</p> <p>The worker observed that the kibble had tilted and moved away from the area adjacent to the kibble. The kibble released from the LHD quick detach system (QDS) plate, falling from a height of about 2 metres to the ground.</p> <p>Nobody was injured.</p>
