**NSW
Resources
Regulator**

COMPLIANCE AUDIT PROGRAM

TRITTON OPERATIONS, NYNGAN NSW

Tritton Resources Pty Ltd

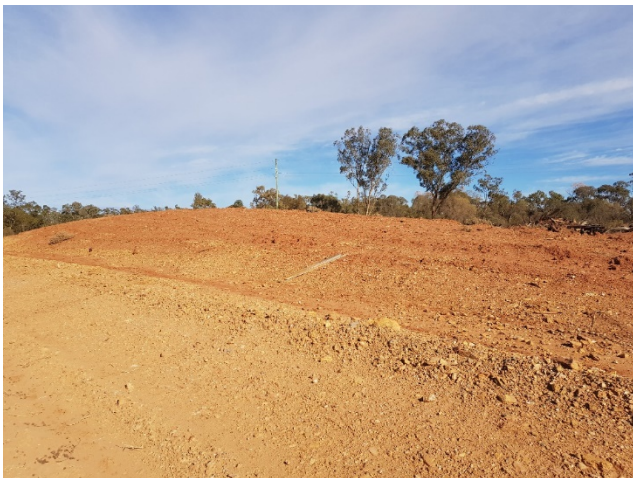
Figure 1 shows an example of a topsoil stockpile on the northern side of the TSF that had generally been constructed in accordance with drawing SD4-1 in the plan. However, it was noted that no erosion and sediment controls were installed around the stockpile. Figure 2 shows another topsoil stockpile to the south of the TSF that has been established using a paddock dumping technique, which is not in accordance with the requirements of the ESCP. This is raised as **observation of concern no. 1**. Tritton should review the procedures for topsoil management having regard to the risks associated with topsoil stockpiling.

Figure 1 Shaped topsoil stockpile to the north of the Tritton TSF

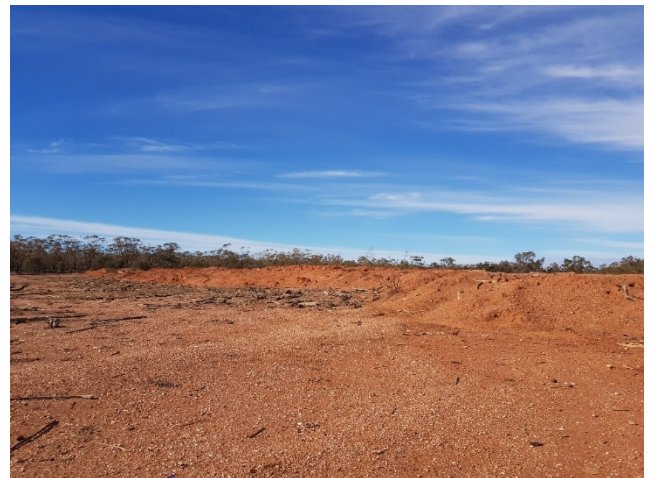
Figure 2 Paddock dumped topsoil stockpile to the south of the Tritton TSF

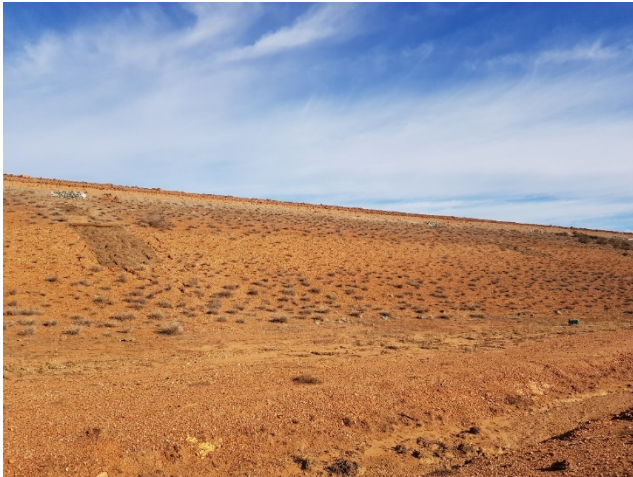
There is an emerging risk to rehabilitation success on the batters of the TSF because of adverse climatic conditions and soil fertility that have only been partially addressed. Topsoil quality is poorly understood and little in the way of testing has been done to ascertain different grades of topsoil. The lack of characterisation has resulted in sodic topsoil being placed on the TSF batters and erosion is evident on areas with this soil type (Figure 3). This is raised as **observation of concern no. 4**. Further investigation and testing should be undertaken to determine remedial actions to reduce the risk of further erosion of the embankment.

Figure 3 Erosion on the western embankment of the TSF

Erosion of the TSF embankments would trigger the TARP in Section 9.2 of the MOP either for ‘final landform not safe, stable and secure’ or ‘sediment and erosion control structures inadequate or fail’. The responses for each of these triggers involve the engagement of a technical expert to prepare an assessment report and recommendations. Tritton provided a copy of *Erosion and sediment control procedures – Tritton Tailings Dam 1: Management recommendations* prepared by CMW Geosciences dated 27 August 2018, which was prepared in response to the erosion issues identified on the TSF embankments. This would indicate that the TARP actions were initiated. The recommendations provided by CMW Geosciences included additional investigation work to better understand the lack of success experienced in the revegetation of the western embankment.

Further, it would be beneficial to consider repairing erosion before implementation of erosion control works. The installation of jute mesh in relation to discharge points on the TSF has been ineffective and will not arrest erosion unless the underlying surface is repaired.

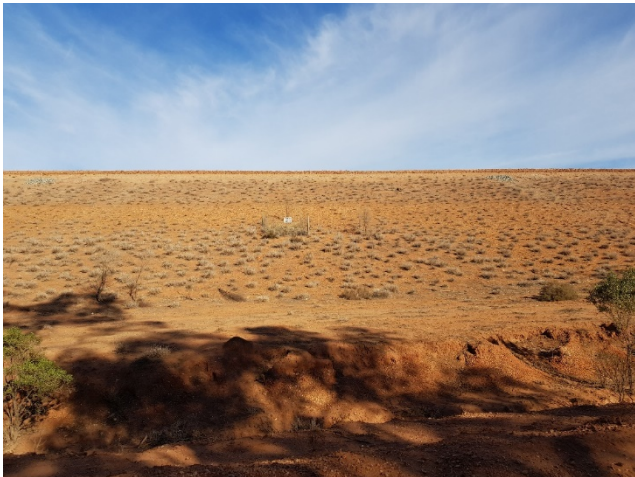
results, it would be reasonable to expect some asset protection measures (i.e. fencing) but no exclusion zones were observed to have been established on rehabilitation areas at Tritton. This is raised as **observation of concern no. 5**. Tritton should review the trial plot results and establish controls to minimise the impact of grazing animals.

Figure 4 Small exclusion trial plot on the TSF embankment

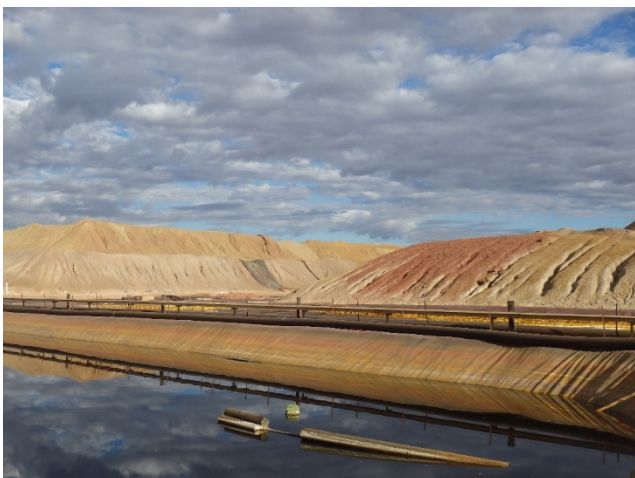
The approved MOP for the Murrawombie Mine indicates that 10.8 hectares of the heap leach pads (HLP) were to be rehabilitated in year six of the MOP (2021), with a further 10.8 hectares rehabilitated by the end of the MOP period (2022). Rehabilitation of the HLP appears to be behind schedule as the pads are still actively used (Figure 5) and no rehabilitation actions have progressed to date.

Figure 5 Heap leach pads and pregnant liquor pond at Murrawombie Mine

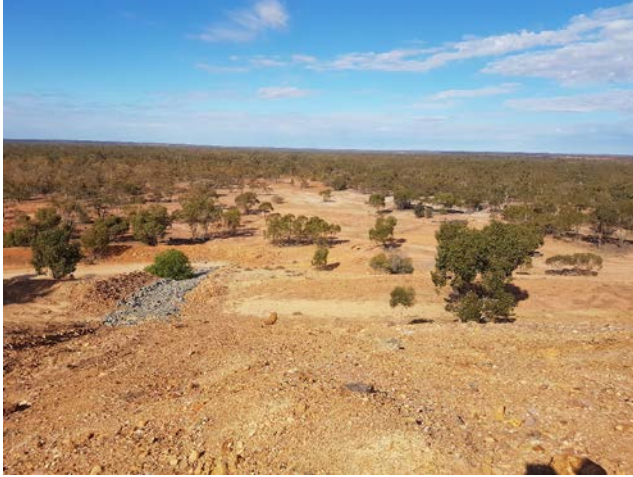
It was observed that the Hartman-Larsens WRE was poorly vegetated and unstable in several areas. It was also noted that there was no erosion and sediment control plan for the site. The sediment basin on the southern flank of Hartman-Larsens WRE appeared to be undersized and a fan of sediment was observed during the site inspection originating from the sediment dam indicating it was overtopped on several occasions in the past (Figure 6).

Rehabilitation performance was also poor at this WRE and issues included landform instability, inadequate growth medium development and poor revegetation outcomes. It was noted that the TARP contained in the MOP included requirements to engage with relevant technical experts about growth medium development and revegetation, however in a similar manner to the Murrawombie WRE, no technical consultation was undertaken to address these issues. Consultation and planning are required before undertaking further work to ensure target outcomes are achieved. This is raised as **observation of concern no. 7**.

Figure 6 Sediment overflow from undersized basin

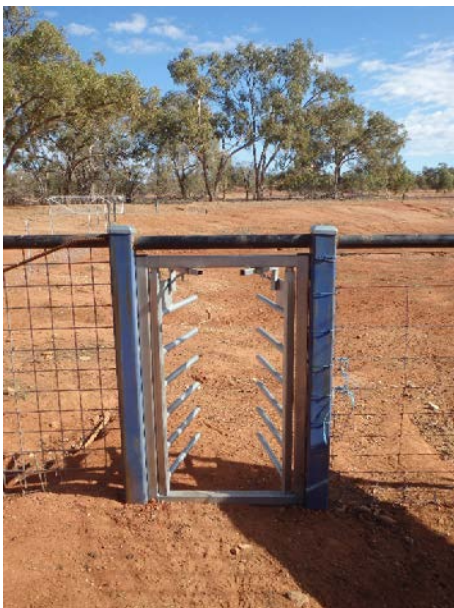
Rehabilitation monitoring at North East Mine identified that grazing animals were a risk to rehabilitation outcomes and exclusion fencing has been implemented at the mine. Tritton has also constructed a goat trap (Figure 7) to trap and remove goats that do find their way into the rehabilitation area.

Figure 7 Goat entry on the goat trap behind the WRE rehabilitation area

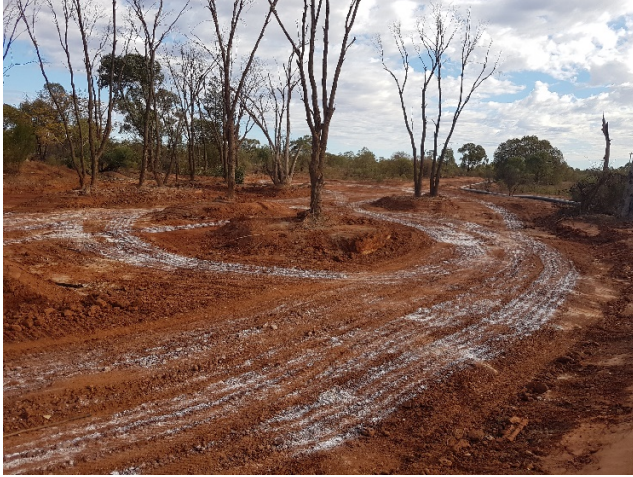
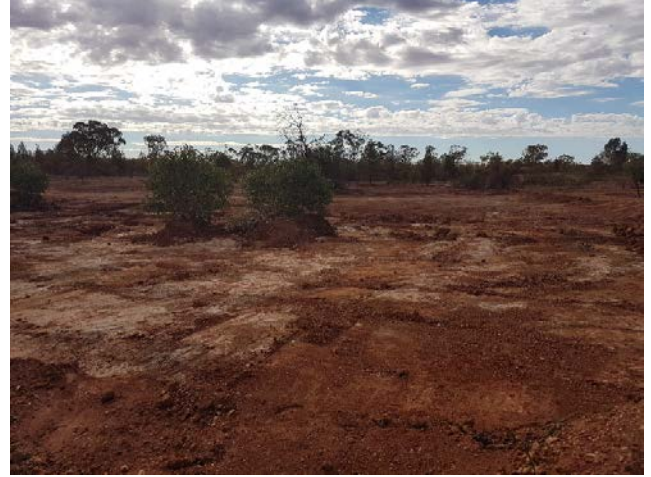
The site of the spill was inspected during the audit and it was noted that the area had been remediated and had recently been reseeded (Figure 8 and Figure 9). The water pipeline had been segmented to assist in isolating any future failures of the transfer pipeline. The site will continue to be monitored by the site environmental advisor and validation testing will be carried out to measure the effectiveness of remediation. It was noted that the incident continues to be managed by the EPA.

Figure 8 Remediation of the water pipeline spill area

*Figure 9 Remediation of the water pipeline spill area*

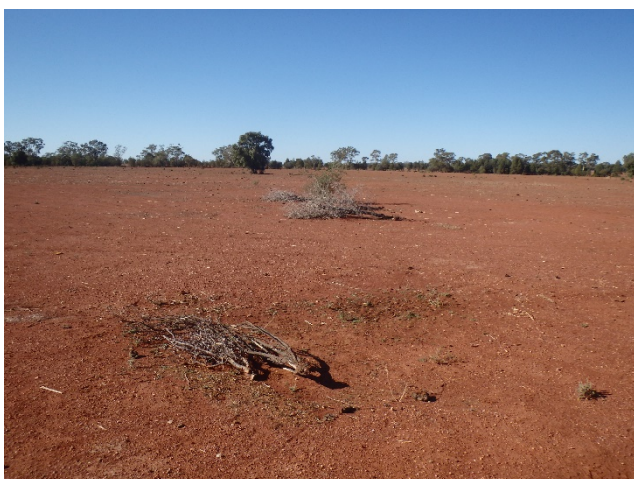
The two holes inspected on EL4962 had both had final rehabilitation completed, having been drilled in April 2018. Generally, no significant issues were identified. Figure 10 and Figure 11 show the sites of the two holes drilled on EL4962.

Figure 10 Exploration drill site TGHRC005

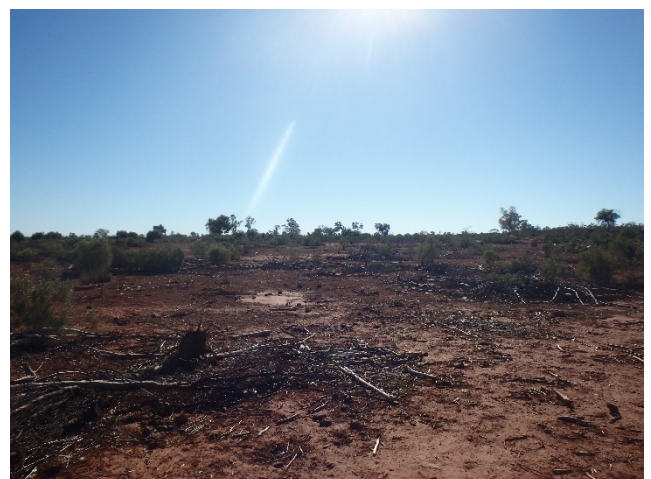
Figure 11 Exploration drill site TGHRC004

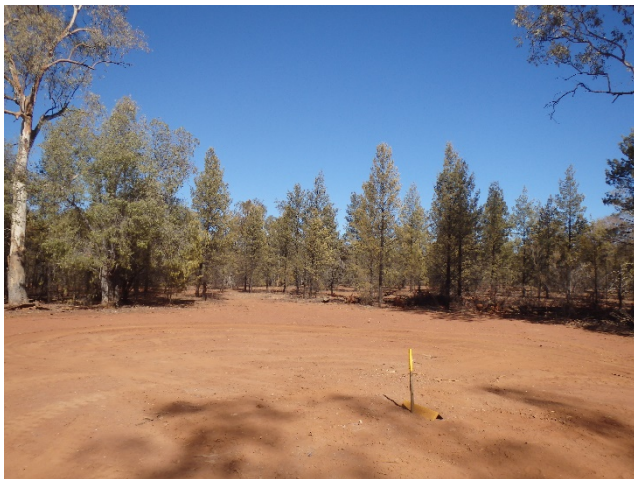
The sites of the holes inspected on EL6126 that were drilled in late 2018 and early 2019 were tidied up with wastes and aboveground sumps removed but had not had final rehabilitation undertaken. Generally, no significant issues were identified at these sites. Figure 12 and Figure 13 show examples of the preliminary rehabilitation on the holes drilled in early 2019.

Figure 12 Exploration drill site TKJD024

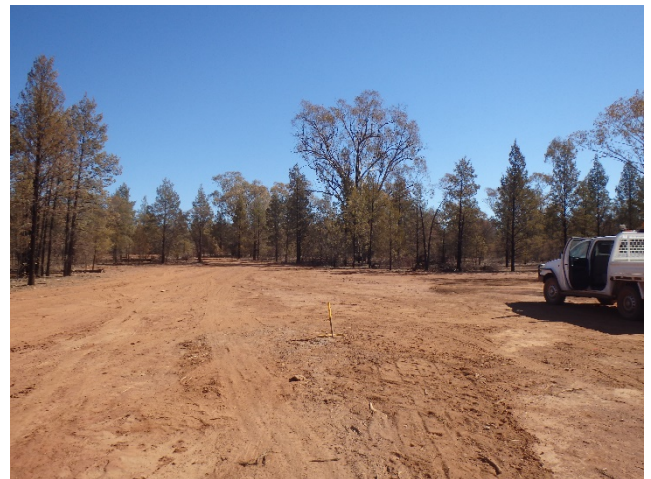
Figure 13 Exploration drill site TKJD017

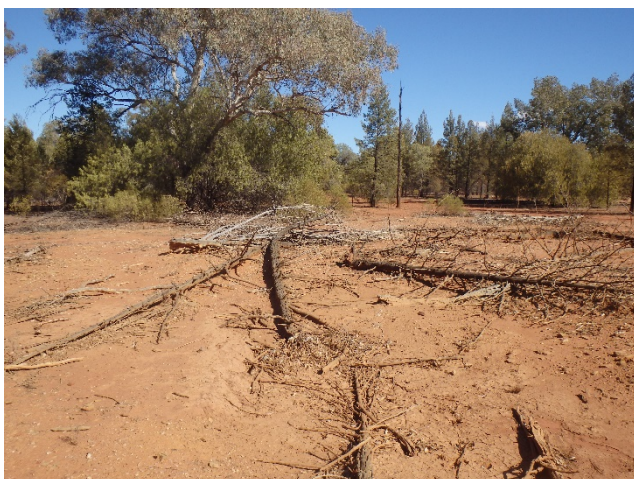
During the inspection of holes drilled in 2019, an opportunity arose to inspect a drill site that was drilled and rehabilitated in 2013. This site was drilled using inground sumps rather than the aboveground sumps that are now used. As shown in Figure 14, the area of the inground sumps has sunk and remedial works may be required to achieve the completion criteria. This is raised as **observation of concern no. 8**.

Figure 14 Exploration drill site TKJD008 showing sumps have subsided

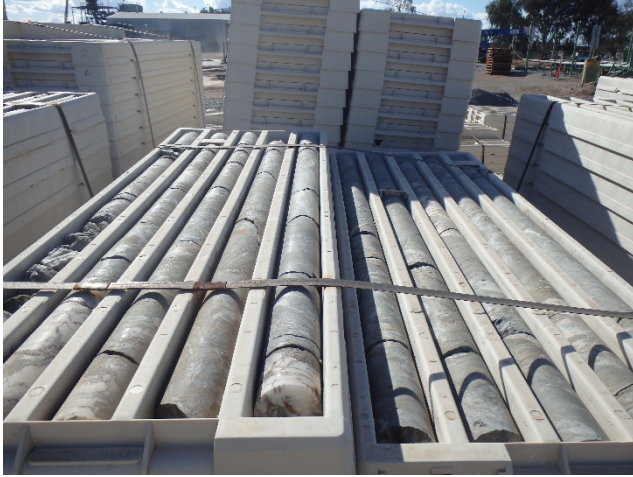
It was observed that both chip samples and core were collected from drilling programs conducted on EL4962 and EL6126. Core was observed to be maintained in modular plastic core trays (Figure 15) in a large core yard (Figure 16), while chip samples were observed to be stored in modular plastic chip trays (Figure 17) in shipping containers (Figure 18). All core and samples inspected were observed to be appropriately labelled.

Figure 15 Core stored in modular plastic core trays

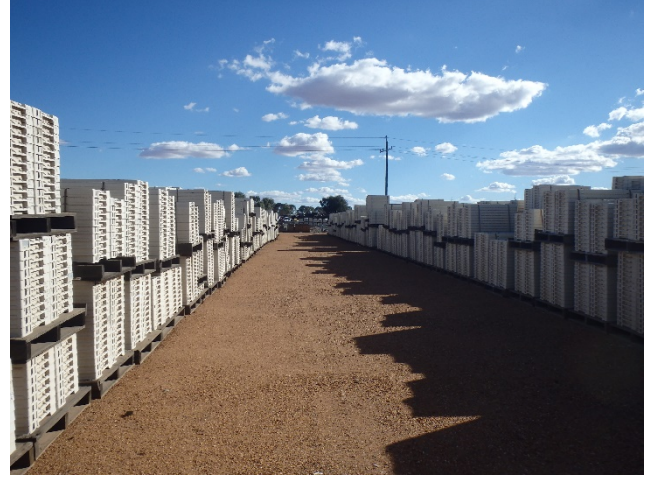
Figure 16 The Tritton core yard

Generally, storage of core and samples was observed to be well managed. The location of core trays and chip samples within the core yard has been mapped so that locating particular samples is an easy process.

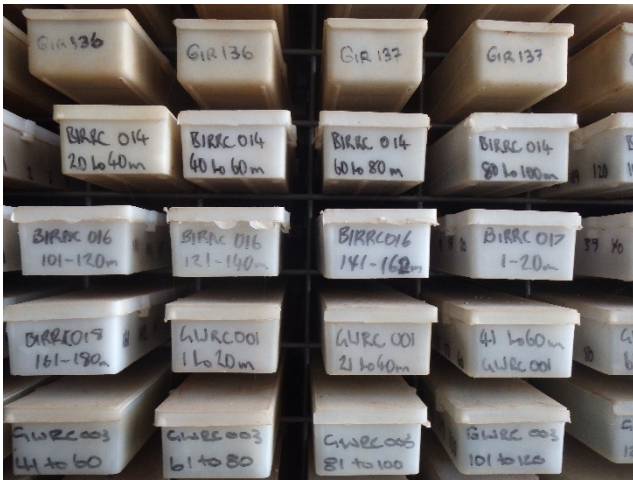
Figure 17 Chip samples stored in plastic chip trays

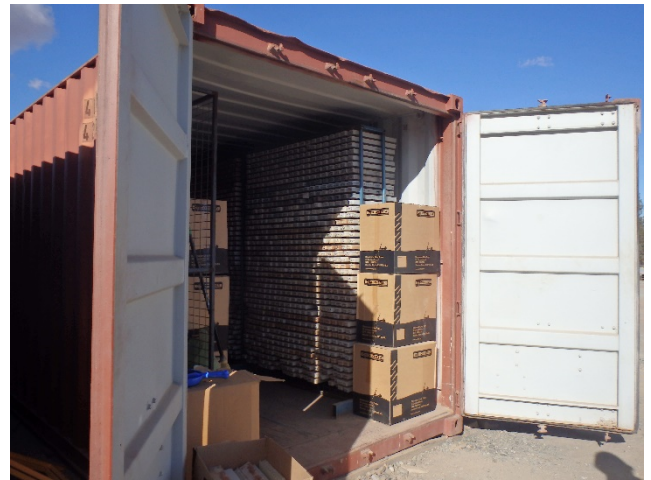
Figure 18 Chip tray storage in a shipping container
