**NSW
Resources
Regulator**

COMPLIANCE AUDIT PROGRAM

EL7223 EXPLORATION DRILLING PROGRAM

Shenhua Watermark Coal Pty Ltd

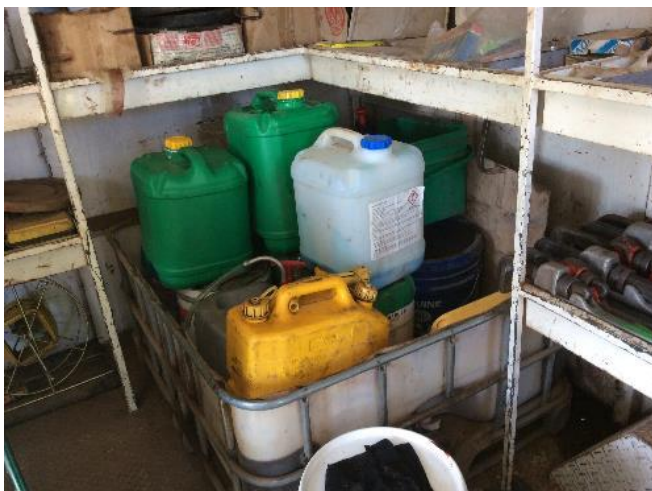
Drilling fluids, oils, greases and other chemicals were observed to be stored in a bunded container within the Mannion Drilling site caravan (refer to Figure 1). Discussion with Mannion staff indicated that all drilling staff were trained in the correct use, handling and storage of chemicals, fuels and oils.

Figure 1 Chemicals and fuels stored on bunded pallet in drillers caravan

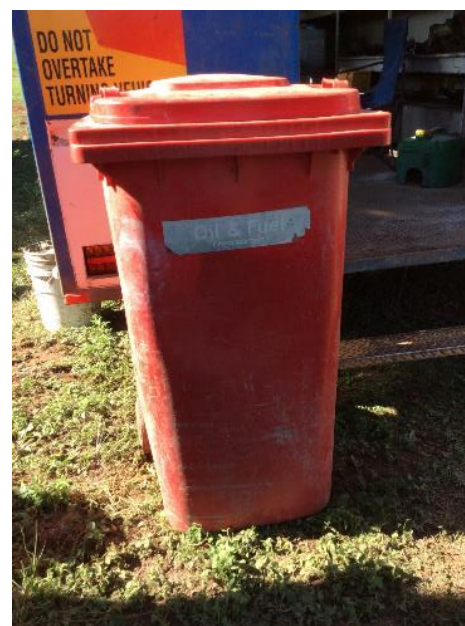
A fully stocked spill kit was observed on site at BH22 which was the hole being drilled. The kit included absorbent materials, spill control matting and spill socks. The spill kit was located outside of the drilling caravan adjacent to the drill rig and was easily accessible by staff on the drill site (refer to Figure 2).

Figure 2 Fully stocked spill kit outside drillers caravan

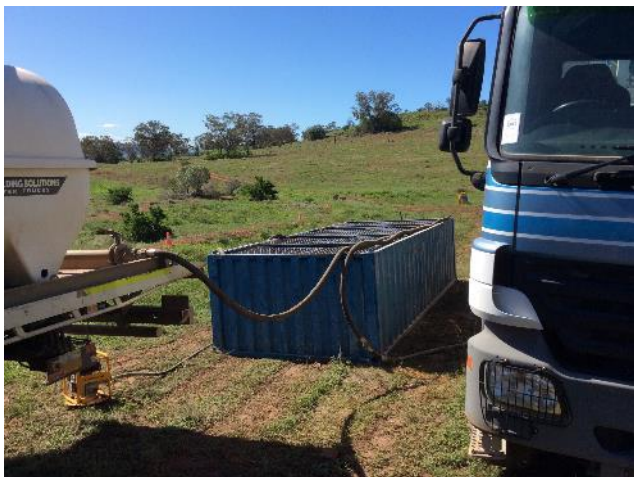
An aboveground sump (metal skip bin) was observed in place at BH22 to contain drilling fluids, although drilling was not in progress at the time of the inspection (refer to Figure 3). Sediment fencing was observed to be in the process of being erected on the downslope side of the drilling fluids bin (refer to Figure 4). Water for drilling was observed to be trucked into each site.

Figure 3 Aboveground metal sump for drilling muds/returned water at BH22

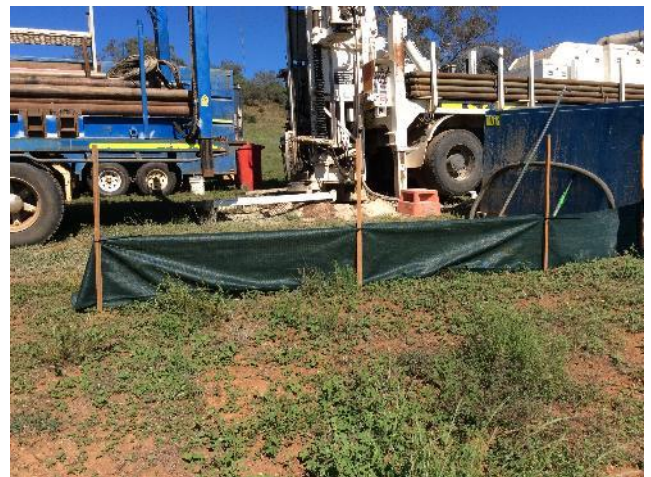
Figure 4 Sediment fencing erected downslope of drill rig and adjacent to aboveground sump at BH22

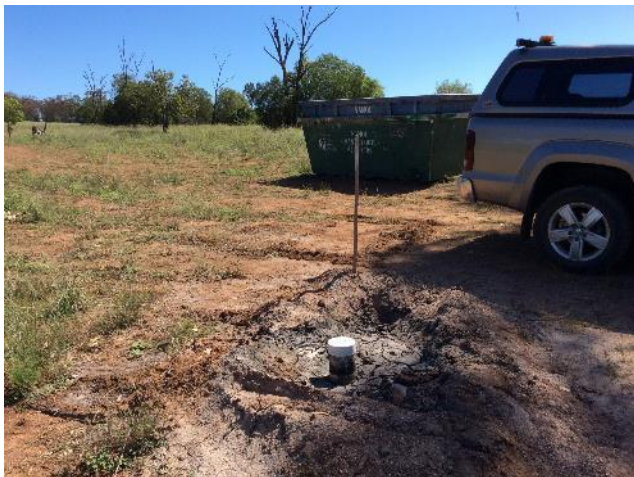
Drill cuttings from open holes were collected in steel skip bins for disposal off site at a licensed waste facility (refer to Figure 5). Waste receipts were also observed to be maintained as a record of amounts disposed.

Figure 5 Metal skip bins for drill cuttings ready to be relocated to next chip hole

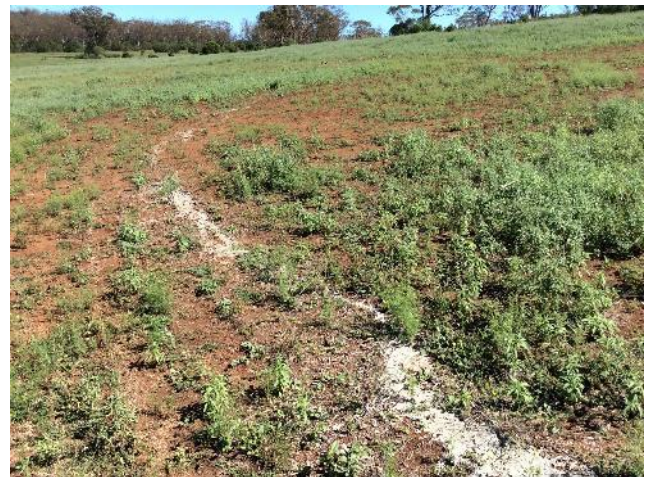
Some minor grouting wastes/spills were observed at some of the drill sites, but rehabilitation had not yet been undertaken at these sites (refer to Figure 6). Any minor grouting residues would be tidied up during the rehabilitation phase.

Figure 6 Minor grout spill along access track at site E015 (OP56)

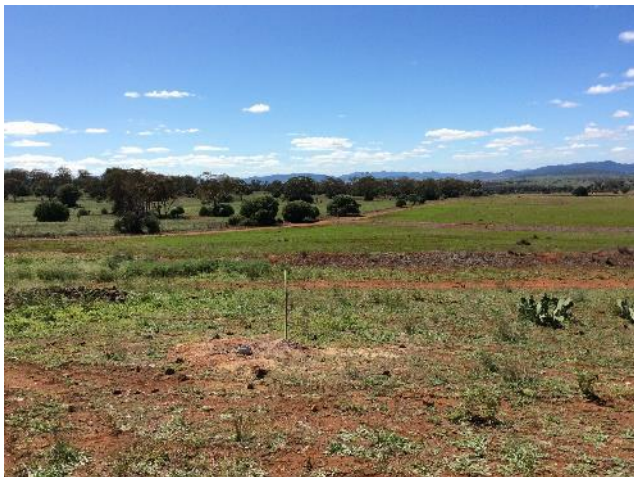
Figure 7 Typical hole in a cleared paddock area (Site E06 - OP70)

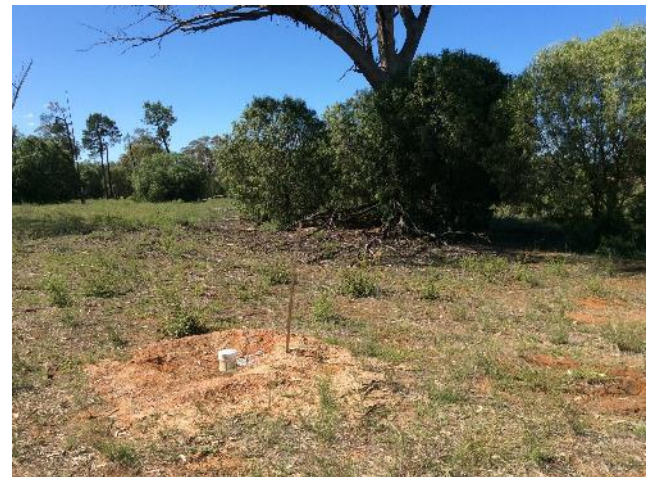
Observations made during the site inspection confirmed that no trees have been felled or branches removed for the current drilling program. Shenhua and Mannion Drilling staff confirmed that no trees were planned to be felled or branches removed for the remaining holes. Hole OP65 (E019) was moved about 5 metres to avoid the dripline of a large tree (refer to Figure 8).

Figure 8 Site E019 (OP65) - hole relocated about 5m to avoid the drip line of tree

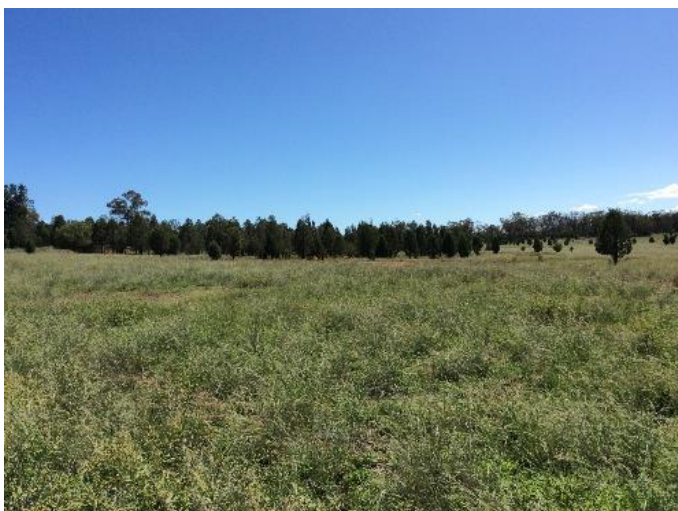
During the preparation of the ESF4 application, the AHIMS search identified that there was one known archaeological site in the vicinity of BH29 (E028) (refer to Figure 9). The Mannion Drilling supervisor was able to identify the site and advised that drilling staff were instructed to avoid the taped off area. During the site inspection, it was observed that the identified archaeological site had been taped off with barrier tape (refer to Figure 10). There was no evidence of wheel tracks or disturbance to the taped off area which was located about 100 metres from the borehole site. Alternative access to the borehole site was put in place to avoid the known archaeological site.

Figure 9 View of archaeological site from Site E028 (BH29)

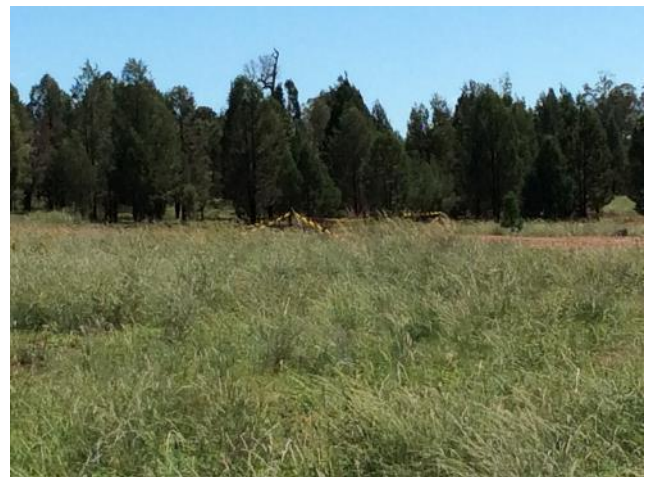
Figure 10 Barrier tape used to mark off the archaeological site

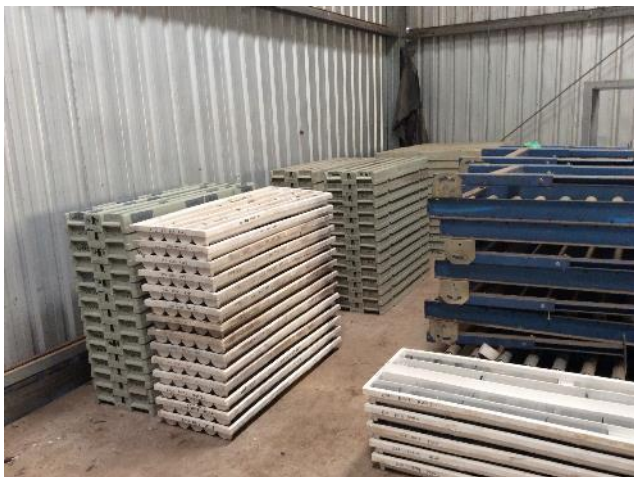
Both core and cuttings were collected during the drilling program. The cores and cuttings were observed to be stored in modular plastic core and chip trays and were stored within a locked shed, protected from the weather (refer to Figure 11). Each core tray or chip tray was observed to be labelled with hole number, tray number, start and finish depths (refer to Figure 12 and Figure 13). For the core trays, any zones of loss of core were identified with wooden blocks containing relevant information (refer to Figure 14). Core or chip samples were observed to be present for each of the holes inspected during the audit.

Figure 11 Core trays inside the locked core shed

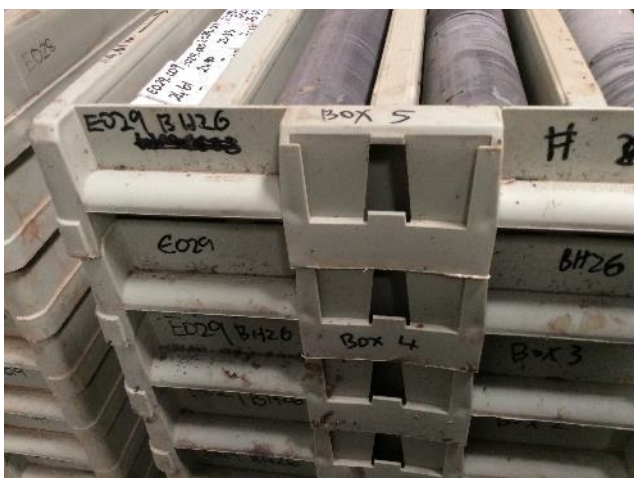
Figure 12 Core tray labelling

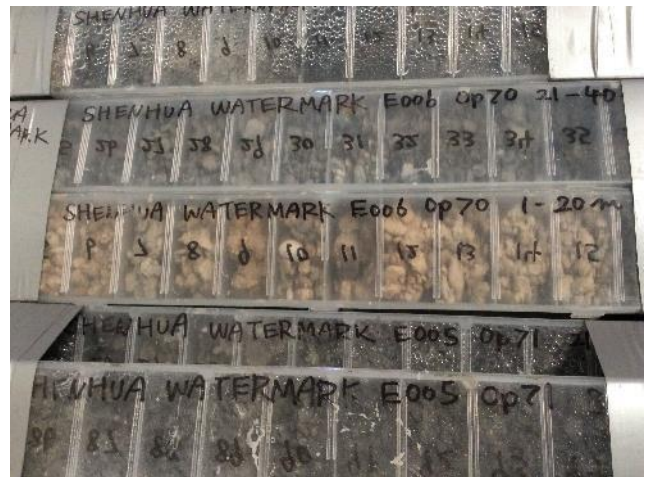
Figure 13 Chip trays for open holes

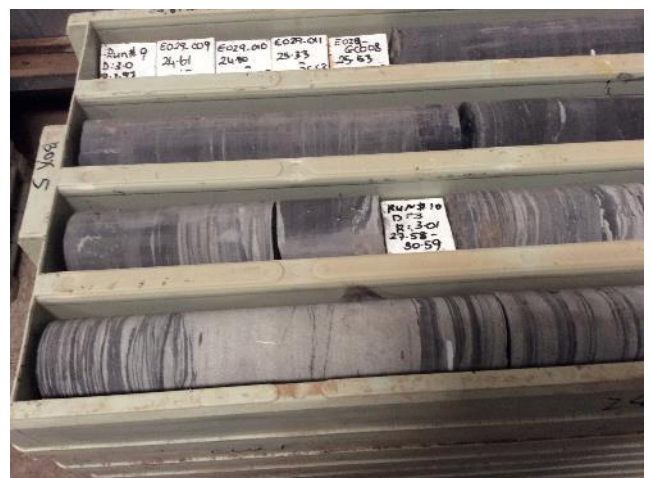
Figure 14 Core tray labelling - loss of core zones
