# MINE SAFETY

# INVESTIGATION UNIT

Serious crush injury to lower leg  
surface of underground coal mine  
21 August 2008

# Crushed by longwall service sleds

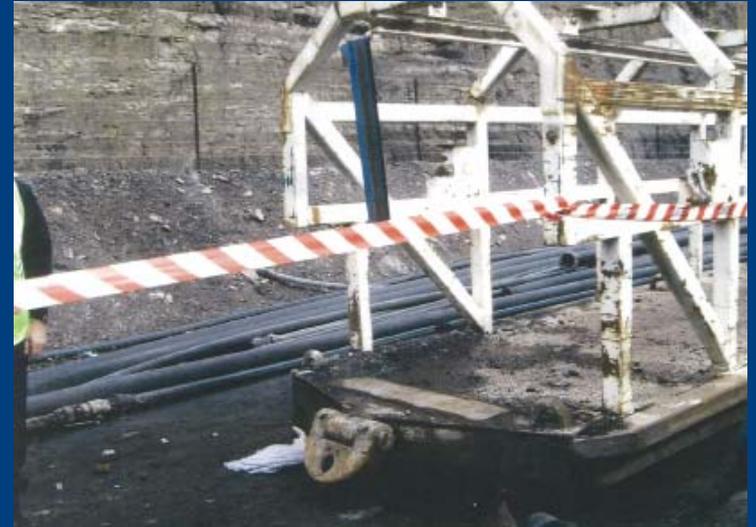
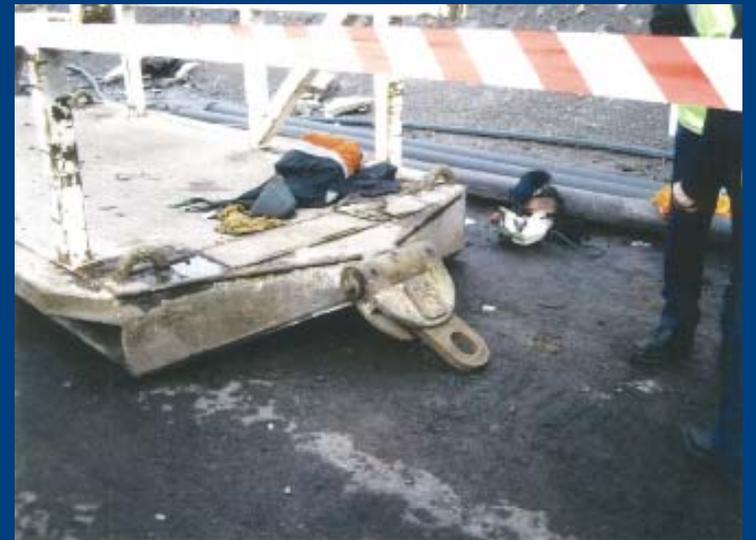
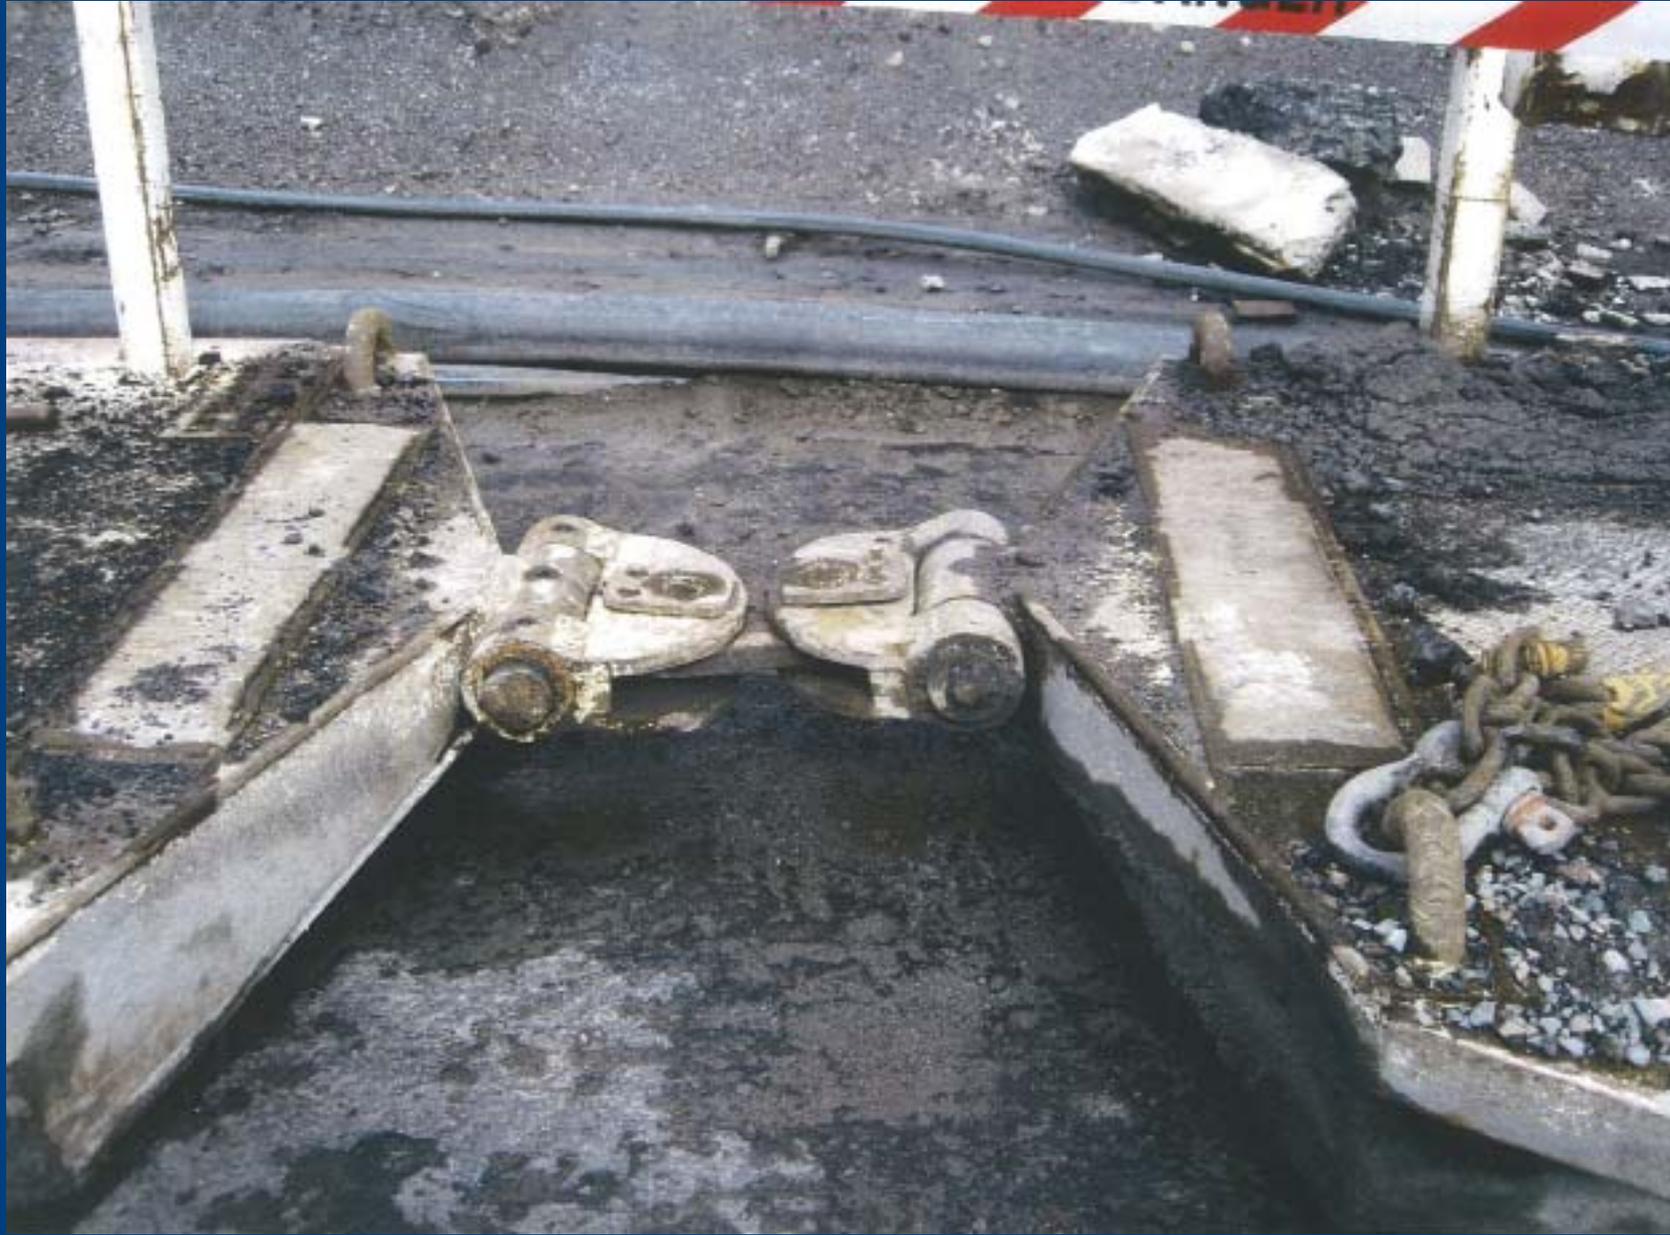
- One cassette stationary, other being pushed into place by Juganaut to allow coupling together
- Person lent down to pickup the coupling as they appeared to be aligning perfectly
- As he did so, placed right foot on the ground near the stationary coupling

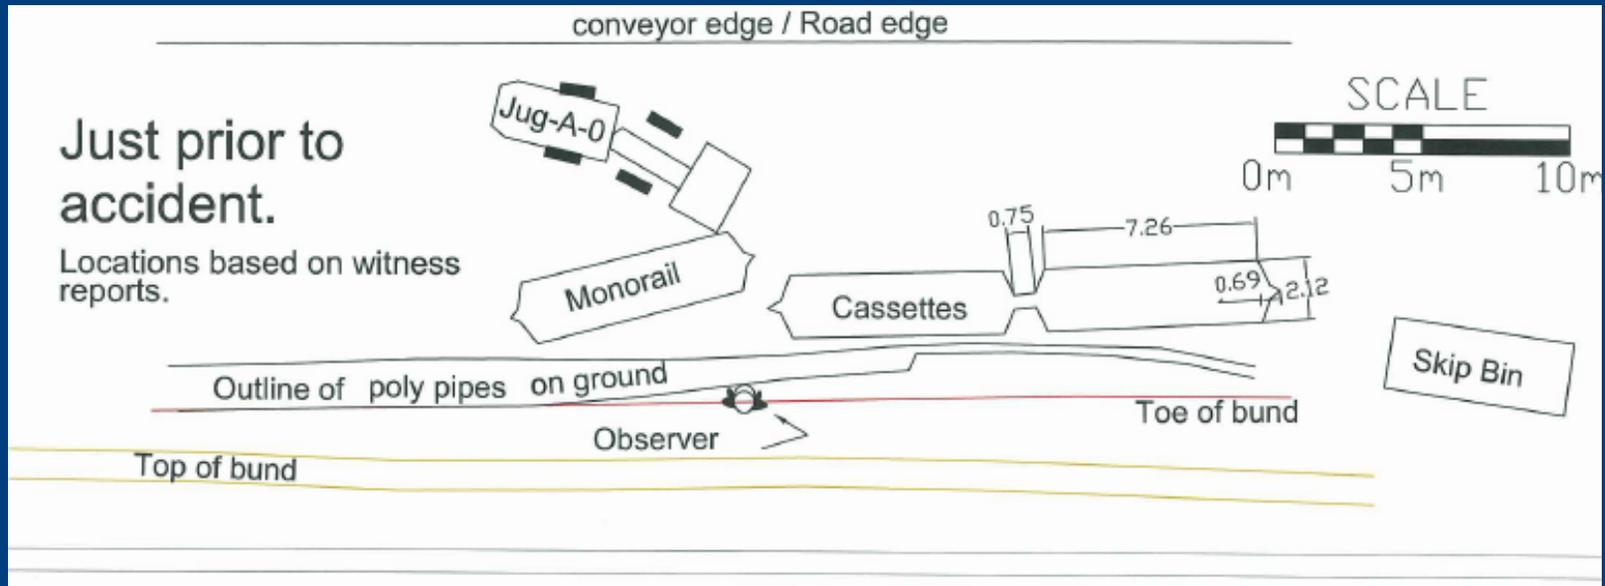
- As the other sled was pushed closer it swung toward and past the joining point

- Lower right leg crushed between the two couplings resulting in compound fractures
- Flown by helicopter to hospital where mineworker underwent a series of operations that day to clean the wound and attend fractures
- Further plastic surgery required to repair leg wounds, including skin grafts
- Unlikely to be able to return to working underground

- Coupling devices require manual handling
- Risk of injury not recognised
- Supervision did not include adequate instruction on how to couple longwall service cassettes and potential dangers
- Inappropriate controls to prevent persons from entering risk zone
- No available safe work procedure

- Identify risk
- Automatic coupling devices
- Appropriate safe work procedures that include machinery 'no go' zones.
