Investigation Report

Fire and explosion on Longwall No 1 Tailgate
at the Blakefield South Mine
5 January 2011

Published report prepared by the
Investigation Unit, Thornton

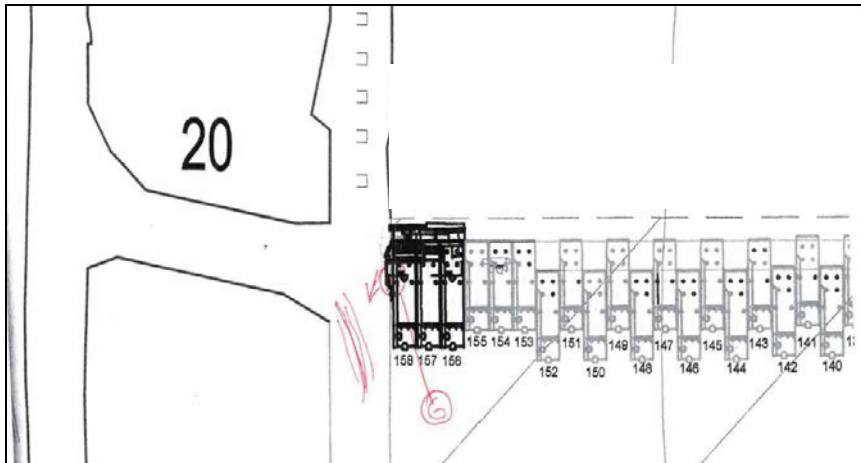
Figure 3: Extract from interview with deputy: Diagram showing the location of the flames in the tailgate area fanning around into 20 cut-through (Chain number removed for clarity)

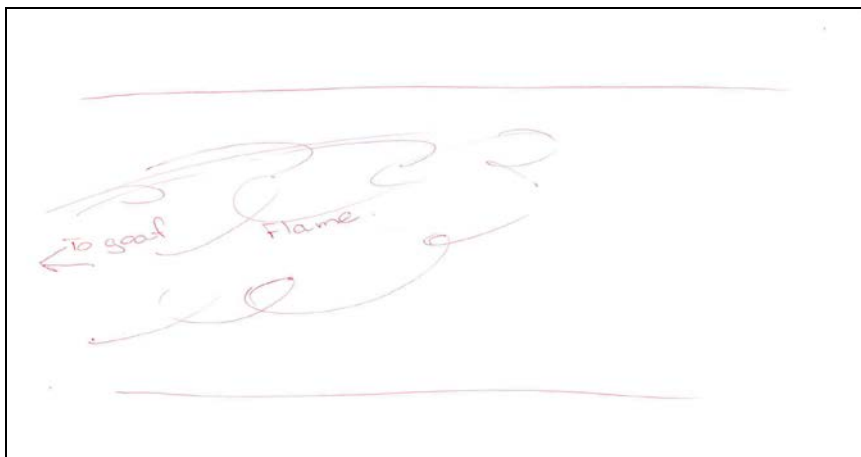
Figure 4: Extract from interview with deputy: Diagram showing long fanning flames emanating from the goaf area.

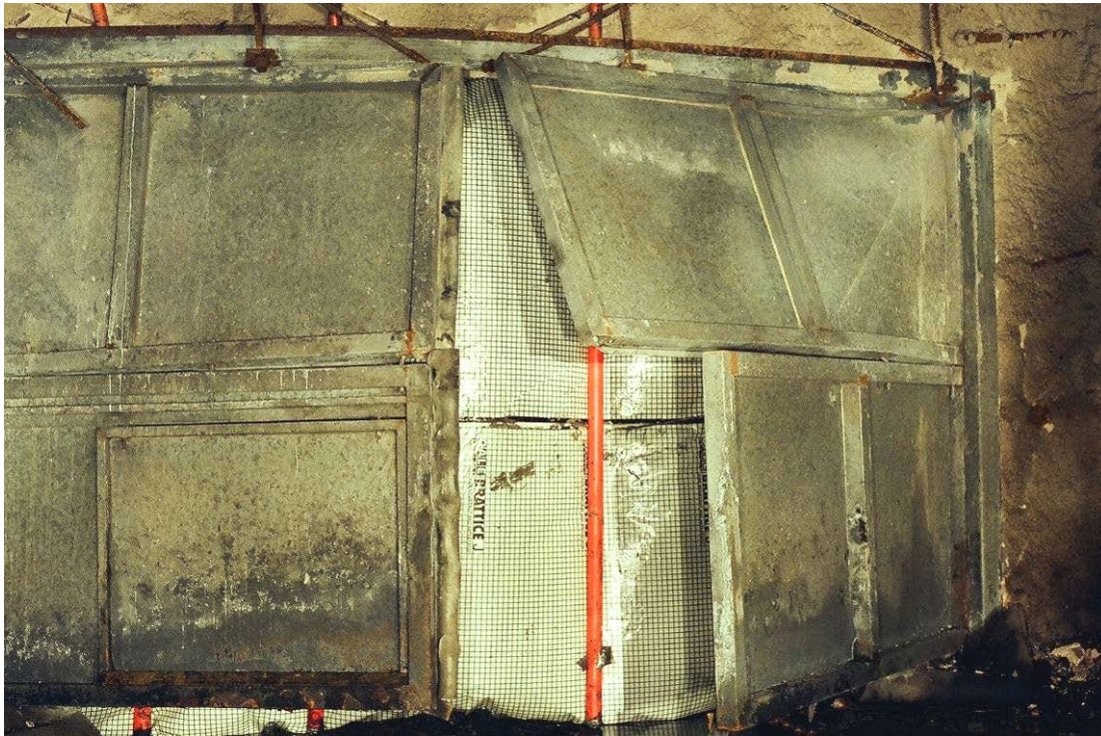
established if they had been blown open or were open before the blast. If these doors were open before the blast it would have allowed air to short circuit the sump area but should not have impacted the general efficacy of the ventilation of the longwall and therefore is not considered a factor in the explosion.²³

Figure 11 – Double doors at 38 cut-through looking from heading ‘A’ to heading ‘B’
Photograph by Tim Flowers 14 December 2011

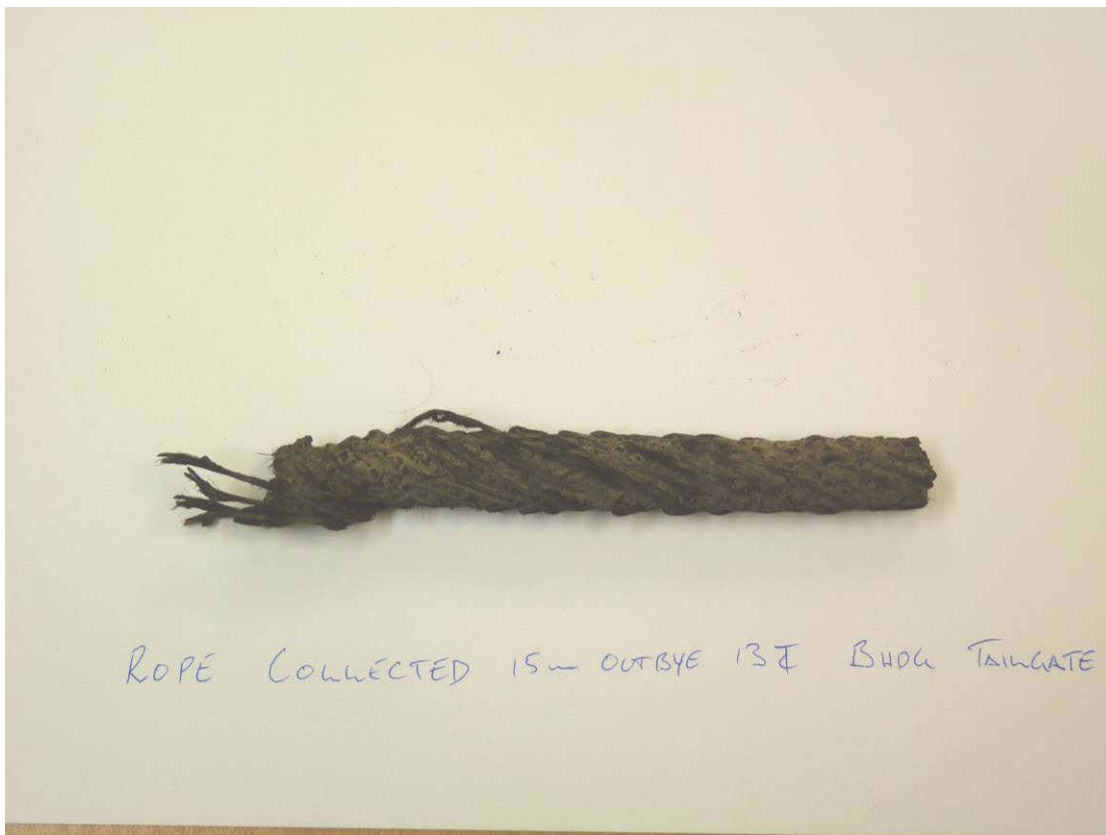
Figure 12: Sample 1 - A piece of heat-affected rope from 15 m outbye of 13 cut-through heading 'B' tailgate 1

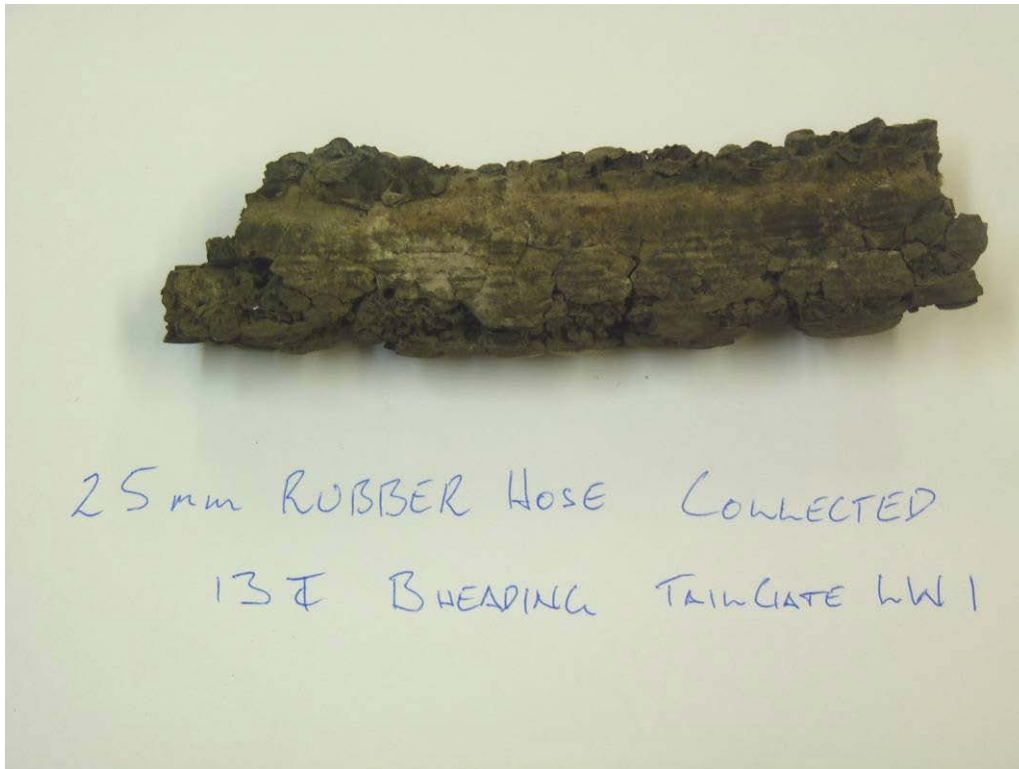
Figure 13: Sample 2 – A piece of heat-affected 25 mm hose from 13 cut-through heading 'B' tailgate 1
Photograph by Tim Flowers 7 September 2011

The package contained three sections of double-walled rubber hose, thermally degraded and apparently pyrolysed. The hose material was brittle and friable, with directional bubbling along approximately 1/3 of the circumference consistent with off-gassing of volatiles. Because the orientation of the hose remains was not recorded at the time of recovery, I could not associate this bubbling reliably with the location of a heat source.

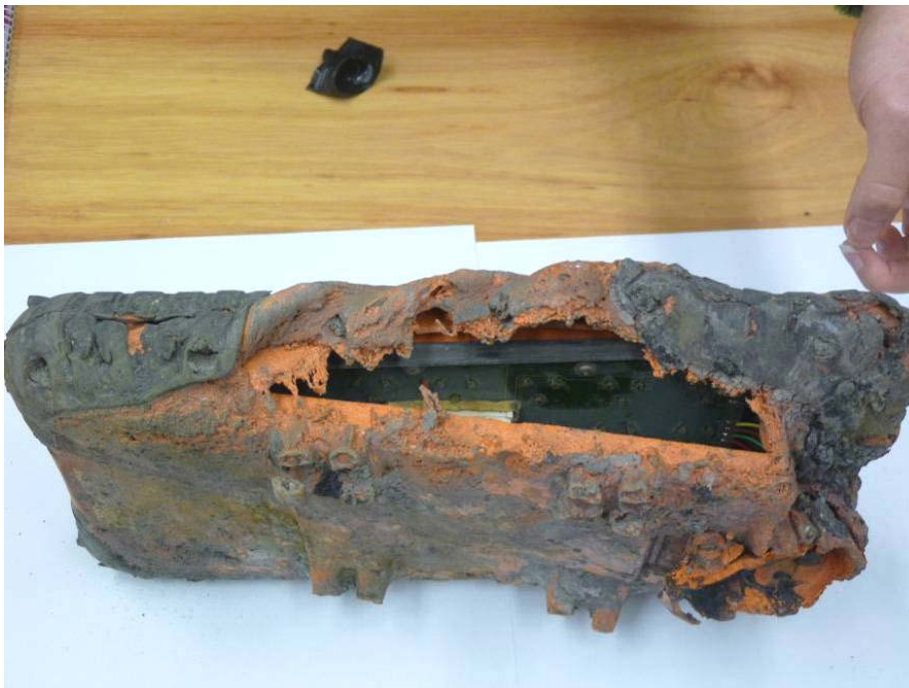
Figure 16: Joy Mimic Unit IECEx TSA 06.0029X located chock 158 LW1 top of box
Photograph by Tim Flowers 24 November 2011

Figure 17: Joy Mimic Unit IECEx TSA 06.0029X located chock 158 LW1 bottom of box
Photograph by Tim Flowers 24 November 2011

"3.09 There was a gap along one edge where the controller appeared to have been broken away from a bracket or mounting. The clean edge showed that this occurred after the heating and I was further advised that the unit was broken away from its location on the chock by the recovery operators. Other than this, the casing remained intact with no heat penetration in either direction.

3.10 Initial inspection of the interior through this gap showed no heat, smoke or other internal damage to the electrical components. The unit was then cut open in the presence of interested parties.

3.11 This revealed no heat or smoke damage to the interior, no indications of dry solder joints, component failures or other localised heat sources.

3.12 In my opinion, the controller was damaged only by exposure to external heating at relatively low temperatures (probably under 300°C)."²⁵

5.2 Sample 5 as seen was not a viable ignition source for a methane-air mixture, and in my view a malfunction of the controller did not cause this incident.

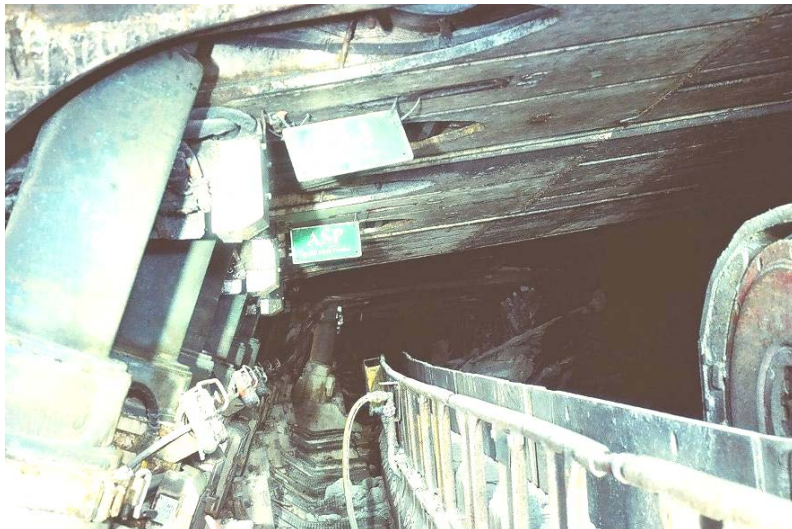
The examination of the LW1 face disclosed that there was no extensive damage along the face from the explosion and subsequent fire.

Figure 18: Longwall as it looked on re-entry

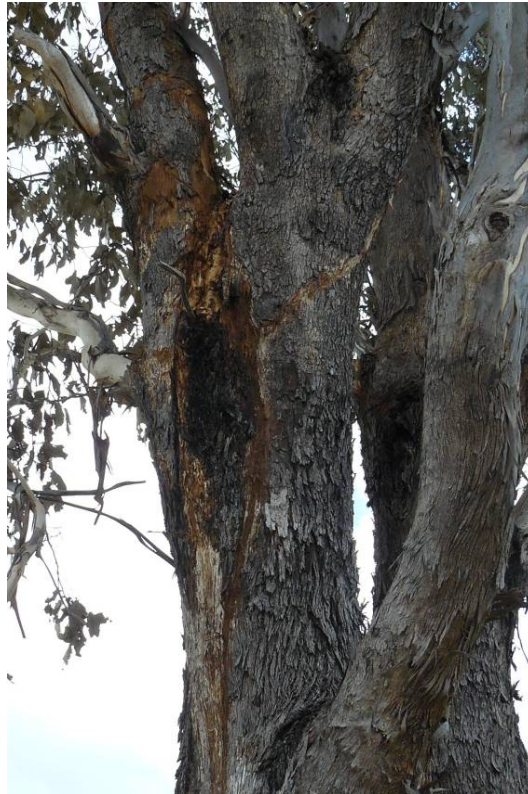
Figure 24 - Tree showing evidence of a lightning strike

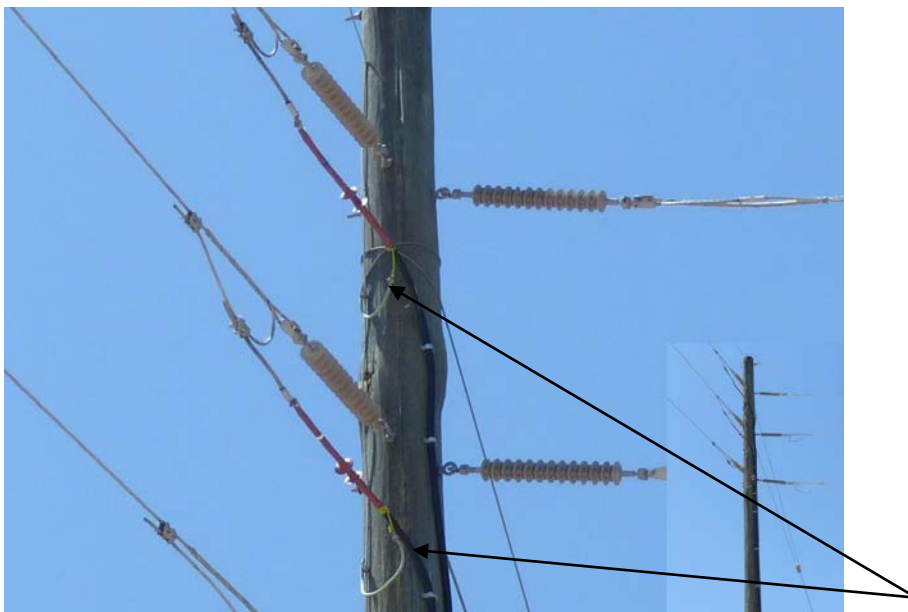
The reports of both Mr Gillespie and Mr Gittins disclose major concerns with the lack of separation between the mine earth and the incoming 66 kV supply earth along with a number of other issues.

Figure 25 – Photograph showing UGOH pole and earthing wires. Note that the overhead high tension earth is connected to the 11 kV earth.

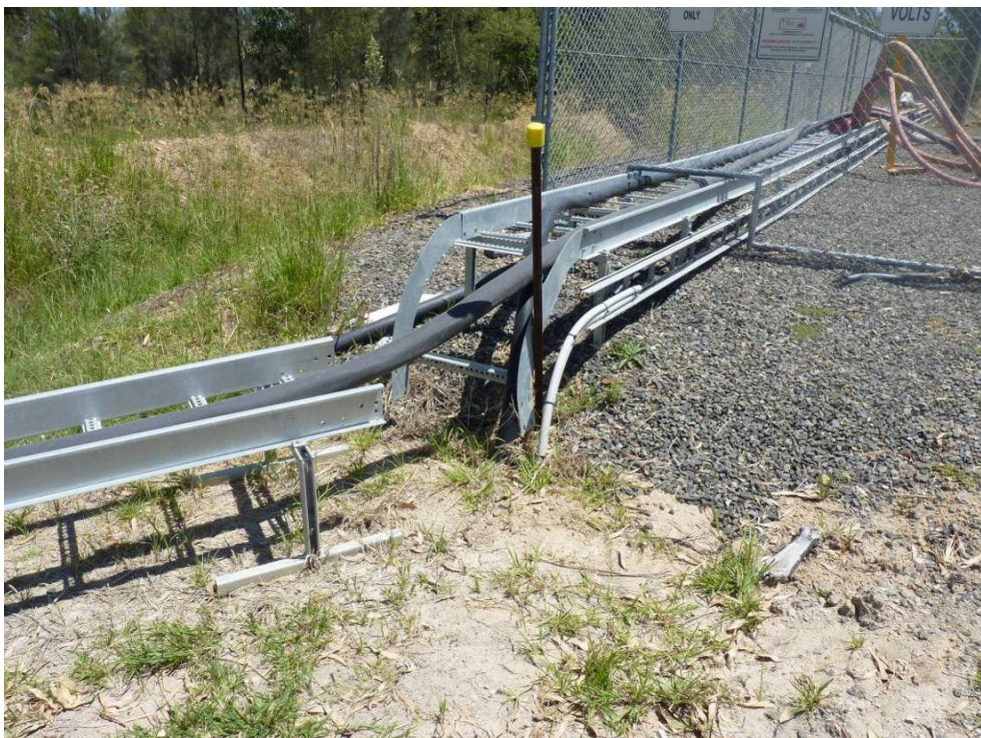
Figure 27: Break in cable tray showing lack of earth bonding

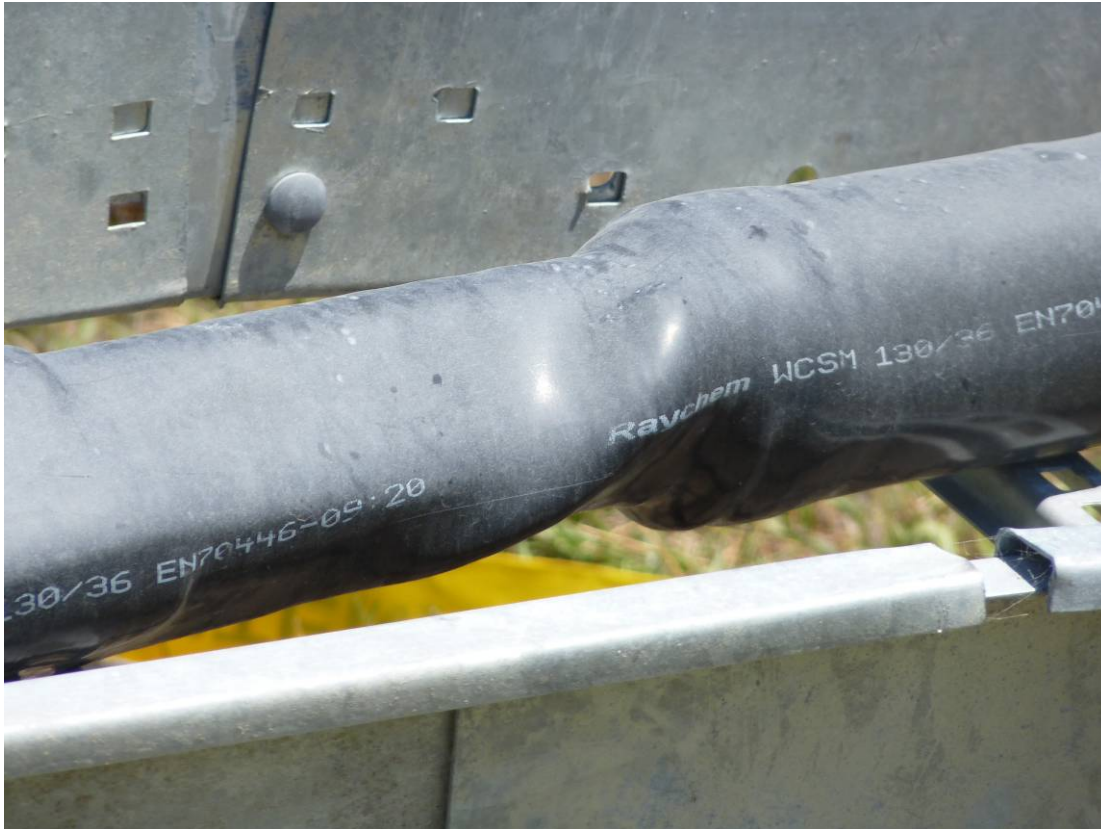
Figure 28 – High tension cable join showing poor quality join

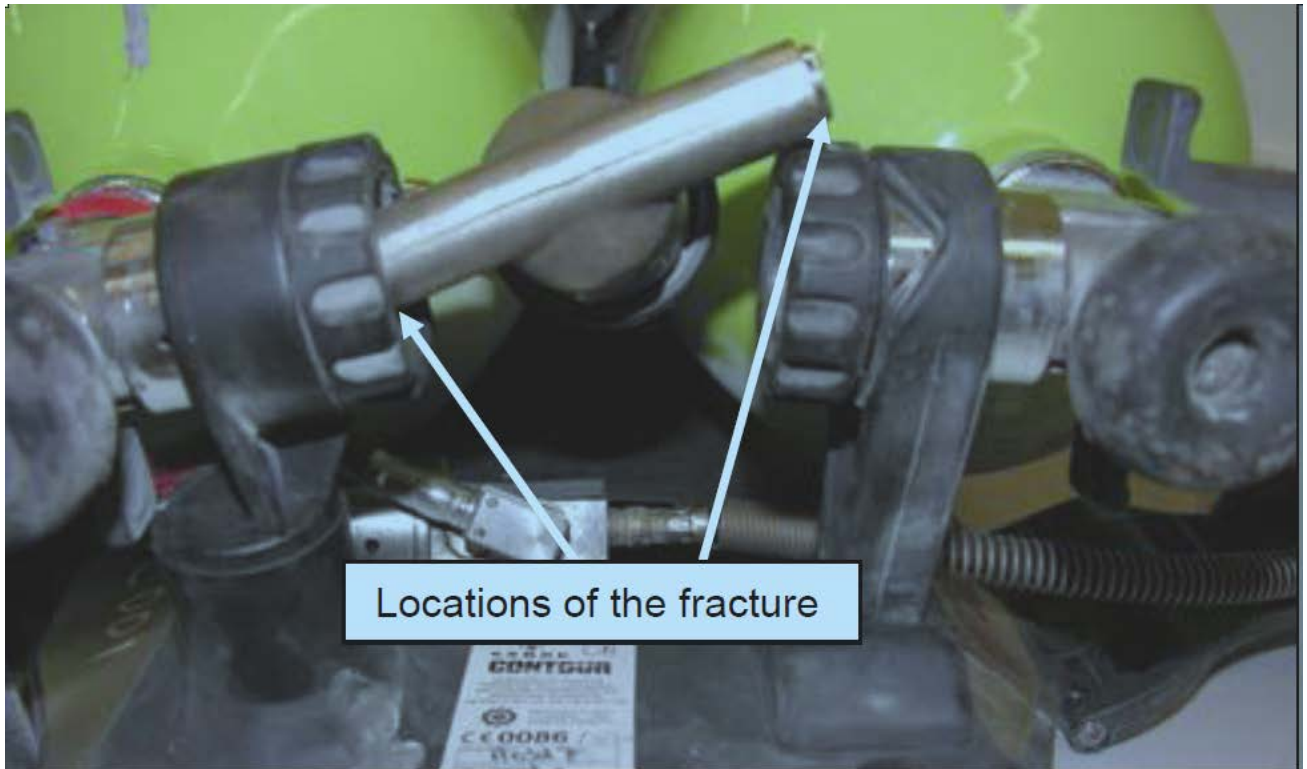
The Bureau Veritas report concluded that both T pieces were fractured due to "*brittle overload*" resulting from higher than normal loading.⁴⁵ This suggests that both units had at some time either been dropped or damaged during transport in and around the mine. It should be noted that the CABAs are housed in specially constructed padded containers which are designed to keep the units in good order. After the fracture in the two CABA units was communicated to Bulga Underground Operations, a follow-up examination of all of the CABA units at Blakefield South Mine revealed a further two units that were similarly fractured at the T piece. The department issued a safety alert with respect to this equipment failure. These failures in the CABA equipment are serious in that in slightly changed circumstances it may have resulted in four fatalities.

Figure 35: Photograph of fracture locations in the CABA unit⁴⁶
