Compressed Air Breathing Apparatus T-Piece Failure

NSW Department of Industry & Investment

19 December, 2011

Report: 11-2673768-1

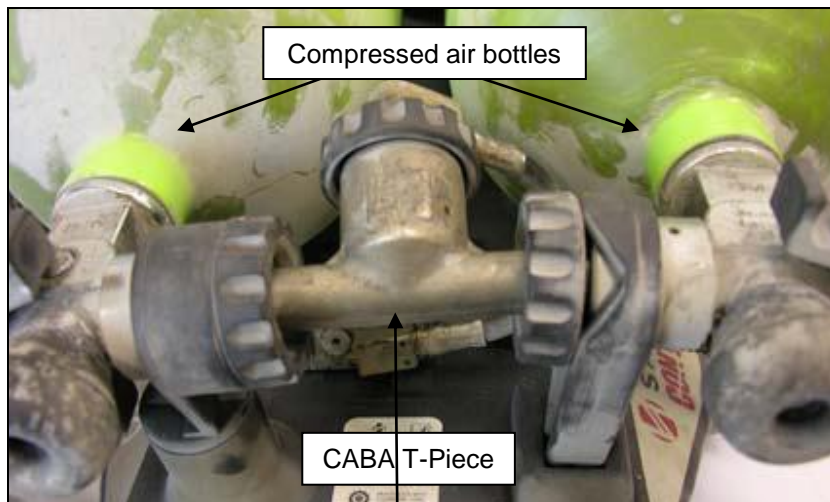
Figure 3- General photo of a failed CABA unit from 5/1/2011 showing the location of the compressed air bottles and T-piece.

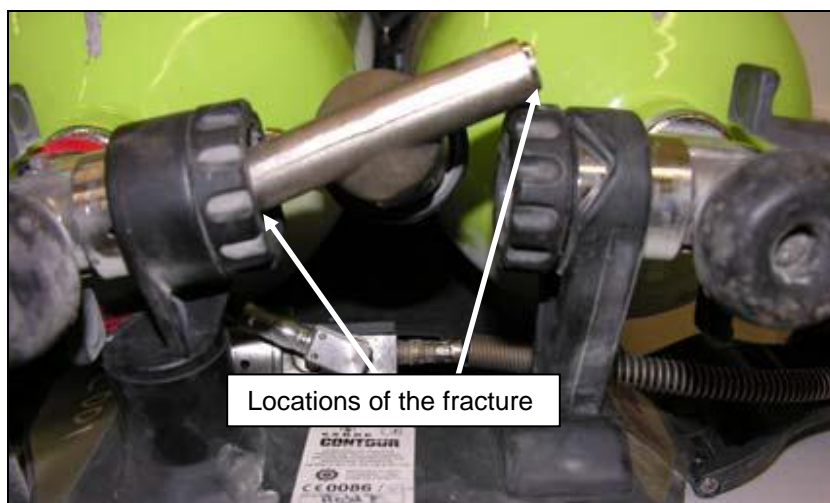
Figure 4- General photo of the failed CABA unit from 5/1/2011 showing the location of the fracture.

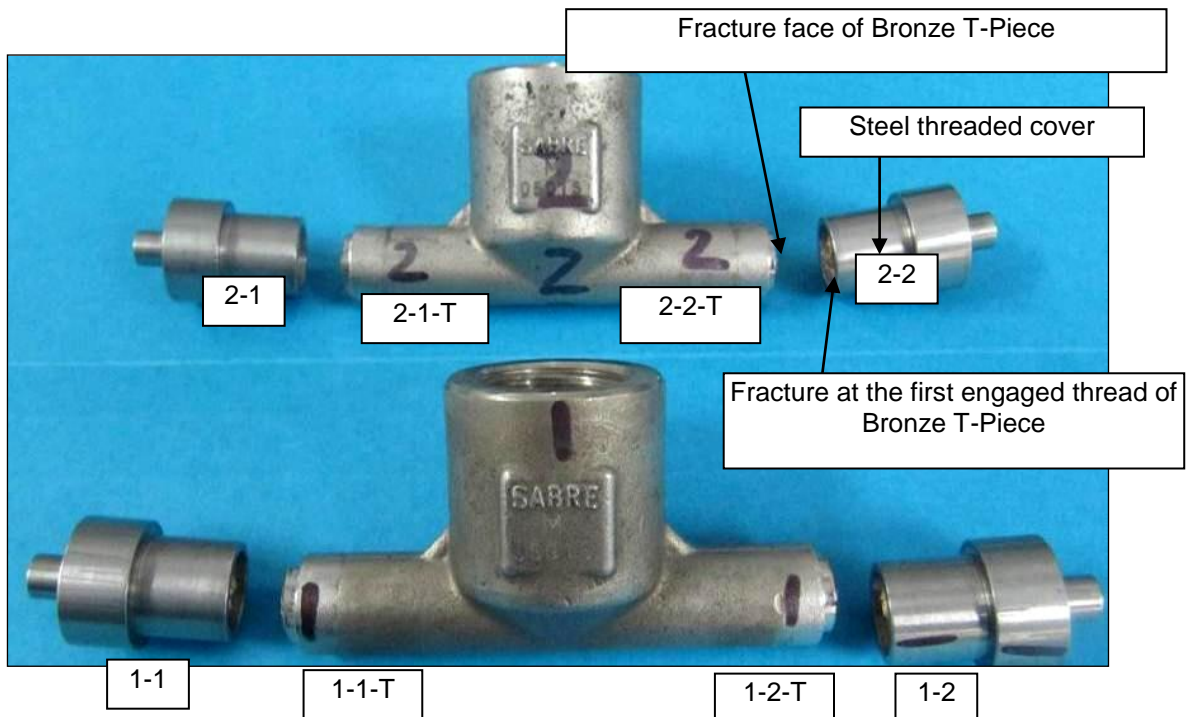
A general view of both failed T-pieces as received is shown in figure 5. The T-pieces consisted of a pipe forming the main body terminating at one end with two branches normal to the body each of which contained an external thread at their distal end. A steel connecting piece was screwed onto both branches of the Tee piece and were in turn connected to the compressed air bottles. Both T-pieces were fractured at the first engaged thread.

Figure 5- General view of the failed bolt and attached nut as received.

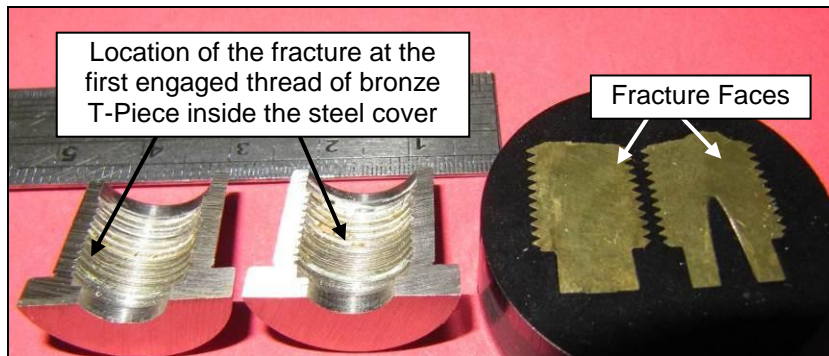
Figure 6 shows the location of the fracture at the first engaged thread. No deformation or bending was observed around the fracture on the threaded section of both T-pieces. All four fractures had occurred at the first engaged thread location representing a stress concentration effect. The stress concentration at the thread root reaches a maximum at the first engaged thread, because this thread tends to sustain the highest load of all of the remaining threads.

Figure 6- Showing a transverse section through the fractured bronze threaded section, inside the steel cover.

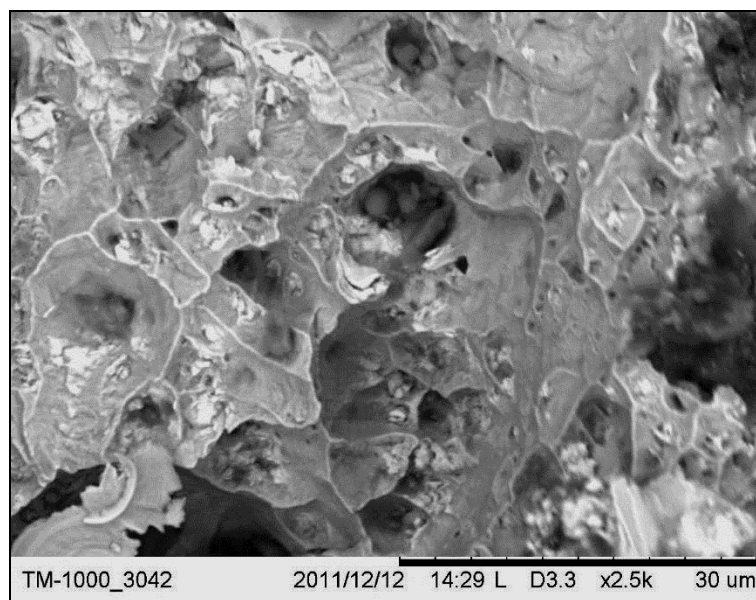
Secondary Electron Imaging (SEI) of the fracture face on sample 1-2-T, intersecting the region of progressive crack advance revealed a dendritic type fracture surface, see figure 11. No sign of fatigue striations were observed, consistent with the suggestion of crack advance due to brittle fracture in several stages.

Figure 11- SEM of the original fracture of sample 1-2, fracture face shows dendritic type fracture.

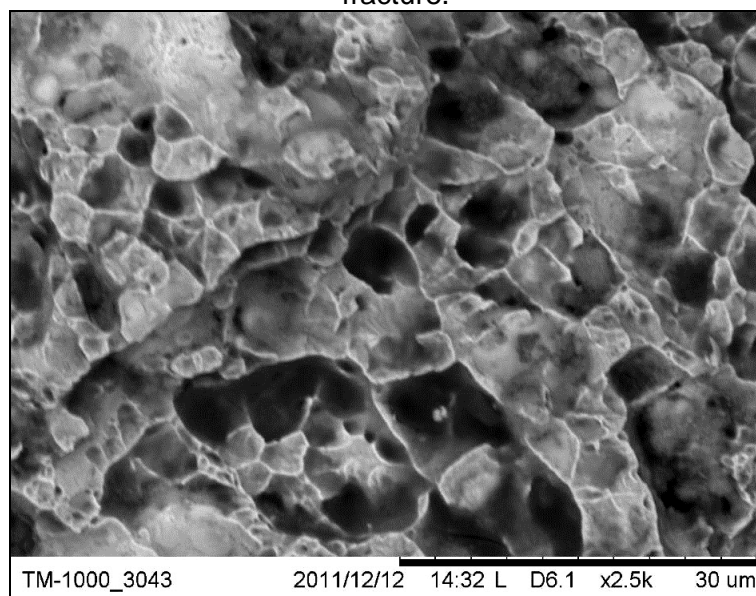
A trial fracture was created on a section through T-piece T11/00705/002. The sample was notched with a hacksaw before overloading by impacting the end with a hammer. The fracture face of the trial sample was examined under SEM. The fracture face exhibited a dendritic fracture similar to the original fracture of all T-pieces suggesting that they had also fractured under an overload situation, see figures 11 and 12.

Figure 12- SEM of the fracture face of trial fracture, showing dendritic type fracture.

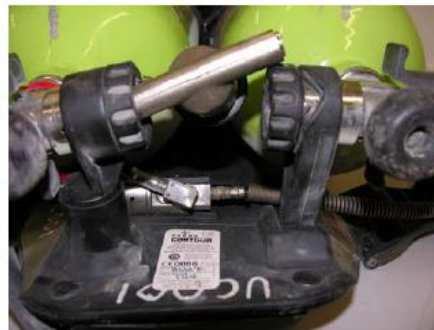
CABA unit with T-Piece removed from housing
