# SAFETY BULLETIN

## Workers injured by high pressure fluid

This safety bulletin provides safety advice for the NSW mining industry.

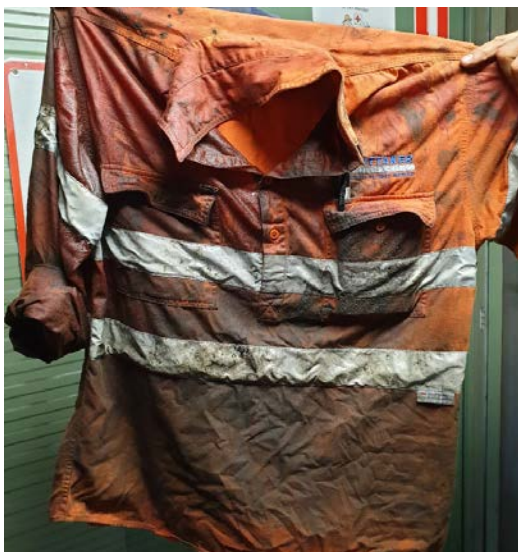
*Figure 1: Shirt damaged by high pressure fluid release*

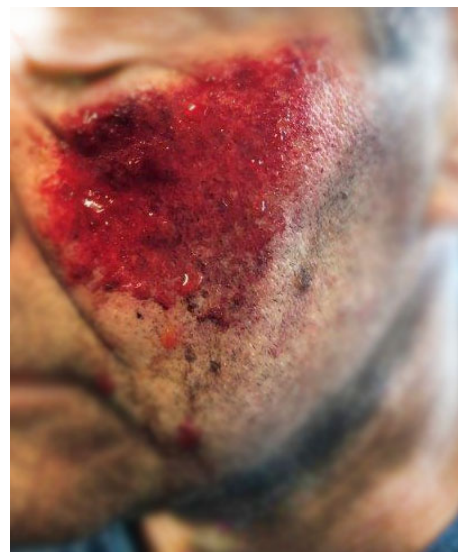
*Figure 2: Facial injury caused by high pressure fluid release*

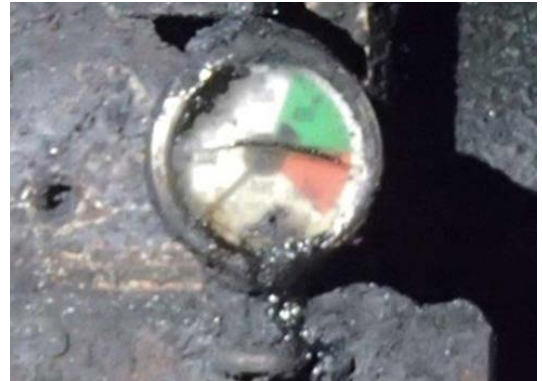
During a longwall changeout a contract maintenance worker isolated a roof support and checked the pressure gauge on the maingate leg which appears to have indicated zero pressure. The worker then loosened retaining bolts on the double check valve on the roof support leg. The stored pressure in the support leg released and tore the workers shirt and caused abrasions to his chest.

The pressure gauge was later tested as operational; however, the cover was cracked. A face audit identified that three out of 680 pressure gauges on the longwall face were also incorrectly indicating zero pressure.

*Figure 3: A pressure gauge on the longwall face*

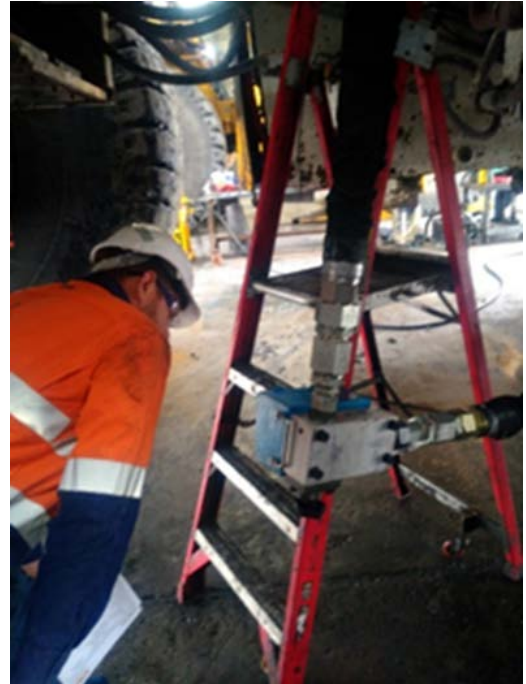
A contract maintenance worker was performing live hydraulic pressure testing to obtain pressure decay data from a hydraulic hoist on a large haul truck. The fitting connecting the hydraulic hose to the test meter released fluid under pressure and the worker was struck in the face by high pressure fluid.

*Figure 4: Simulation of the location of the injured person in relation to the hydraulic fittings connecting to the hydraulic pressure testing equipment*

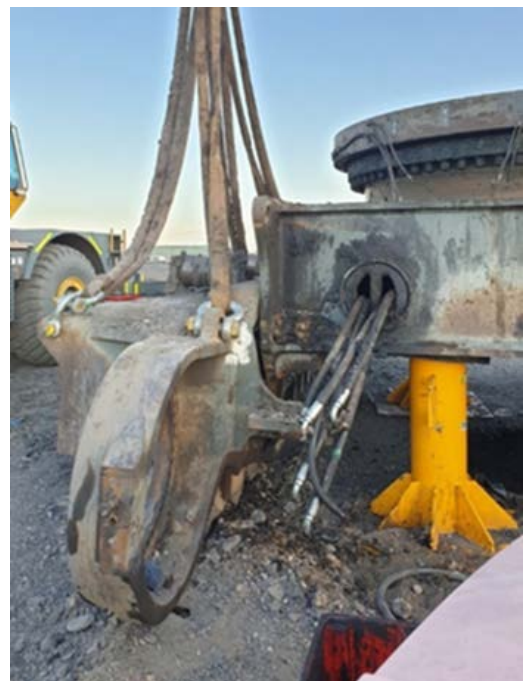
Contract maintenance workers were dis-assembling a large excavator base pod. The confirmation of the isolation undertaken earlier by other workers had failed to identify an accumulator holding stored pressure. Upon disconnecting the hose fitting a worker was struck in the face and body by high pressure fluid.

*Figure 5: Disconnected hydraulic lines exiting from the excavator pod. The accumulator is hidden from view inside the base pod*

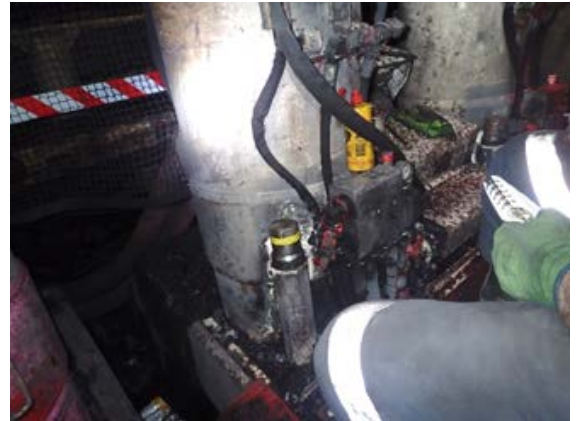
The worker isolated the tailgate side cylinder and attempted to remove the yield valve. The worker left the area and on return went to the non-isolated maingate side cylinder yield valve and attempted to remove the valve. The worker removed a staple on the maingate side valve block and was struck in the face by high pressure fluid.

*Figure 6: A worker located adjacent to an exposed hydraulic valve on a cylinder leg*

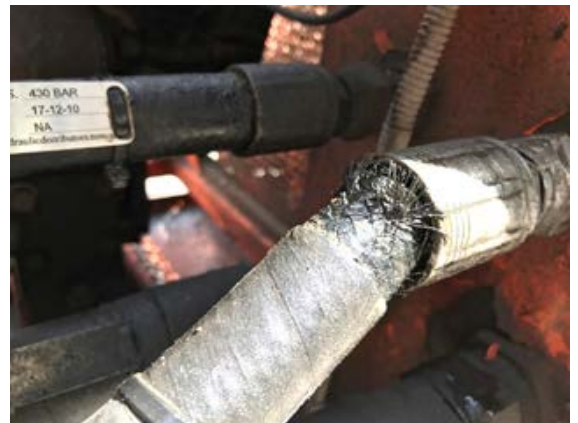
A contract maintenance worker was pre-commissioning a haul truck recovery power pack. The power pack was started without being connected to a host machine or testing equipment. When the worker started the power pack an over-pressurisation occurred, and a hose burst at a fitting. The worker was struck by high pressure fluid.

*Figure 7: The failed hydraulic hose on the recovery power pack*
