Investigation Report

Electric shock injury involving 3.3kV electrical equipment at the Liddell Coal Preparation Plant on 15 November 2007

Report prepared for the Director-General of the Department of Industry and Investment by the Investigation Unit, Thornton

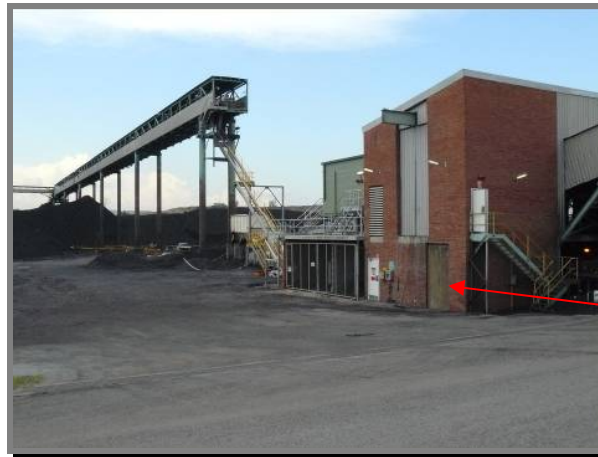
UTL Switch room

Photo shows UTL Building, with UTL switch room below

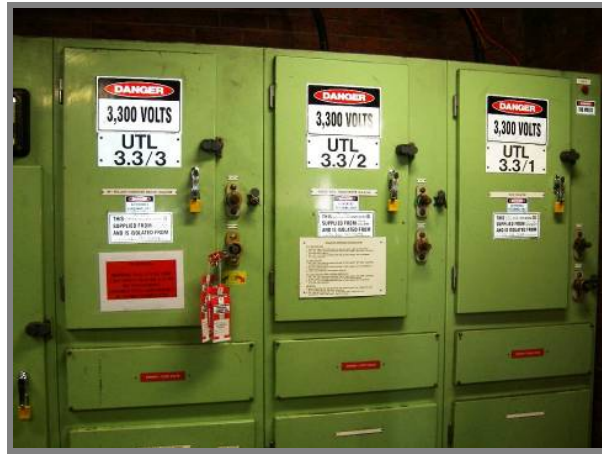
Several hours prior to the incident the technician had been given the task of isolating a surface conveyor belt and drive motor to allow an electrical contractor internal access to the 3.3kV slip ring conveyor motor for fault diagnostics. The isolation was carried out at a 3.3kV main control cabinet (UTL 3.3/3, shown in Photo below).

The motor starter panel was supplied from a high-voltage switch fuse (UTL3.3/3). This switch fuse had previously been isolated by the technician. As part of the isolation, an interlocked earth had been applied to the load side of the switch fuse.

Photo showing 3.3kV switchboard located in UTL building

- additional signs and locks fitted to 3.3 kV switchboard after incident;
- all preparation plant technician/electricians received high voltage training;
- internal screen placed to prevent access to potential live electrical parts in 3.3/3 cabinet;
- investigation into and then fitting of further Castell locking system to 3.3kV switchboard;
- review of electrical authorisations and permit to work system;
- external safety consultant review of electrical procedures; and
- review of electrical engineering management plan to ensure compliance with requirements of *Coal Mine Health and Safety Act 2002* and *Coal Mine Health and Safety Regulation 2006*.

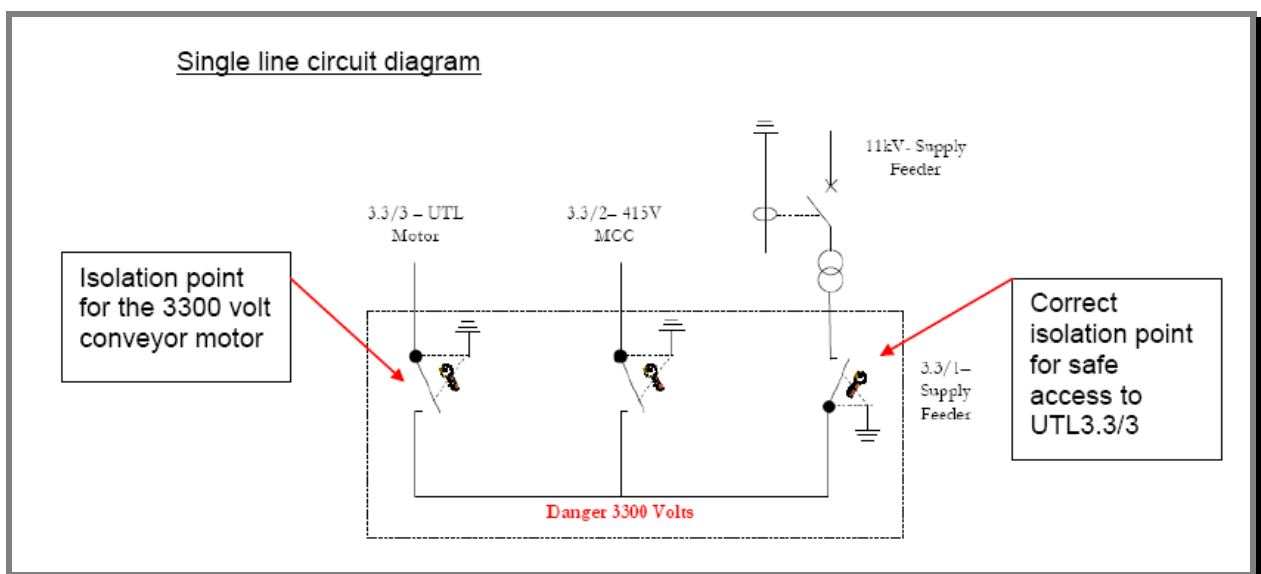
The technician removed a trapped key safety interlock for the isolation of electrical switchgear, known as a Castell key, from adjacent to the earth switch for the fuse switch (UTL 3.3/3); the interlock to the Castell key had been released by the earth switch being applied. The Castell key was used by the technician to gain access to the conveyor switch fuse enclosure (UTL 3.3/3).

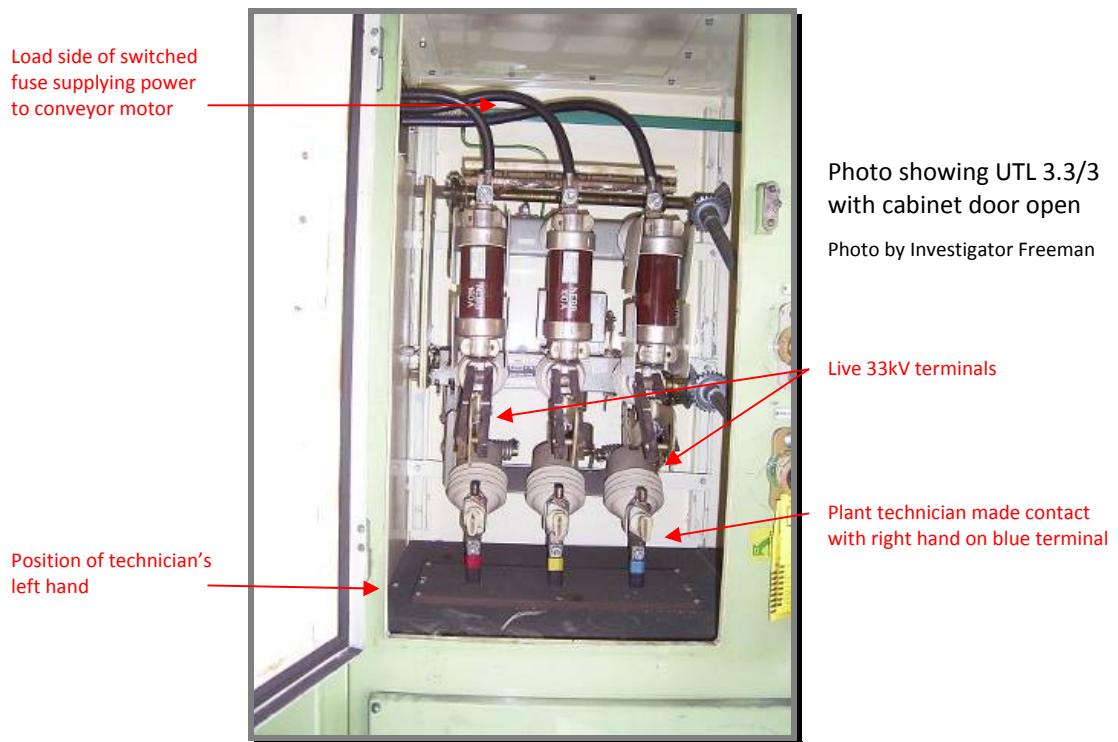
The technician opened the switch fuse unit door and assumed that the bottom of the switch was isolated (dead). It appears that the technician made the assumption that the power (live side of the switch) was connected to the top side of the combination-fused switch. The technician could see the switch was open. The technician did not “test for dead” before attempting to touch electrical conductors.

The technician had placed his left hand on the bottom of the panel frame. He then went to check for a loose connection on the blue phase with his right hand. When he made contact with the blue phase nut he received a severe electric shock between both hands and consequently across the chest. He also received burns to both hands.

- Risk realised** The technician made contact with energised and uninsulated 3.3kV electrical conductors in the isolator compartment UTL 3.3/3 of the 3.3kV switchboard located in the UTL switch room.

- He made contact with the energised and uninsulated 3.3kV conductors of the supply side of the isolator, identified as UTL 3.3/3, with his right hand while his left hand rested upon the earthed, metallic structure of the switchboard permitting electric current flow through his right arm, across his chest and finally through his left arm to earth.

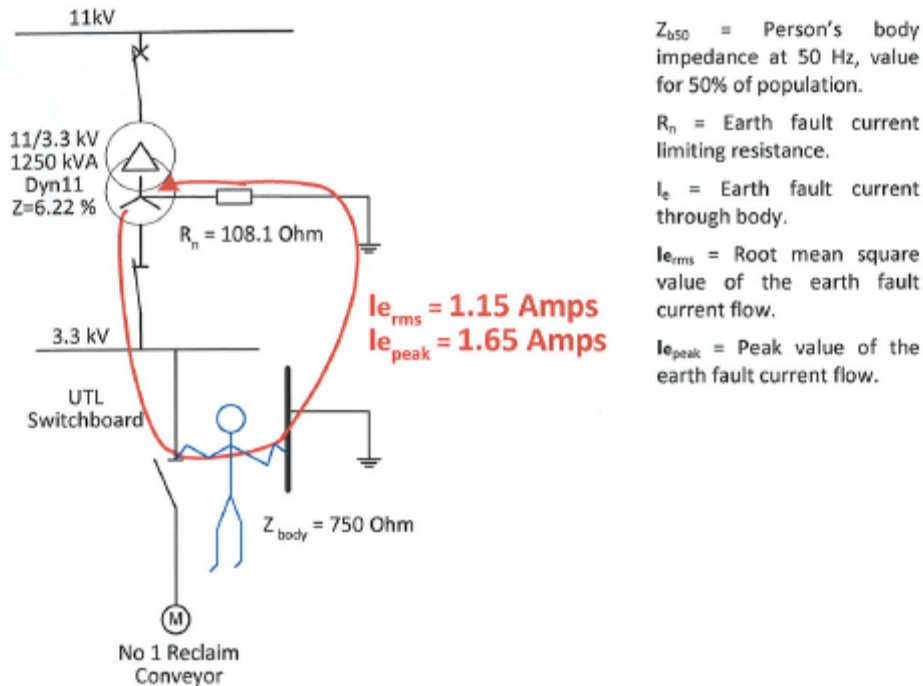
- 50% of population 750Ω
 - 95% of population 850Ω
- Electric circuit diagram** The electrical circuit formed during contact with the 3.3kV supply can be represented by the following diagram. The diagram notes the fault currents calculated as described below.

Using the data noted on the diagram above the earth fault current that flowed through the technician's body was calculated using a computer software program named Interactive Mine Power System Analysis that was sourced from the US Department of Interior, Bureau of Mines. This software program implements the Gauss Sidle Technique of load flow analysis.

Based on the data of the diagram above the computer software calculated values of the earth fault current that passed through the technician's body were:

- Root mean square value of the earth fault current flow ($I_{e_{rms}}$) = 1.1462 Amps.
- Peak value of the earth fault current flow ($I_{e_{peak}}$) = 1.6534 Amps.

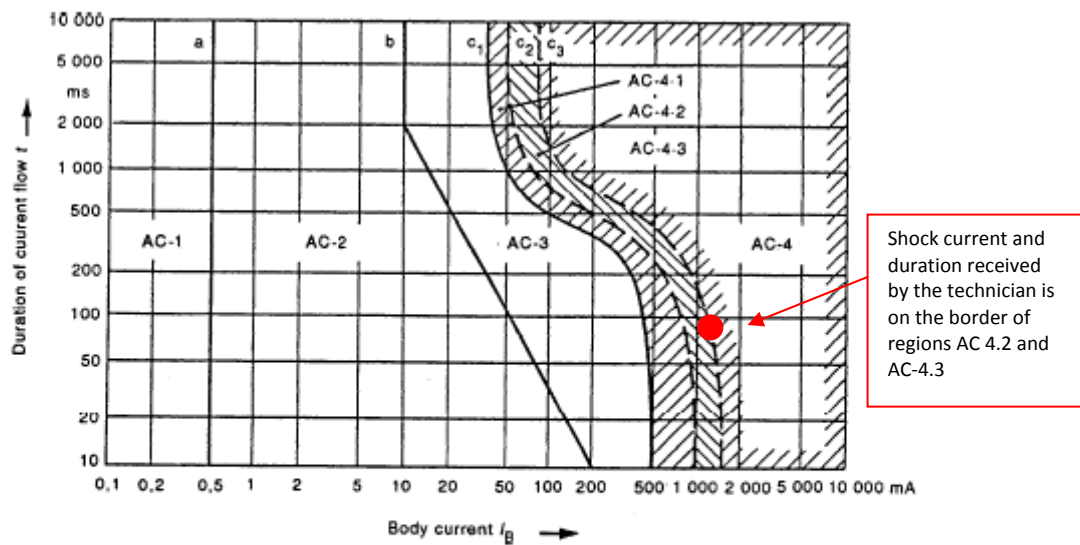
Figure 14 – Time/current zones of effects of a.c. currents 15 Hz to 100 Hz
(For explanations, see table 4)

Figure 14 and Table 4 of the AS/NZS 60479.1:2002 plot body current against current flow duration to indicate varying effects upon the human body. These tables are reproduced below and are marked for the current values and shock current duration, which approximates the electric shock current and shock duration received by the technician.

Application of the shock current and duration received by the technician, as detailed in Figure 14 and Table 4 of AS/NZS 60479.1:2002, indicates that he was exposed to the following severe risks:

- Cardiac arrest
- Breathing arrest
- Severe burns
- A probability of ventricular fibrillation of, or in excess of, 50%.
