INVESTIGATION UNIT

Fatal Injuries from a Recoiling Polyethylene Pipeline
At a Horizontal Directional Drilling Installation on a
Petroleum Assessment Lease in Northern NSW

1 August 2009

Horizontal Directional Drilling Fatality

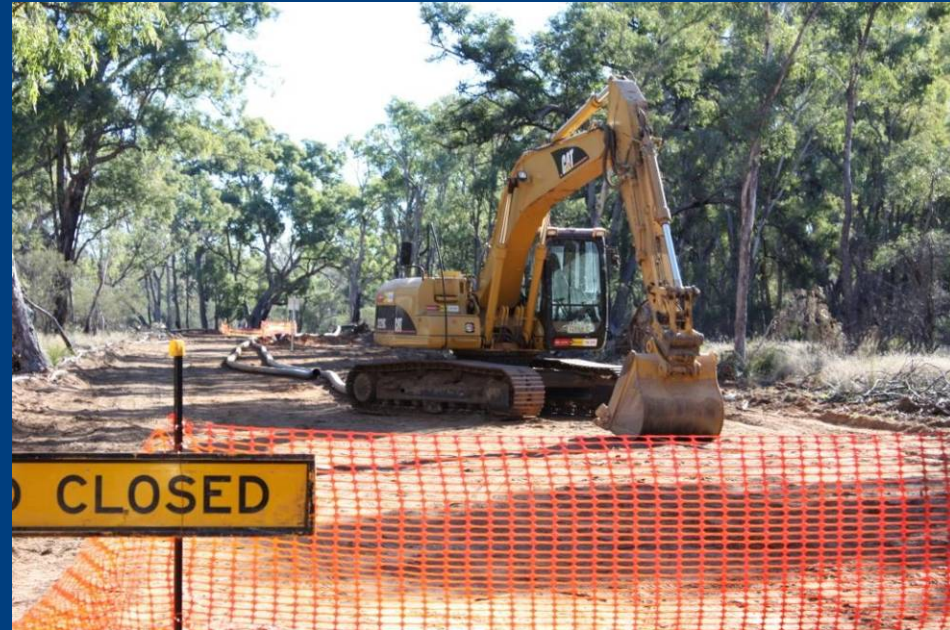
- Incident - 1 August 2009
- Involved contractors and sub contractors
- At a Coal Seam Gas exploration site in NE NSW
- Excavator was pulling pipe using lifting chains
- Chains failed and pipe recoiled striking bystander

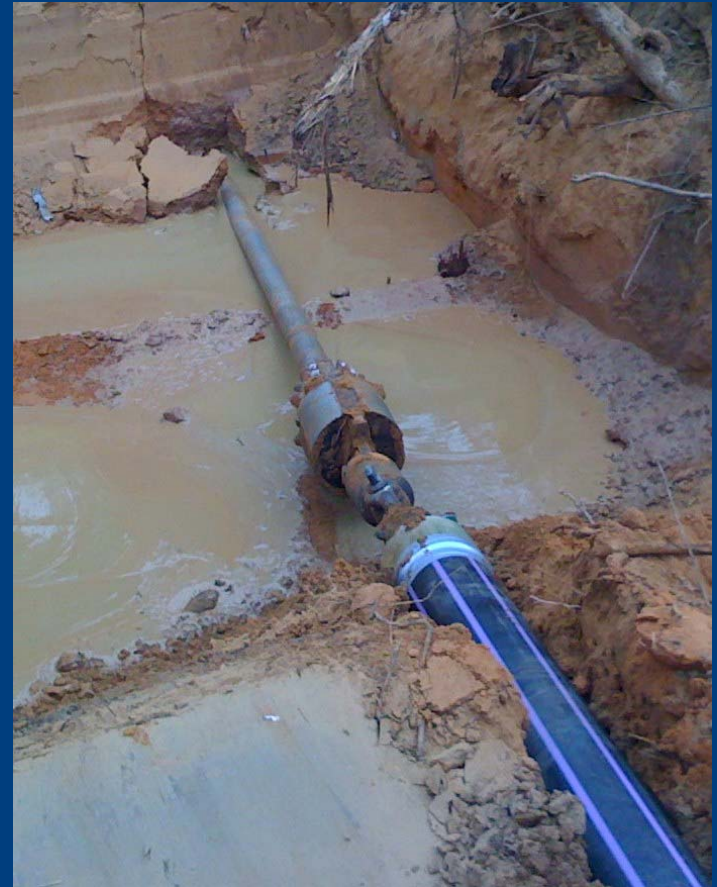
- The pilot hole was successfully drilled about 360m under a creek in a State Forest bush location
- Back reaming had progressed about 230m
- The 200mm pipe was being pulled in behind the reamer
- The coupling failed leaving the reamer and pipeline in the ground under the creek
- Initial digging in the creek did not find the pipe

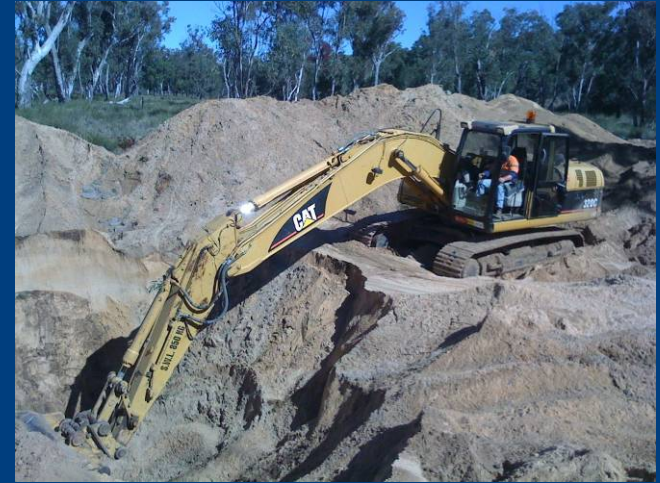
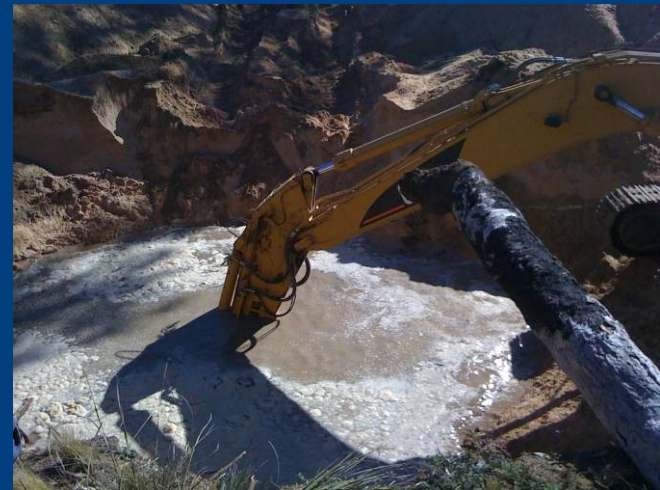
- The pipe and reamer were located using a transmitting beacon inserted to the end of the pipe
- Digging in the creek located the pipe
- Due to water and running sand the reamer could not be recovered
- Attempts were made to sever the pipeline using the bucket on the excavator

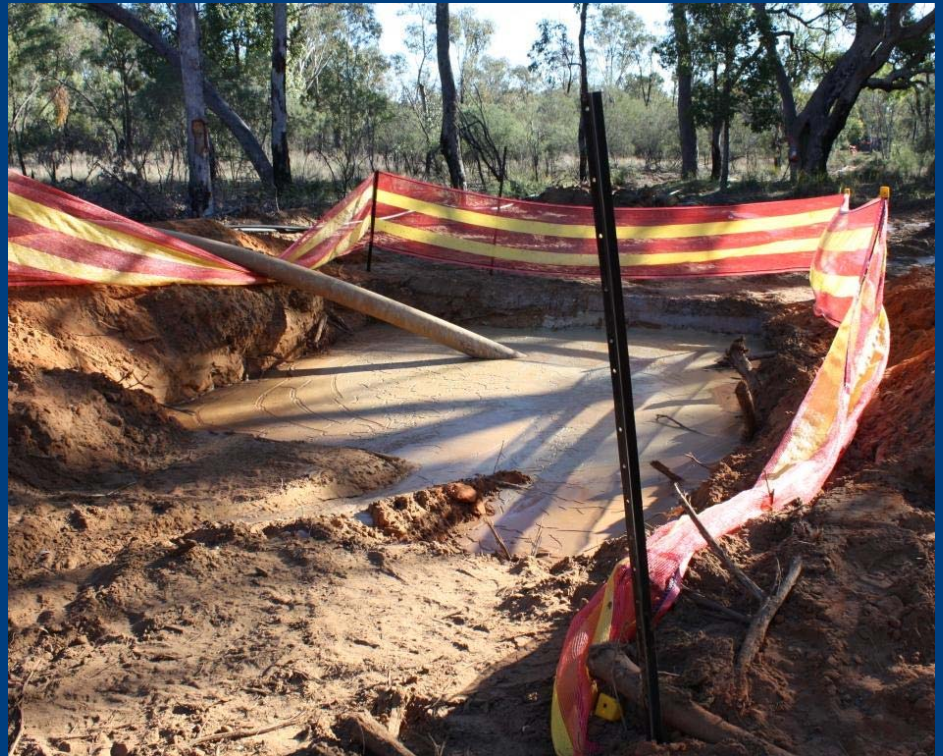
- Approximately 145m of pipe had been extracted
- The chains connecting the pipe to the excavator failed
- The pipe recoiled rising up at the pit end
- The bystander was close to the pipe and received a blow to the head

- The victim was found lying at the front of the pit
