EXTRACT OF CONSULTANTS' REPORT

Double fatality at Austar Coal Mine on 15 April 2014

Mine Safety Investigation Unit

Title: Double fatality at Austar Coal Mine on 15 April 2014 - Extract of consultant's report

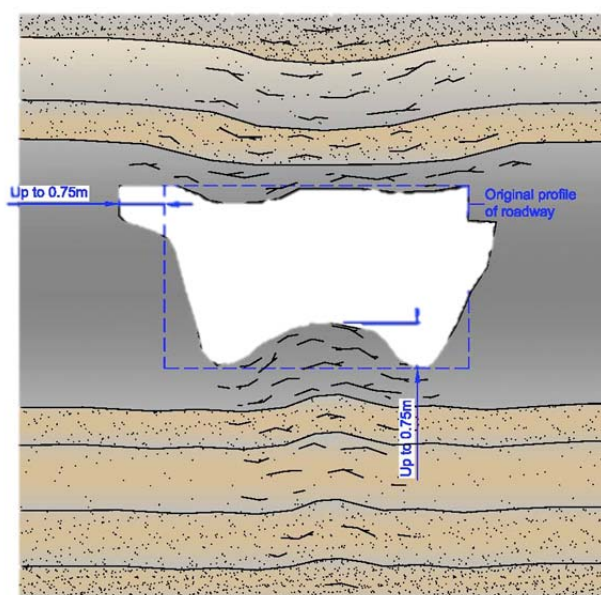
Figure 2 of the report is produced below.

subsequent inspection, 70 to 80m of the left hand rib was found to have spalled for a distance of 1 to 2m into the roadway (see Figures ... and 2) - note: a) although it is not certain when it occurred, up to 0.75m of floor heave was noted in D Hdg and b) some degree of rib spall and floor heave was also noted in 5 C/T.

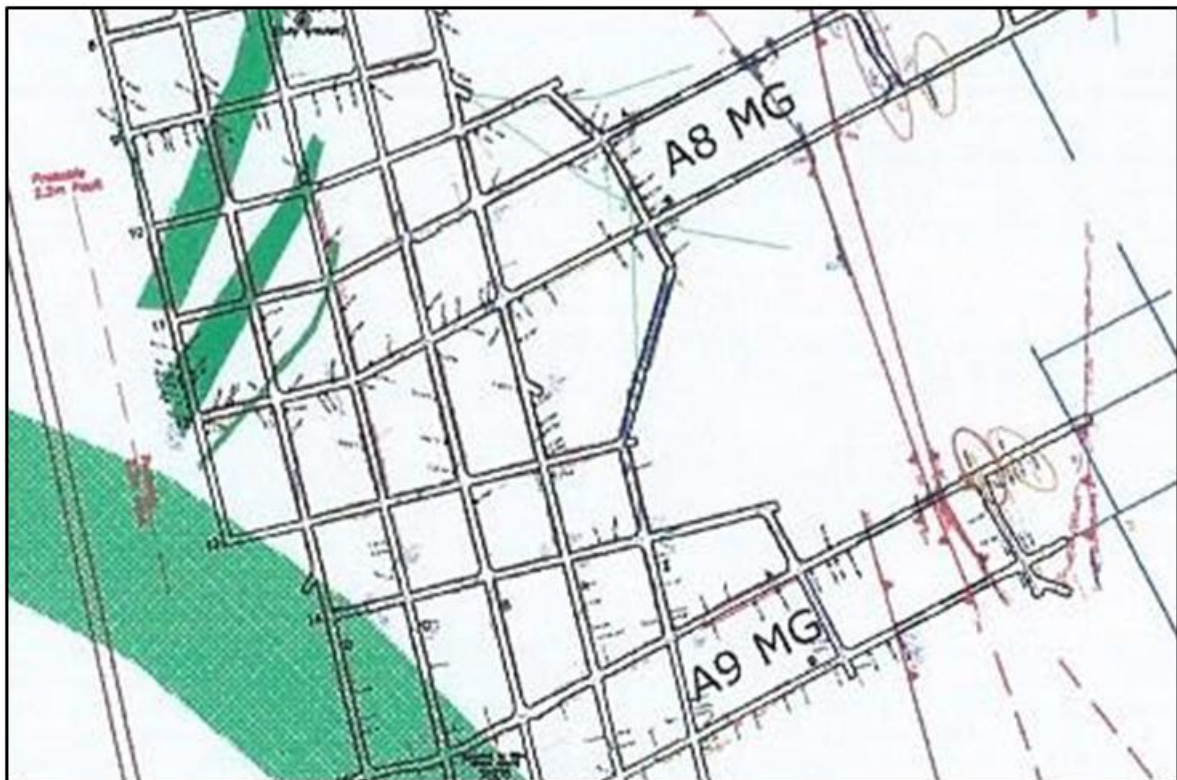
Figure 4: Maingate A9 development status at time of accident on 15 April 2014.

During the preceding shifts, some bump activity had occurred, including a large bump during afternoon shift of the previous day (14 April). Mining conditions in B Heading at the time included some spall of the right hand rib, below the Dosco Band (see Figure 6, for an image of the Dosco Band parting within the coal seam). However the left hand rib was standing straight. Roof conditions had deteriorated, and so some supplementary forward, low-angled spiling with cable bolts had been installed in the centre of the roadway.

In regard to the prevailing geological conditions, A Heading, inbye of 2 cut-through (on the left of the panel facing inbye) had previously struck a fault with a resulting roof fall. A “dog-leg” angled stub heading had been driven to the right of the panel off an extension of 2 cut-through, in an effort to locate the possible faulting ahead of the panel. The dog-leg drivage again resulted in a roof fall at the face, although it is difficult to ascertain whether the projected fault expected in the vicinity was actually exposed in the face, or whether the poor conditions that led to the fall were associated with poor ground leading up to the fault.

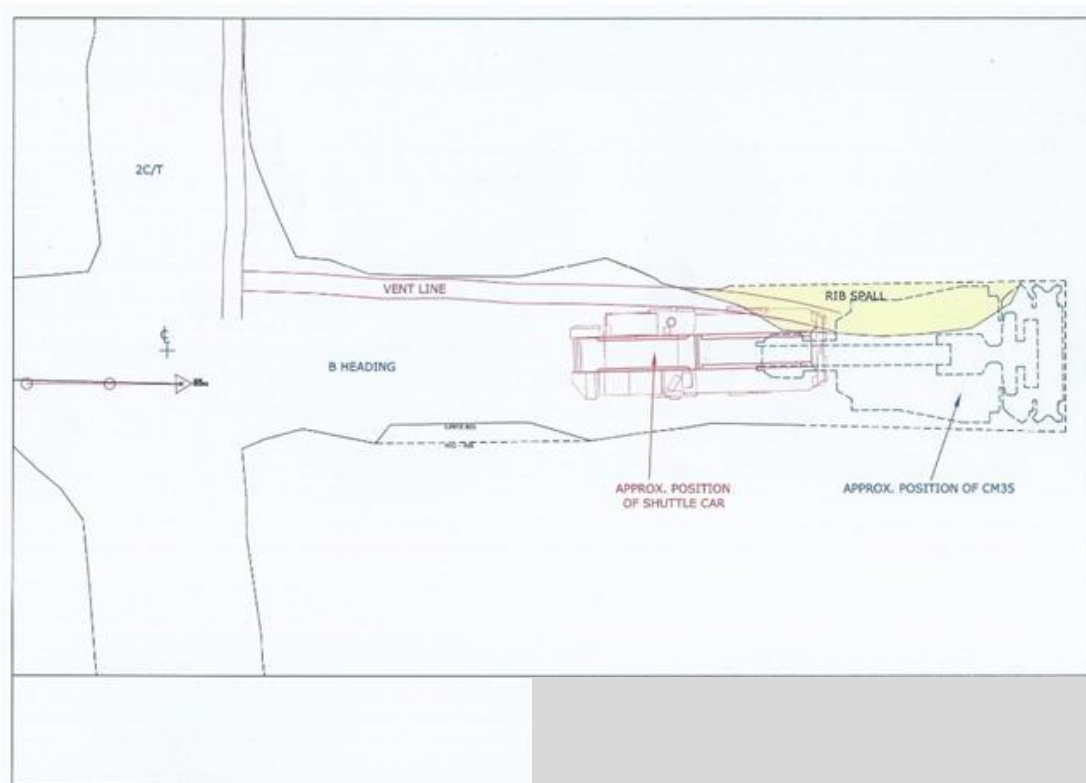
Figure 5: Plan view showing continuous miner position relative to face and burst location.

Figure 5 shows a plan sketch of the continuous miner position when the burst occurred from the left hand rib beside the miner, striking and engulfing the two men who had been standing on the platform on board the miner.

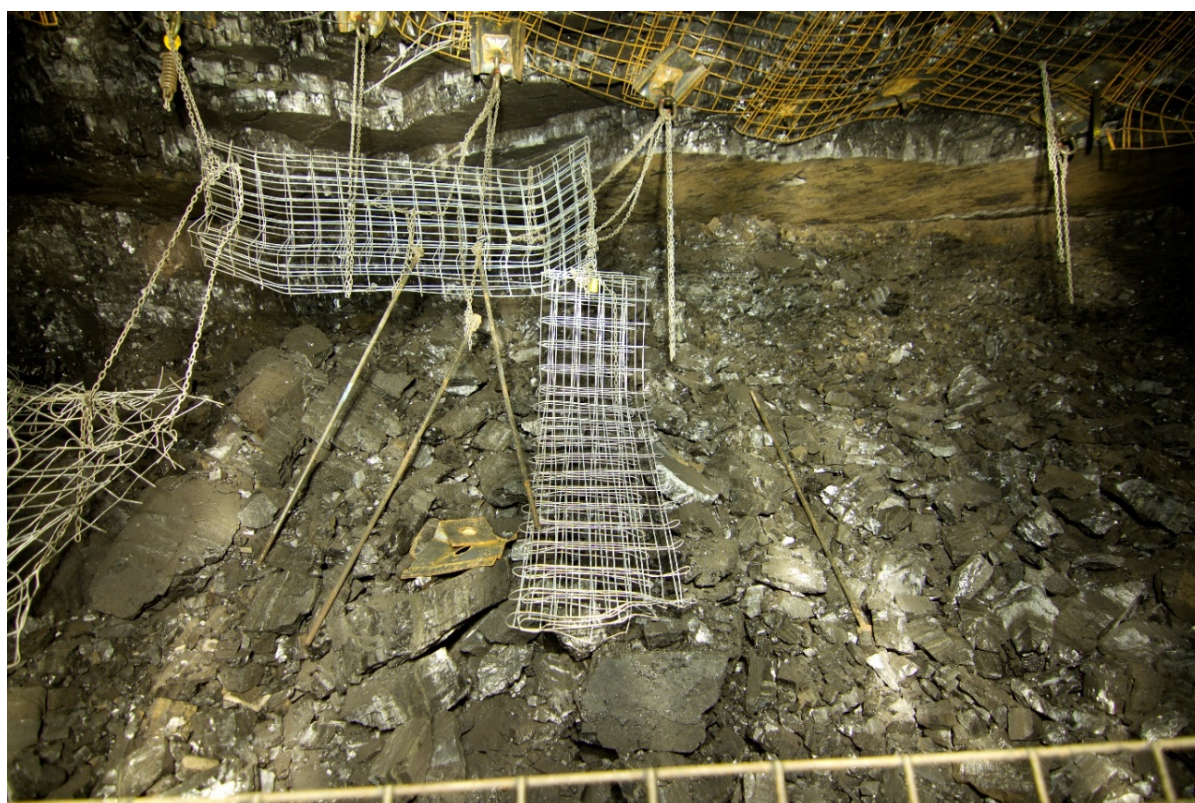
Figure 6: Looking into the burst cavity from the position of the continuous miner.

Figure 6 shows the central portion of the burst cavity, taken from where the continuous miner had been located. The actual burst location extended several metres either side of this location. Clearly evident in this photograph is the marker band in the seam known as the Dosco Band. This appears to have formed an upper-bound to the burst cavity, and has acted as a shear plane below which the coal has moved out horizontally during the dynamic failure process. The bedding plane surface of the Dosco Band also clearly exhibits evidence of shearing, and the distinctive reddish brown colouring, which has been reported from other burst locations around the world, associated with the fine dust caused by high stress pulverising/shearing of the coal particles. The extent of the burst cavity into the rib has not been accurately established, but it clearly extended beyond the depth of the previously installed rib support.

Subsequent investigations have found no evidence of any significant levels of gas involved in this accident, ruling out a gas driven component to the failure, so it cannot be classed as a gas outburst.

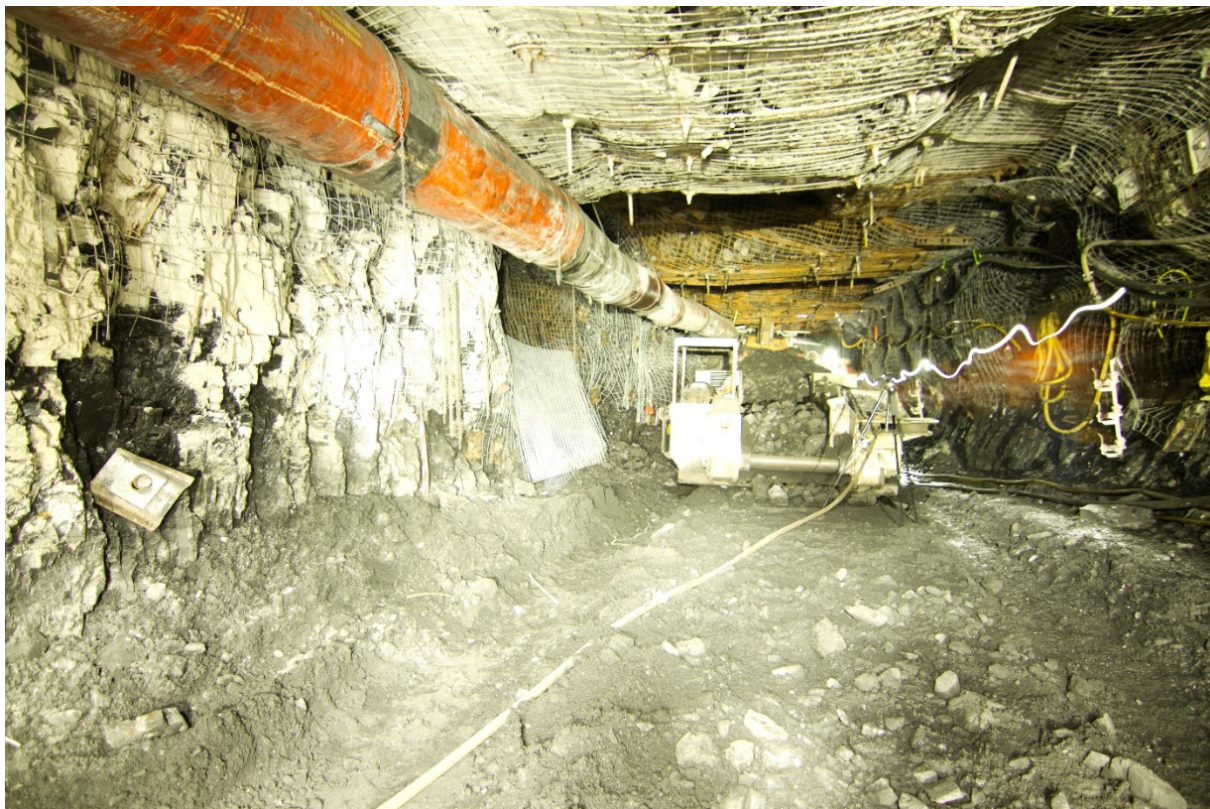
Figure 7: Burst location on the left side of shuttle car parked at the back of the continuous miner, looking inbye in B Heading.

Figure 7 is a view looking into B Heading while the continuous miner and shuttle car were still in place at the face. This shows the pressure burst cavity beside the left hand side of the miner. It also shows the deterioration in the roof conditions at the location, prior to the event. Cable bolts had been installed over the miner location in a supplementary spiling support pattern to add stability to the roof, prior to the event occurring. Reasonably good rib conditions are evident on the left hand side, outbye the burst location, in contrast to more damaged ribs on the right hand side. Figure 8 is a close-up photograph of the burst cavity beside the miner, clearly showing the distinctive smooth shear plane of the Dosco Band that formed the upper bound of the burst cavity.

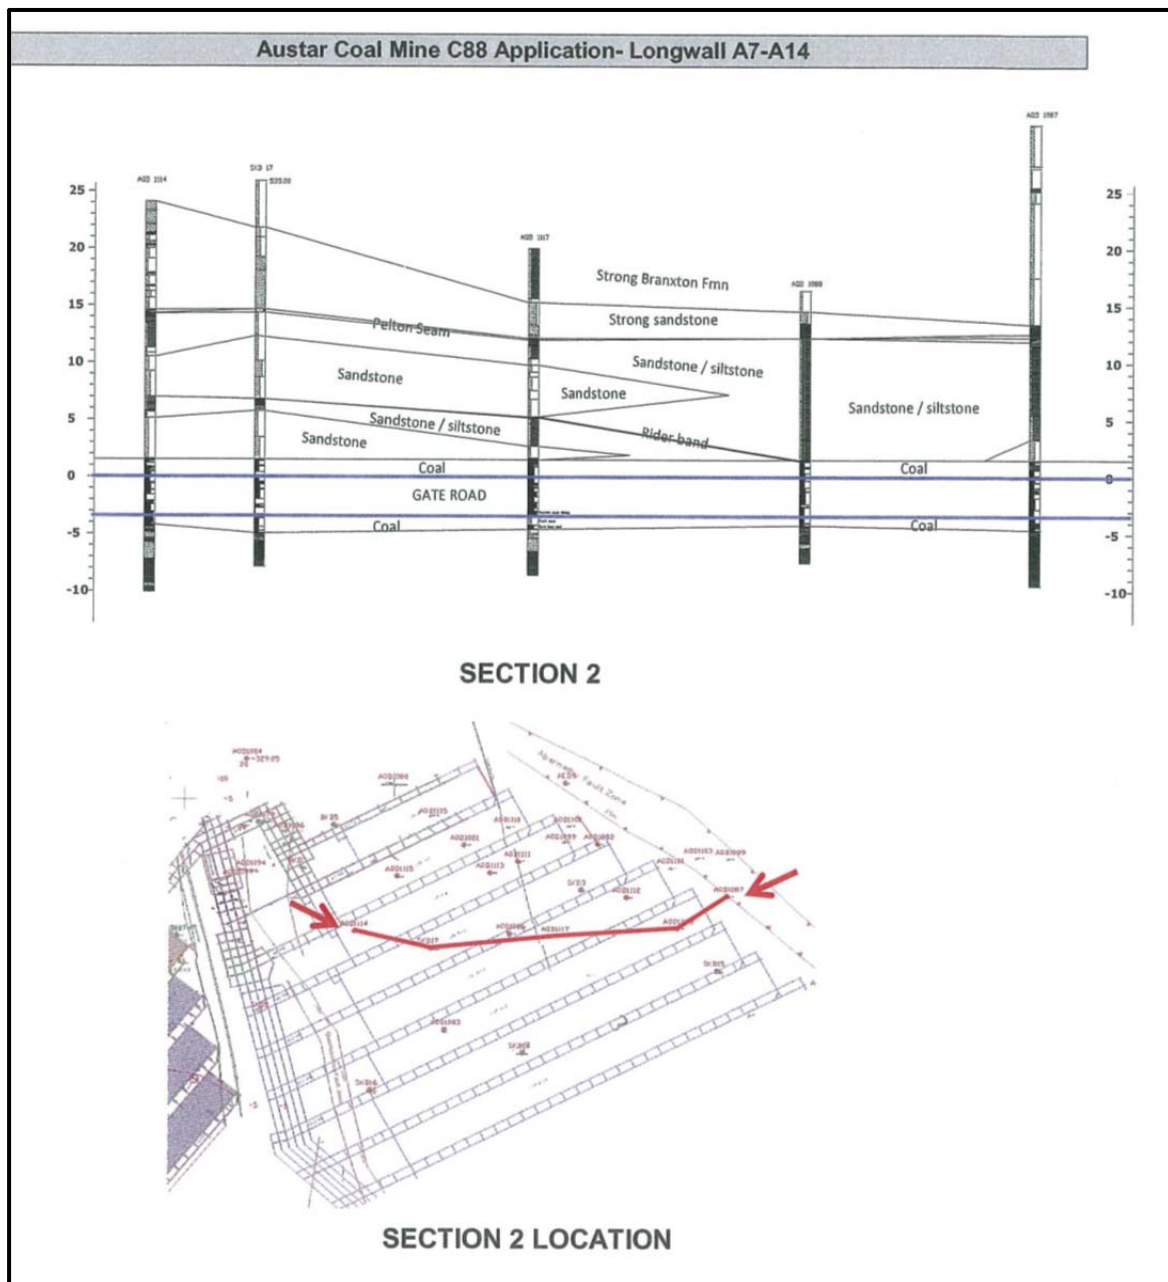
Figure 11. Stratigraphic section of overburden geology close to Maingate A9.

In the case of the Austar Coal Mine incident of 15 April 2014, there were high strength, massive strata units (layers of competent rock) present – both in the immediate roof and in the floor. Whether variation in thickness and or strength of these units occurred in the vicinity of Maingate A9, which could have led to a sudden failure, is unknown, but is a potential factor. There is no doubt that there was an extensive array of regional and localised geological features in the vicinity of the accident site that would represent a likely contributor to the trigger event for a pressure burst – either by creating a stress change, or by causing significant degradation in rock/coal mass strength due to structure (cleats, joints, shear zones, etc). Finally, there will always be a reduction in confinement when a mining excavation advances into an area of solid rock or coal.

Figure 11 is a stratigraphic section through a series of boreholes in the vicinity of Maingate A9. This shows the presence of a number of stiff sandstone units above the coal seam, with some lensing. These are moderately thick sandstones within the first 20m of roof, overlain by the massive Branxton Sandstone formation, located about 20-25 m above the Greta Seam in the vicinity. Unfortunately these boreholes do not penetrate more than 10 m into the floor. However other data from the region (such as reported as near-seam stratigraphy in the Longwall A7 Geological Hazard Plan), together with geological data from nearby boreholes does indicate the presence of both conglomerate and sandstone massive strata units below the Greta Seam in this region of mining, in close proximity to the seam floor.

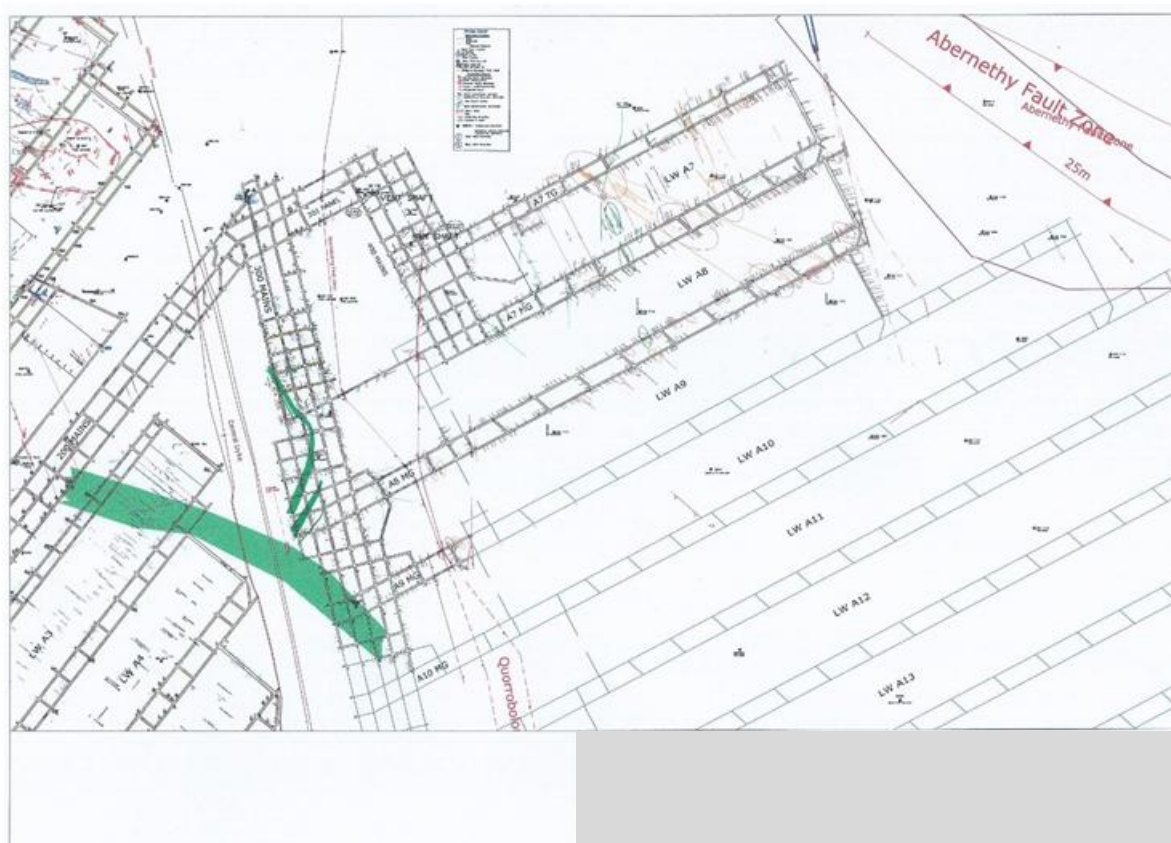
Figure 12. Structural geology features in the vicinity of Maingate A9

Figure 12 shows the presence of known and projected geological structure in the region of longwall panels A7 to A9, and in the area of the 300 Mains development panel. Regionally, the area is affected by the corridor of the Quorrobolong fault zone running sub-parallel and adjacent to 300 Mains. Adjacent to this zone (and essentially a part of it) are the group of faults that were encountered within the first three pillar lengths of Maingate A9. The combination of these major regional structures, together with the clustering of localised faults, have had an impact on the integrity of the rock and coal properties in the area, as well as almost certainly impacting on stress magnitudes and directions (vertically and horizontally).

Directional longhole drilling was undertaken from the 300 Mains in advance of Maingate A9 development, to establish the presence and nature of some of these projected geological features, as well as to inform on coal seam continuity and gradients ahead of Maingate A9 development. Figure 13 shows the pattern of holes that were drilled in the vicinity. While these holes clearly penetrated the cluster of faults that crossed Maingate A9 between 1 and 2 cut-through, they appeared to have all stopped short of the structures that were encountered beyond 2 cut-through in A Heading, and that were projected to lie just beyond the face of B Heading and the dog-leg heading at the time of the incident.

There is no doubt that in areas of structural disturbance such as this, where there is history of pressure bump and possibly burst conditions, forward knowledge of the structural geology
