# FIRES ON MOBILE PLANT

July – September 2020

Title: Fires on mobile plant, July - September 2020

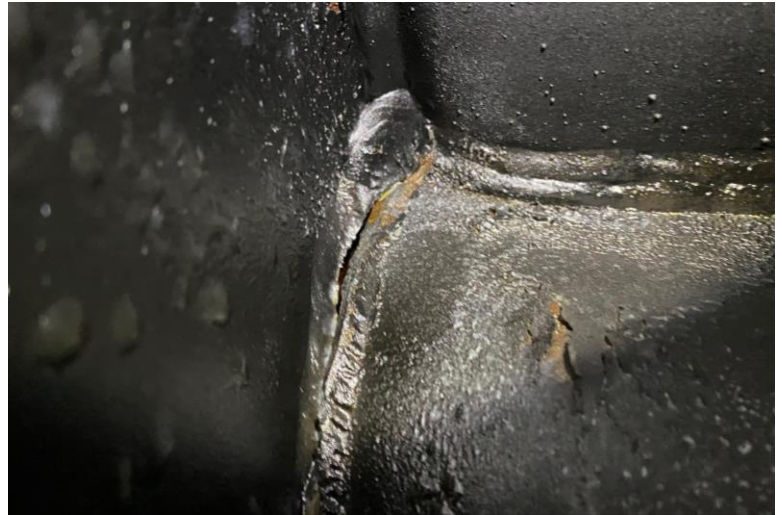
*Figure 17. Location of cracked weld*

The operator of a loader in an extraction drive observed a flame coming from the muffler box on the loader. The operator stopped the machine and used a fire extinguisher to suppress the flame. The flame reignited and was extinguished again. The automatic fire suppression system was manually activated to cool the machine.

The apparent cause was fuel leaking from a crack in the internal fuel tank into the diesel particulate filter (DPF) box. The loader had previously contacted a wall, but the damage to the fuel tank was not identified at that time.

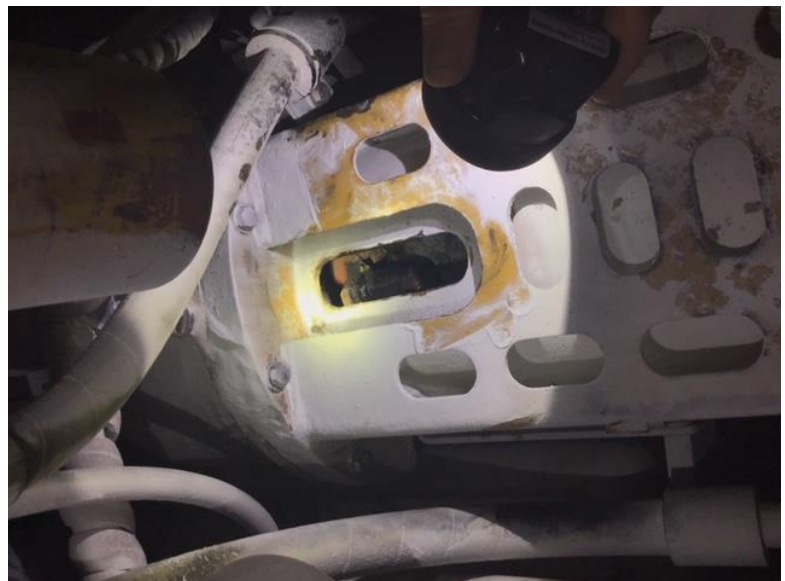
*Figure 18. Location of fire*

A Caterpillar R3000H Production Loader was travelling down the main decline when it lost power. The operator contacted the Maintenance Team who advised to park up. When the operator alighted from the machine a small flame was noted in the torque converter area. Both the onboard fire suppression system and a hand-held extinguisher were used to extinguish the flame.

The investigation identified a failed output bearing on the torque converter. The failure generated excessive heat which ignited the grease in the universal joint. The bearing failed due to a blockage in the oil supply gallery preventing the bearing from being lubricated.

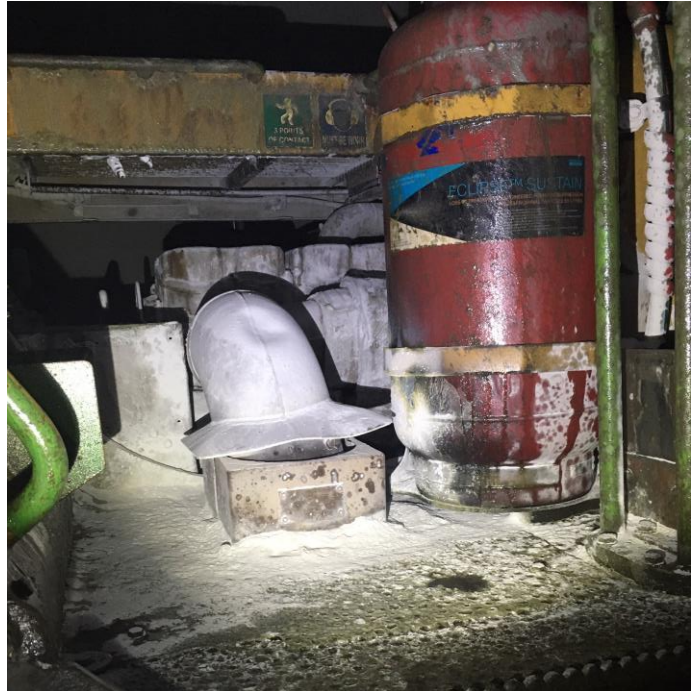
Figure 19. Damaged DPF box and exhaust pipe

A hydraulic hose has blown and sprayed oil over a Caterpillar R3000H loader. The operator started to reverse the loader to the doors to enable safe access for maintenance workers. The operator noticed flames, shutdown the machine and manually active the fire suppression system. The flames were coming from inside the DPF box. The flames re-ignited and the operator used a handheld extinguisher to extinguish the flames. The hose failure was attributed to a combination of heat exposure and corrosion of the hose. The ignition point was a created due to a structural failure of the DPF filter which allowed the exhaust pipe to list up out of DPF box, exposing a normally shielded hot surface.

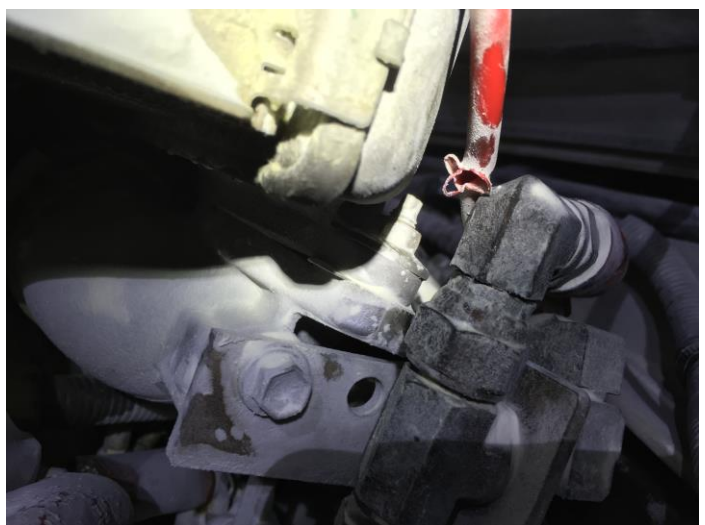
Figure 20. Failed injector line

A truck operator observed a fire on a Landcruiser while it was travelling up the main decline. The vehicle was pulled over at a stockpile & the fire was extinguished with a handheld fire extinguisher.

The investigation identified an injector had been replaced by only removing one end of the fuel pipe and pushing it to the side instead of loosening / removing the pipe completely. This has caused the pipe to not seal correctly, fail and fuel has leaked down onto the exhaust manifold / turbo area which has ignited and caused a small flame.

The injector was inspected for leaks after replacement and no leaks were present, it is believed that after driving the pipe has failed.
