Serious injury

Event: Grader operator suffers serious head injuries

Location: Mt Arthur Coal Mine, Muswellbrook NSW

Investigation Information release

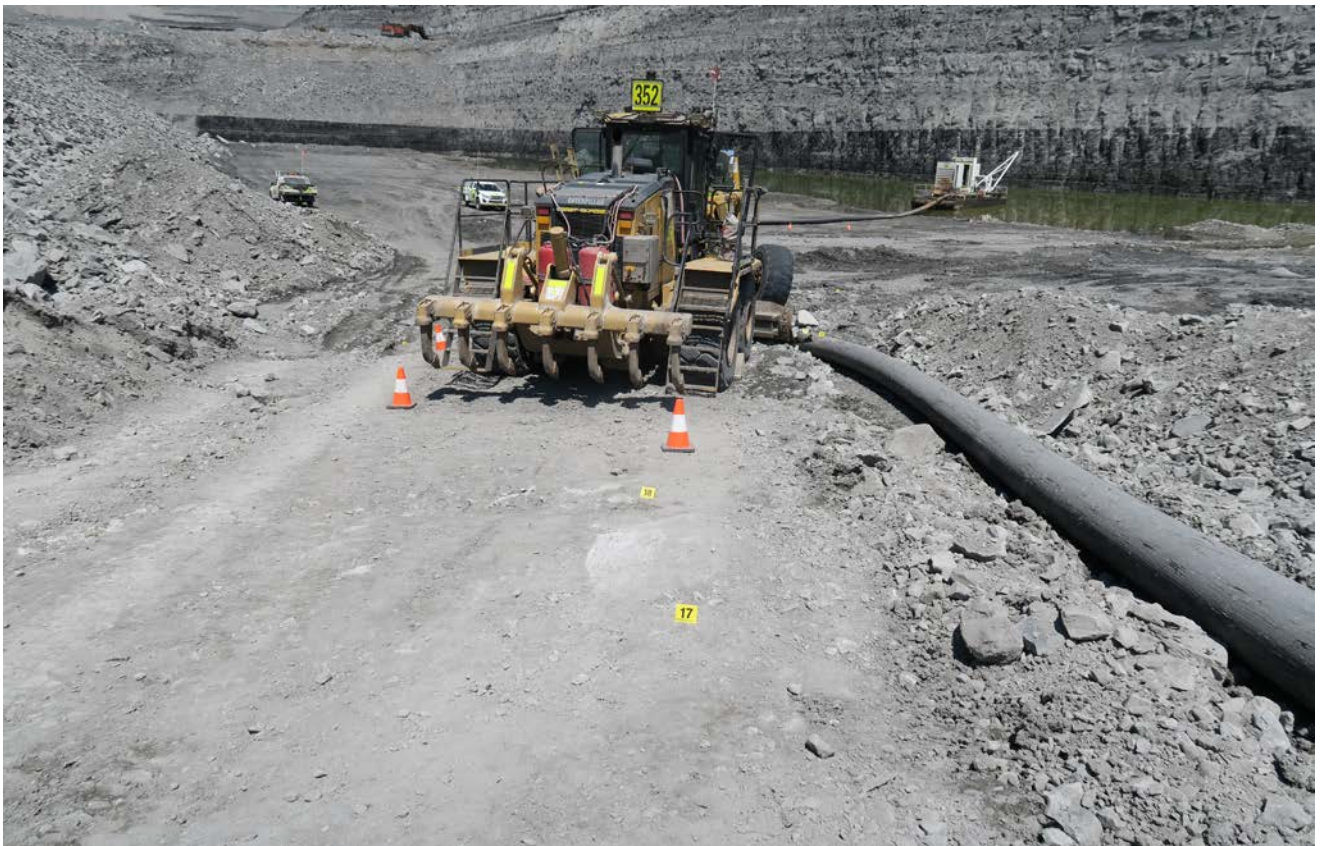
Photograph 1: The grader and waterpipe.

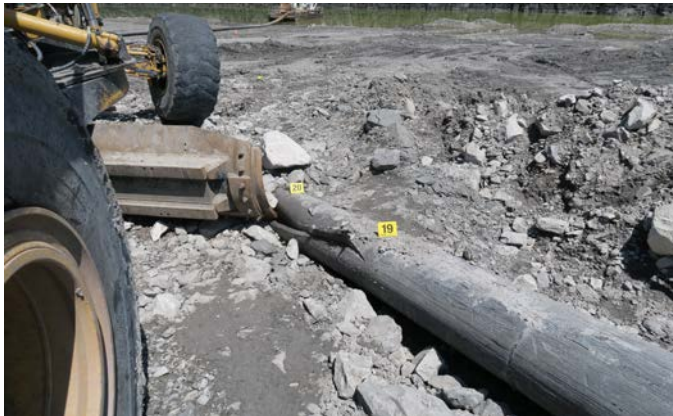
Photograph 2: The grader and the punctured pipeline.

The right side of the grader blade punctured the pipe. Water ejected at high pressure, causing dirt and rock material to hit the right-hand side of the grader cabin. The laminated glass in the grader door shattered. Rock, dirt and glass were forced into the cabin of the grader and hit the worker. The worker suffered multiple facial fractures and deep lacerations to her face, which required surgery.

Mine operators must have effective safety management systems in place and identify risks associated with the operation of mobile plant. In managing these risks, mine operators must have regard to the possibility of interactions occurring in areas where mobile plant operates near mine infrastructure. Consideration must be given to identifying and demarcating infrastructure and isolating potential energy sources. Appropriate separation distances between the mobile plant and infrastructure must be maintained.

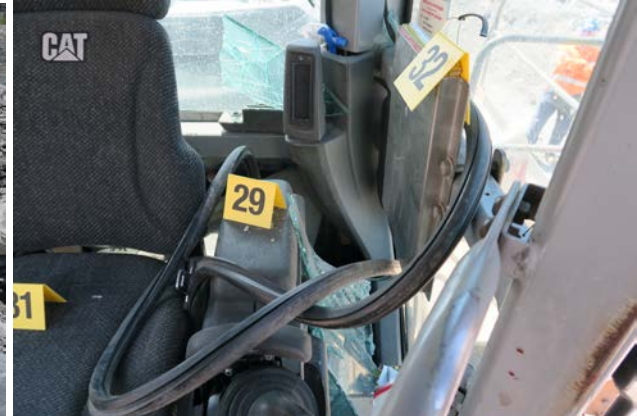
Photograph 3: Broken glass in operator's cabin
