INVESTIGATION INFORMATION RELEASE

Causal investigation initiated after worker injured by pin ejected under pressure

Incident date: 9 July 2019

Location: Ravensworth Open Cut Coal Mine, Singleton NSW

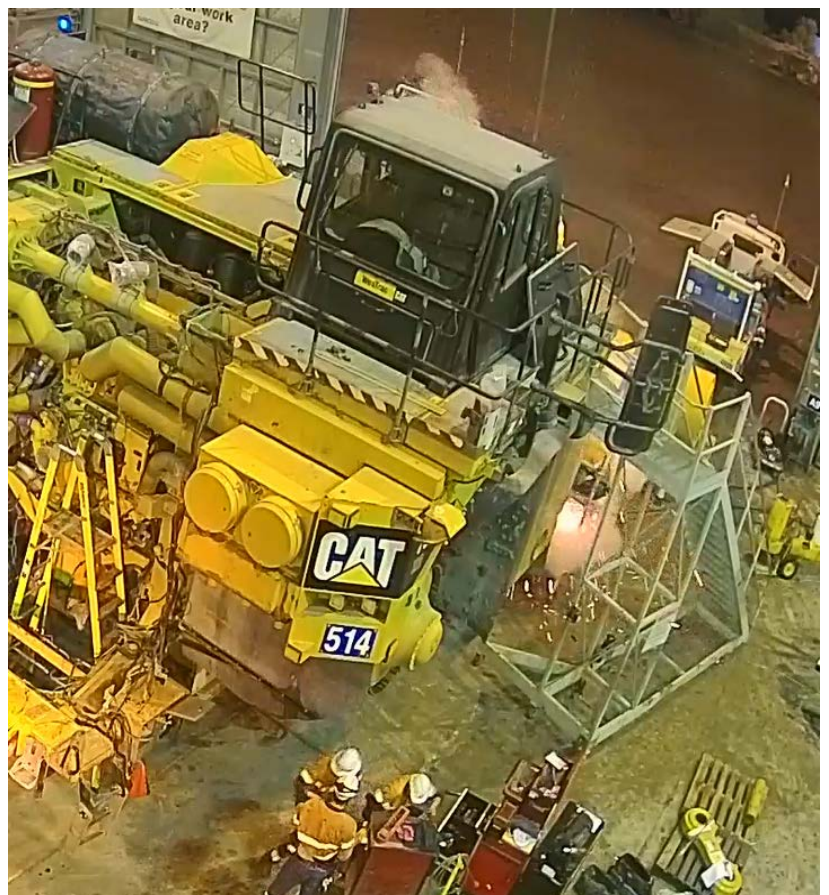
Figure 1 Image from video footage of workshop at time of the incident

The pin was violently ejected, hitting the boilermaker on the left side of his body, resulting in a large hematoma to his left hip, a greenstick fractured left thumb and minor facial and eye injuries from the slag spray. The spotter, who was working with him, was propelled backwards from the force, but was not injured.

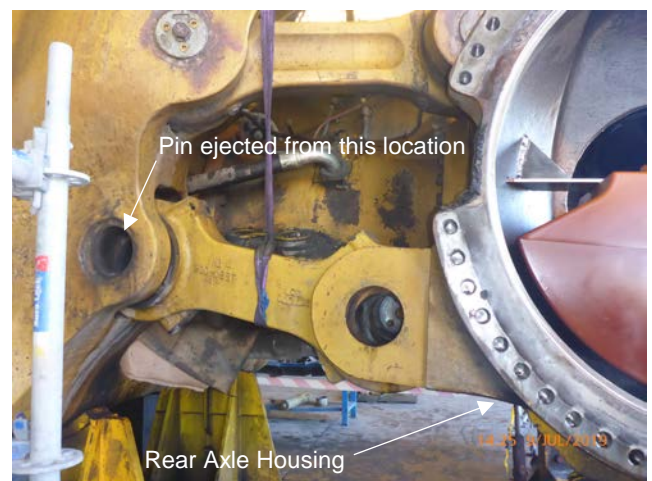
On 8 July, fitters were working to remove the pins from the lower left-hand suspension link, known as a 'dogbone'. They had managed to partially withdraw both front and rear pins prior to handing over to night shift.

Night shift fitters then successfully removed the rear pin but realised after several hours the front pin appeared to be seized. The night shift fitters then requested a boilermaker to conduct thermal lancing of the pin, to remove it.

Figure 2 Lower Suspension Link (Dogbone) supported by crane as preserved following the incident

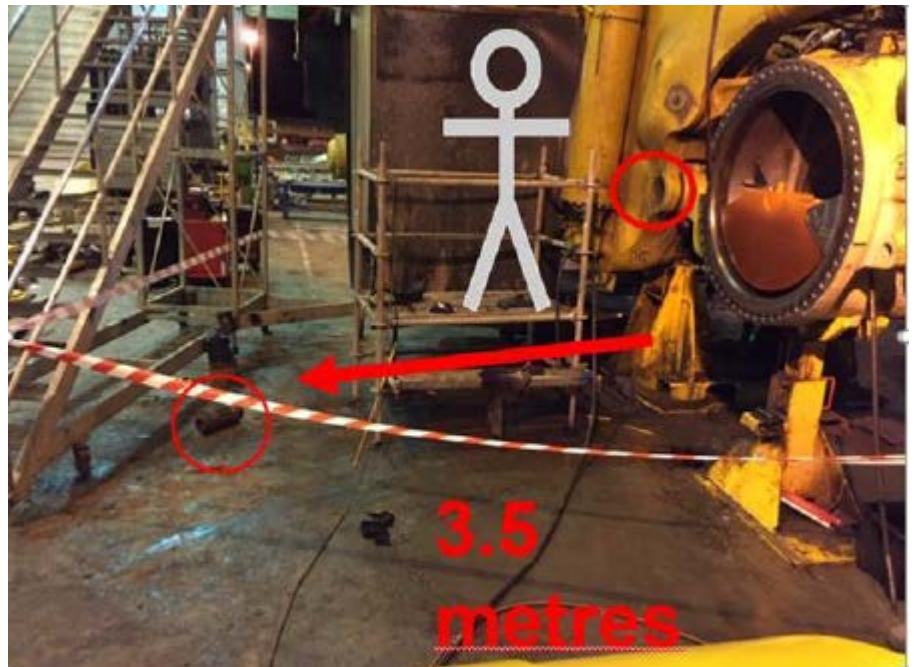
for the process to be repeated. Lancing began for the second time for about six minutes to enlarge the hole through the pin. Standing on the scaffold, the boilermaker turned off the lance and began using a water hose, initially to cool the area behind the pin clevis, then the pin itself. The ejection occurred seconds after quenching the pin.

Figure 3 Boilermaker work position when struck

- Mine operators should review risk assessments, and as necessary, revise control measures for undertaking thermal lancing, considering the potential for a steam or hydrocarbon explosion event, confinement and safe standing zones and PPE for protection against being struck by projectile pins and slag spray.

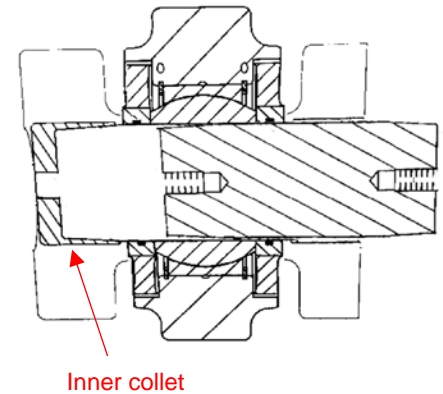
- The outer pin retaining collet had been removed by hot work gouging. The inner collet remained in position.

- The pin – weighing 46.7kg – was withdrawn by mechanical means about 70 millimetres from its installed position before starting lancing, forming a pocket or void behind the pin.

- At some time before the haul truck was brought to the workshop, the seals of the spherical bearing had failed. This meant lubricating oil was lost and the cavity was subsequently filled with grease, under a manufacturer's recommended interim control action (ICA).

- A second lancing operation took about five minutes to further open up the hole through the pin, also without incident.
- Post-incident evidence found slag build-up in the void between the rear of the pin and inner collet, with the slag blocking one of four holes in the collet.

Figure 4 - CAT 797F Pin Assembly

Initial investigations and testing suggest the primary cause of the incident was most likely due to the rapid expansion of steam from the quenching water being applied to the hot pin and slag. The team is also considering other factors such as the presence of grease and other hydrocarbons. The final report will provide details of other factors at the completion of the investigation.

- Mine operators should review procedures for removal of pins with prioritisation of mechanical means of removal over thermal removal (lancing). The review should consider original equipment manufacturer (OEM) procedures, as well as what to do when those procedures are unsuccessful.
- Mine operators should consider the availability and suitability of tools and equipment used for the mechanical removal of pins. Mines should consider OEM recommended tooling, as well as tooling for alternate methods developed when other methods fail.
- Mine operators must ensure the provision of training in the safe use of tools and equipment. Tools and equipment must be used for their intended purpose and within design limits, in accordance with the procedures, unless a suitable change management process is followed.
