# INVESTIGATION INFORMATION RELEASE

## Collision between an excavator and dozer

**Event:** Dangerous incident - collision between an excavator and a dozer

**Location:** Maules Creek Mine

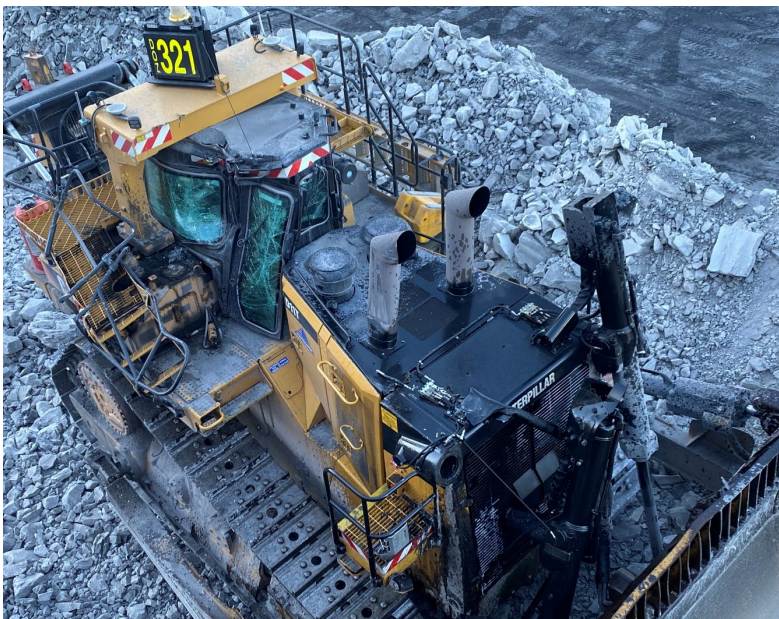
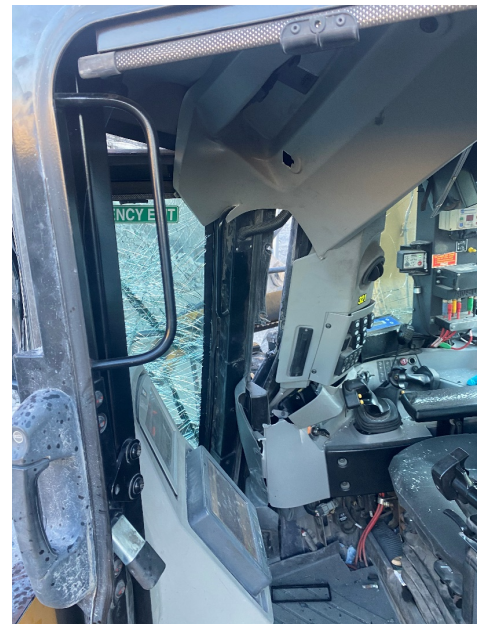
A dangerous incident occurred as a dozer passed through the off-side swing radius of a large excavator as it was slewing. The rear counterweight passed over the dozer blade and struck the cabin structure of the dozer (see Figures 1 and 2). The dozer operator was not injured.

*Figures 1 and 2: Damage to the structure of the dozer cabin and other dozer components*

The counterweight passed over the dozer blade and struck the cabin structure of the dozer. The dozer operator was wearing a seatbelt and could only move his arm and legs to prevent being crushed by the cabin structure. The crushed cabin jammed the door closed and required the dozer operator to kick out a side window to escape the cabin.

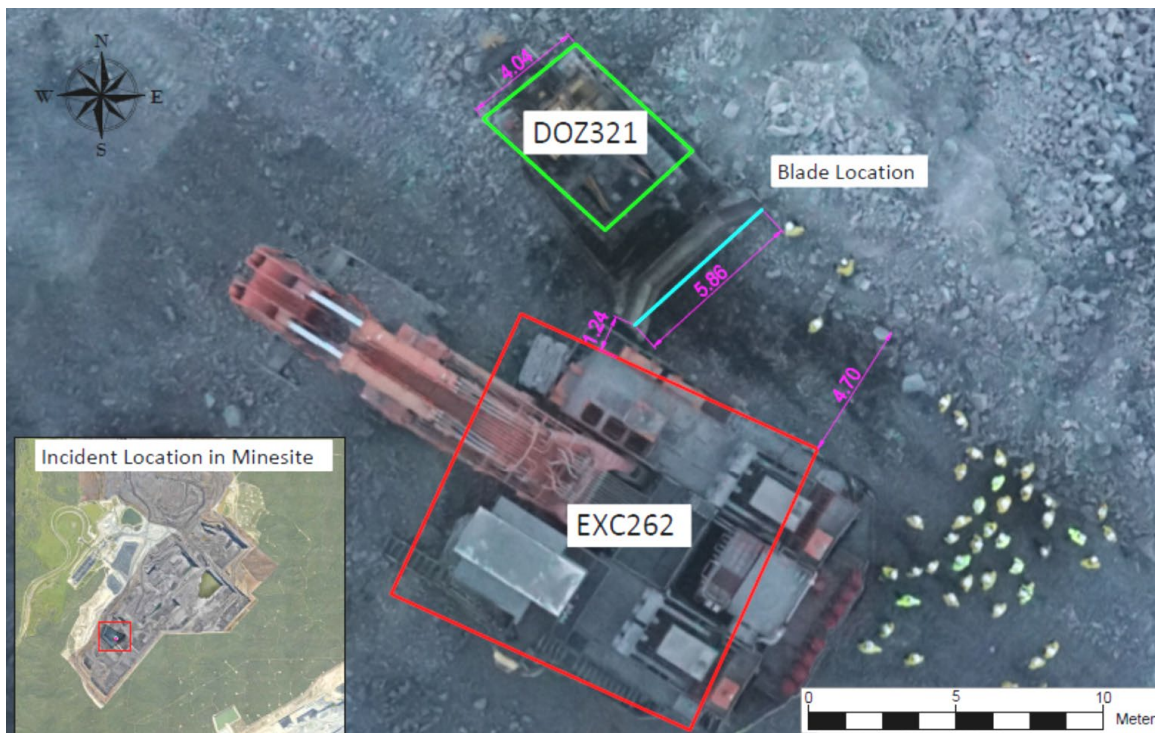
There was a narrow gap on the offside of the excavator and the edge of a bunded low wall where the dozer could pass. The gap was about one metre narrower than the width of the dozer blade.

Figure 3: Incident top view showing the dozer location after being struck by the rear of the excavator

- Mining sequence altered: The excavator had excavated a trench across the top of the ramp which was different to the planned sequence of works and, as a result, the path available to the dozer to pass by the excavator was narrowed due to the location of the trench and excavator. The path was 4.7 metres wide relative to the dozer blade width of 5.9 metres (see Figure 3).

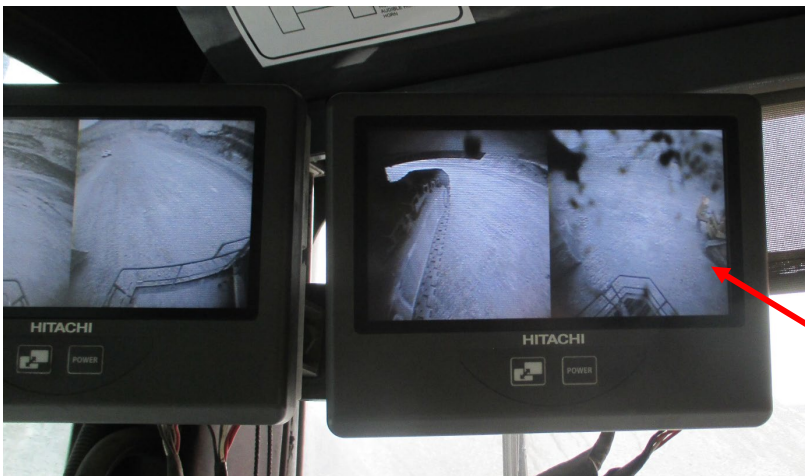
- He could not see a dozer in the display screens because he had not selected the off-side forward facing camera and he assumed the dozer had left the area.

- Video cameras not effectively utilised to assist operator awareness: The excavator is fitted with operator awareness devices (four video cameras outside the excavator and two split display screens inside the cabin). It is unclear which cameras were showing on the display screens at the time of the incident. The mine's procedure does not require the excavator operator to view the off-side cameras when a dozer is passing the off-side of the excavator (see Figure 4).

Figure 4: Two display screens in the excavator cabin depicting camera views of what could have been displayed at the time of the incident.

- Assess and provide information diagrams to excavator operators of visible and non-visible zones, video camera zones and any blind spots when dozers are working in close proximity to the excavator.

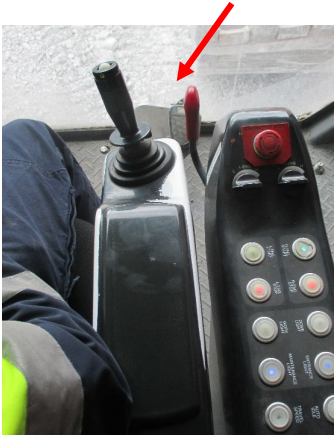
- Hydraulic isolation of the excavator was not required, as part of the mine's procedure, when the excavator passed through the swing radius. There was no visual means to confirm pos-com or isolation status of the excavator by the dozer operator. Hydraulic isolation of the excavator can easily be achieved by using the pilot control shut-off lever located beside the excavator operator's seat (see *Figure 5*).

*Figure 5: Hydraulic isolation - pilot control shut-off lever located beside the excavator operator's seat*

- Consider the implementation of hydraulic isolation of excavators and the installation of external warning light systems to identify the isolation and pos-com status when mobile plant is working in close proximity to excavators.
