MINE SAFETY INVESTIGATION UNIT

INFORMATION RELEASE

High potential incident

Date	18 November 2013
Event	D11 dozer slides into an unmarked test hole on a bench
Location	Bengalla mine, Upper Hunter Valley NSW

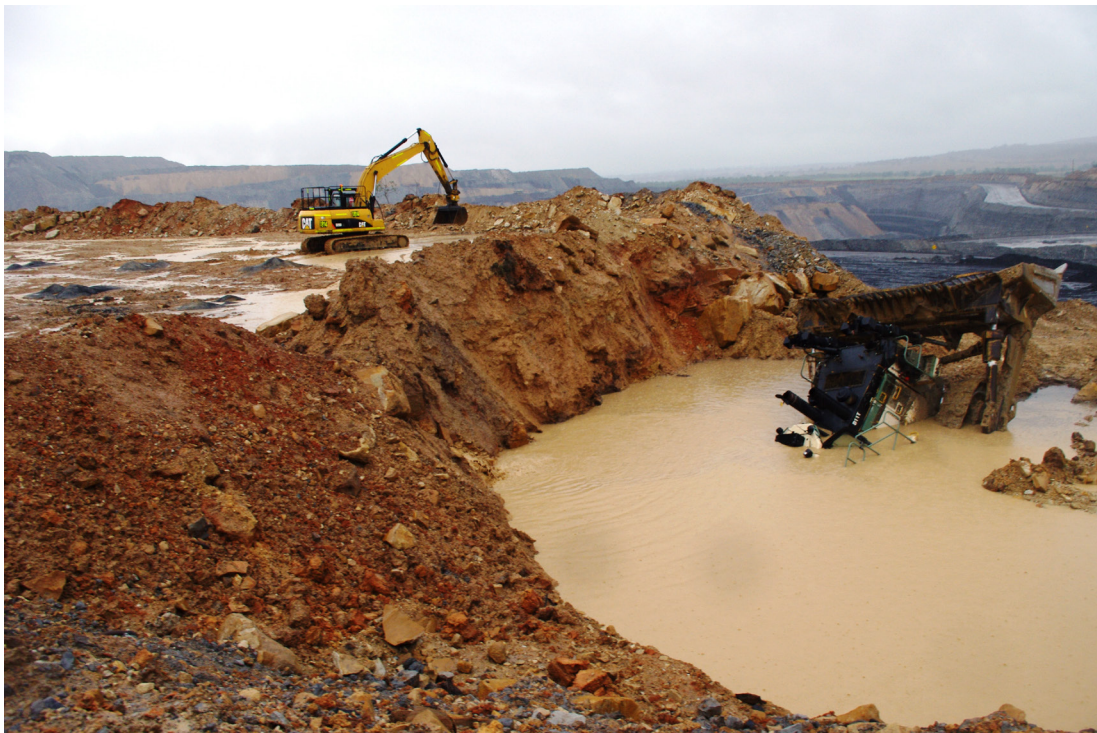
A 113 tonne dozer slid into an unmarked test hole full of water. The test hole had been dug two days earlier into a 5 metre thick overburden bench in an active mining area to determine the depth to coal. Heavy rain occurred on the previous shift and continued on the day of the incident, which filled the test hole. The dozer driver escaped the flooded cabin by leveraging the door handle with his foot.

Dozer submerged in the test hole.

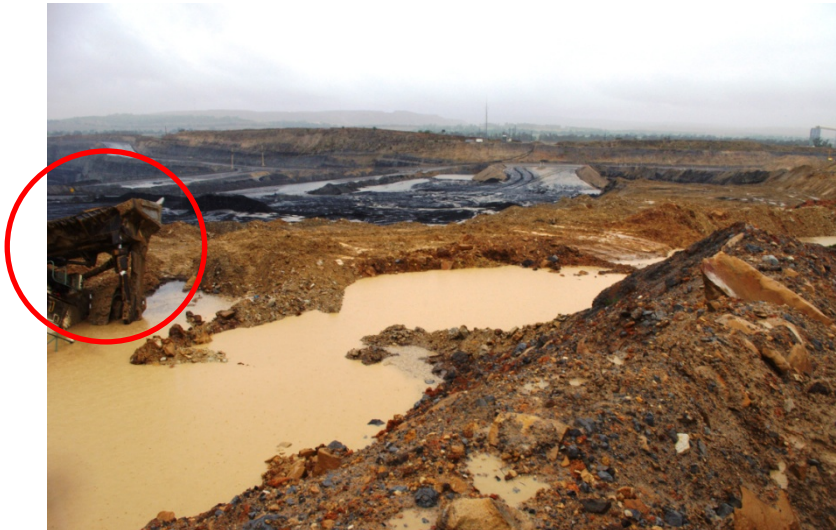
At 7.15 am the dozer driver approached the pooled water on the northern end of the bench in reverse. He stopped to test the water depth using the ripper blade. As the ripper blade was lowered the ground beneath the dozer slumped and the dozer slid backwards into the deep water and test hole. Water filled the cabin to head height. The driver was able to escape the cabin by levering the right hand door handle with his foot. The following photographs highlight the serious nature of this incident and potential for harm.

The submerged dozer and the water-filled trench.

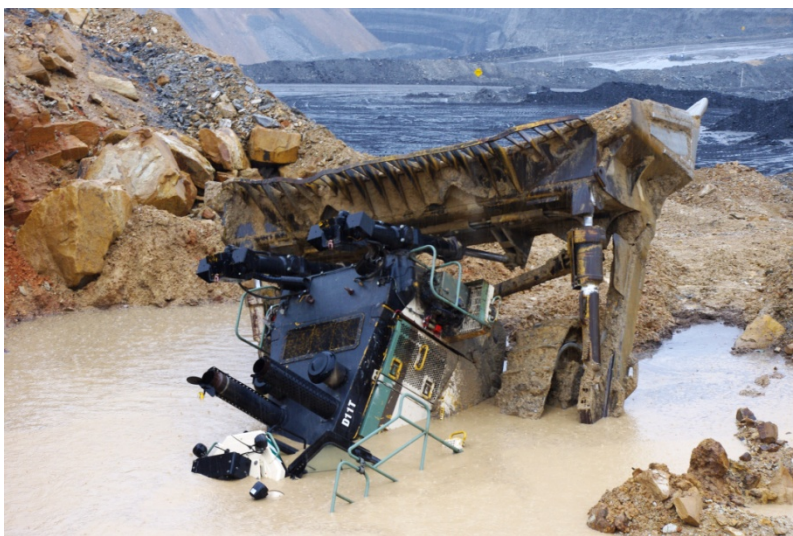
The submerged dozer cabin.
