## Investigation report

Report into the deaths of James Mitchell and Phillip Grant at the Austar Coal Mine, Paxton, NSW on 15 April 2014

Report prepared by the NSW Mine Safety Investigation Unit

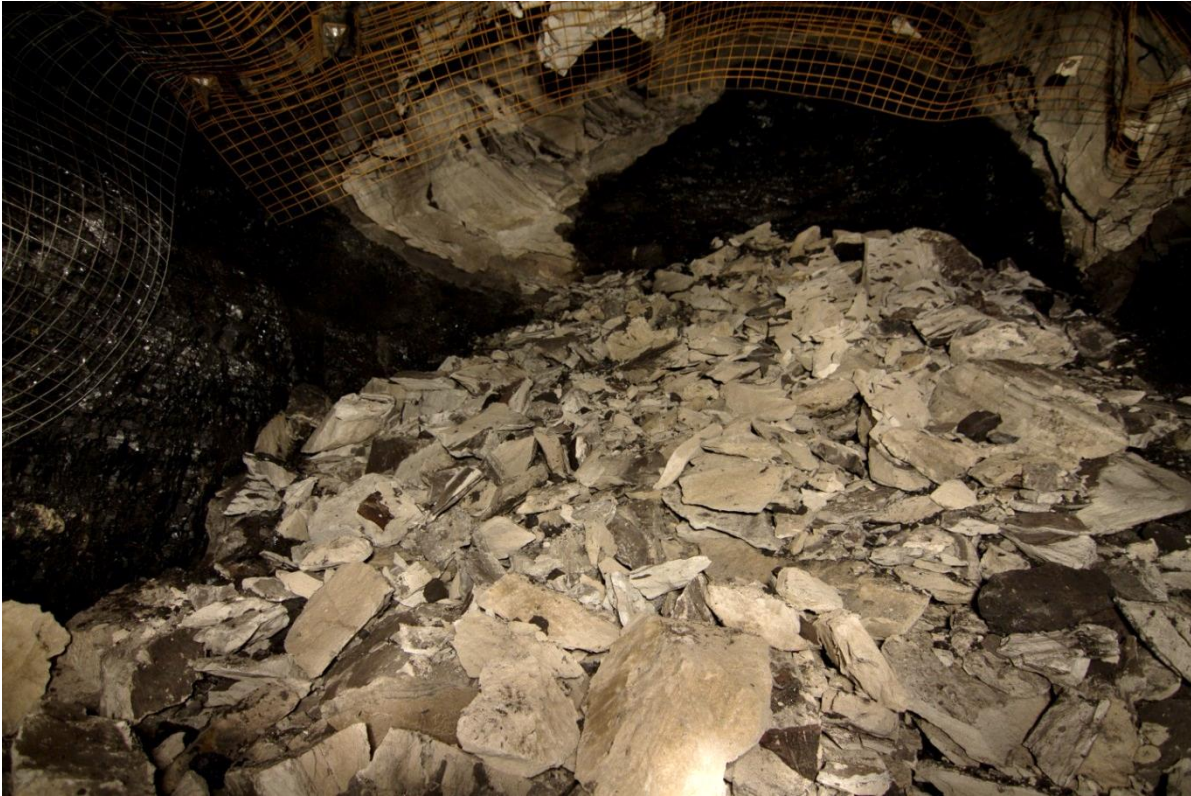
The reason for the slow advance between one cut through and two cut through was that a drift of approximately of 60 metres<sup>41</sup> was driven to breach the Quorrobolong fault that had a vertical displacement of 7.5 metres. Once this was driven, the coal seam was intersected and A and B headings were driven in coal, at a distance of approximately 20 metres to 2 cut through. Heading A then advanced until it intersected with an unanticipated fault. The unexpected fault was estimated to be a three metre upthrow fault trending south. This fault was not anticipated in the mine’s planning and fell at the juncture of the next intersection (3 cut through) where it was planned that the take-off road for longwall MG A8 would intersect Heading A. Figure 6 below shows the fault intersected in Heading A.

Figure 6 Heading A face, intersection with the unanticipated fault.

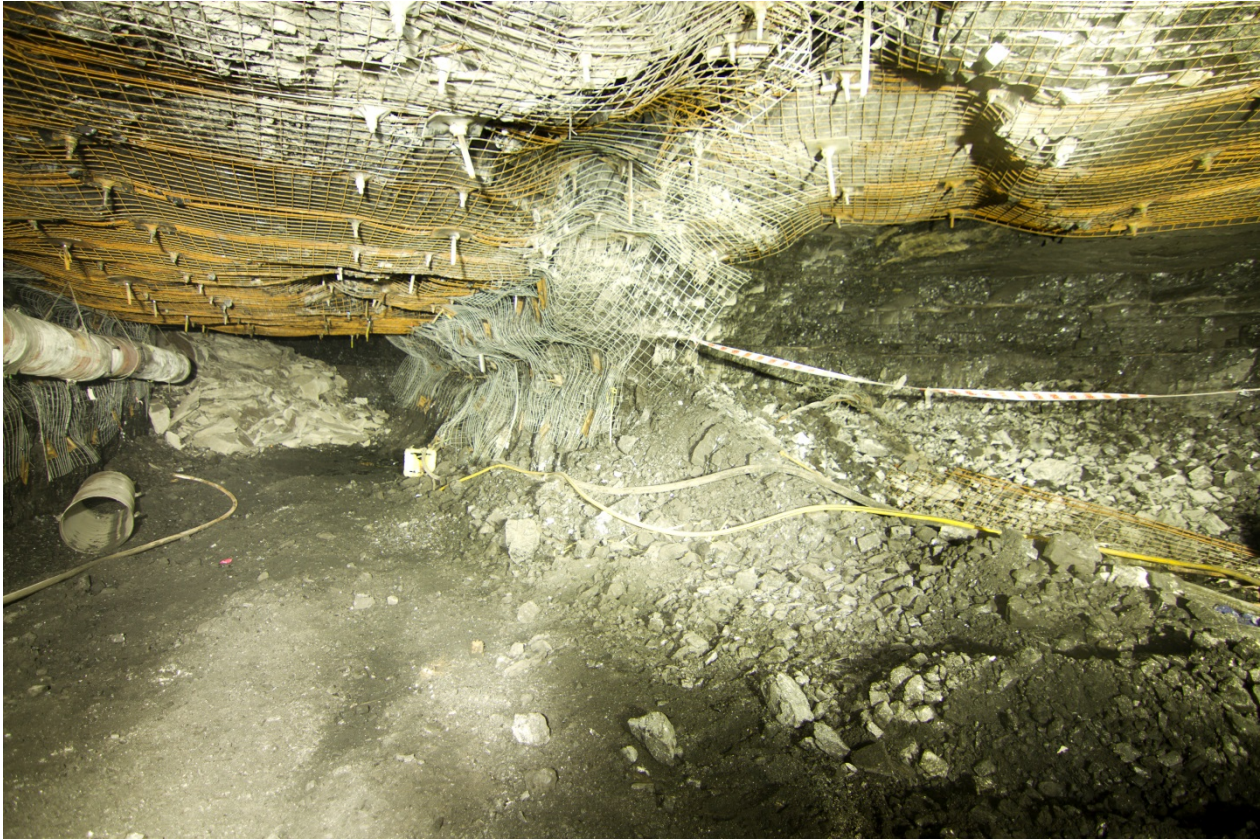
The roof conditions in the stub drivage (as it was referred to at the mine) deteriorated rapidly until at 20 metres CM 35 was withdrawn, as the roof could not be supported and returned to B Heading to attempt to intersect the fault. Figure 9 shows the stub heading and the deteriorating strata conditions encountered in the 'stub' heading. The decision was taken at this time to forepole as B Heading was advanced.

Figure 9 The 'stub' heading showing where CM 35 withdrew from before returning to B Heading.

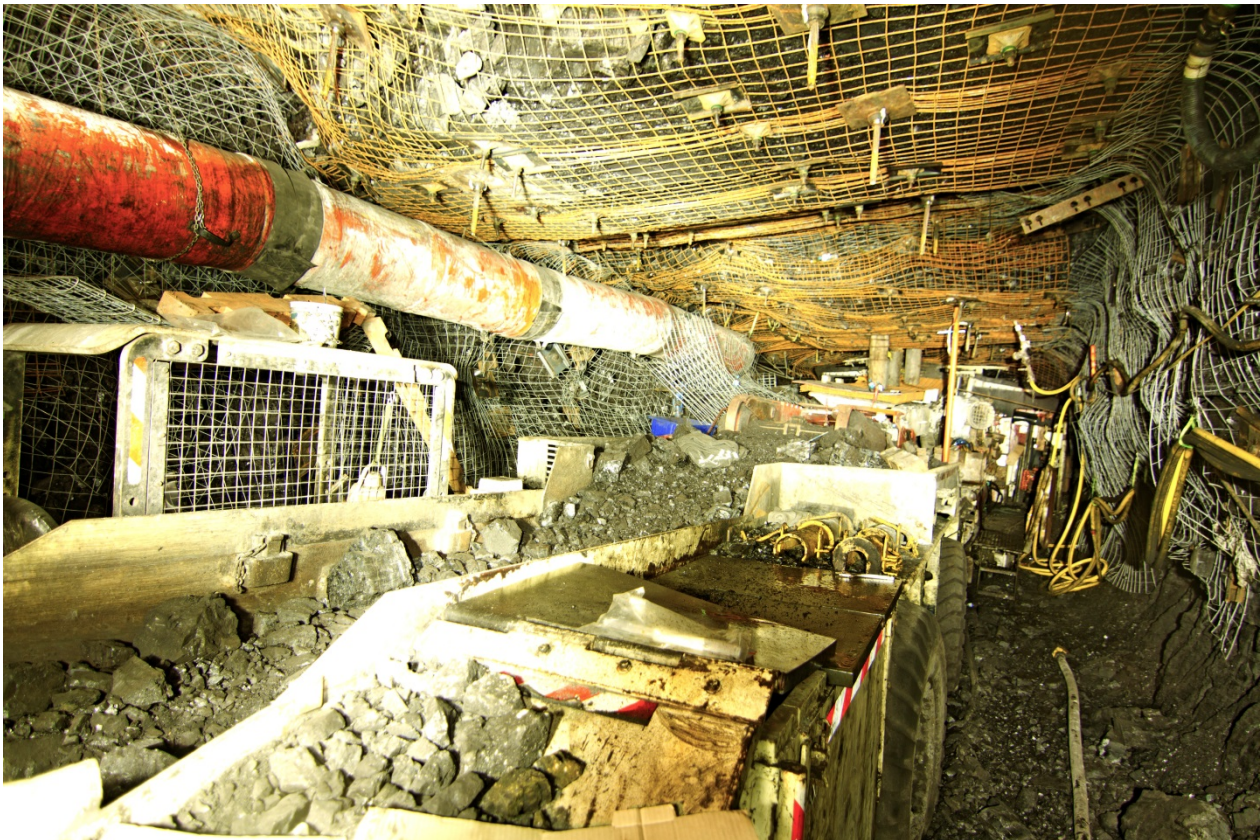
Pictured in Figures 11, 12 and 13 is the incident scene from various perspectives. Figure 11 gives an overview from behind the shuttle car. Figure 12 was taken from the same side as Mr Mitchell and Mr Grant were on, after their bodies and the material that was covering the bodies was removed. Figure 13 shows the incident scene from the other side of the miner and gives a good view of the marker band in the Greta seam known as the 'dosco band' which according to Professors Galvin and Hebblewhite presented a smooth and dominant shear surface and appears to have acted as a shear failure plane.<sup>48</sup>

Figure 11 The incident scene showing the location of the shuttle car and continuous miner CM 35 before recovery of Mr Grant and Mr Mitchell. Note severe rib deformation on the left-hand side of the rib.

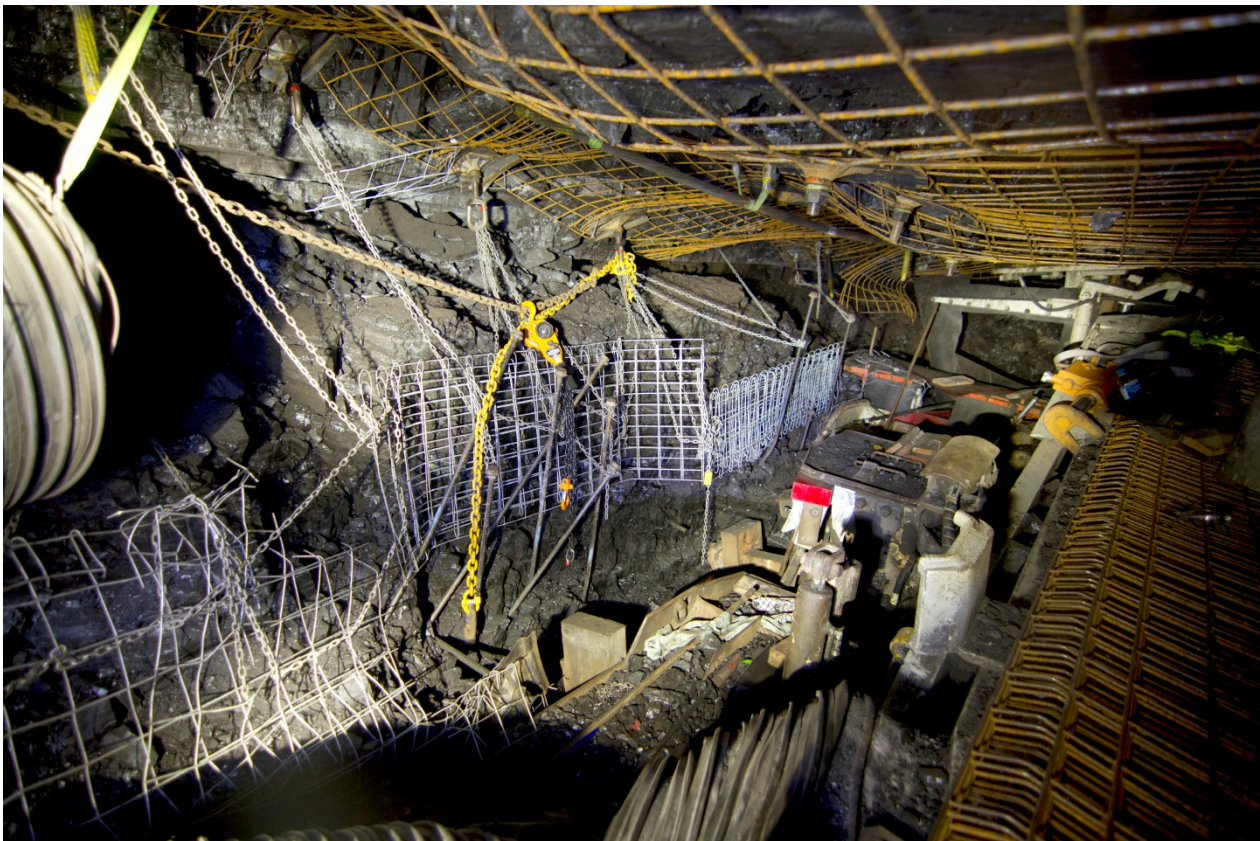
Figure 12 Incident scene showing the left-hand rib after the recovery of Mr Grant and Mr Mitchell.

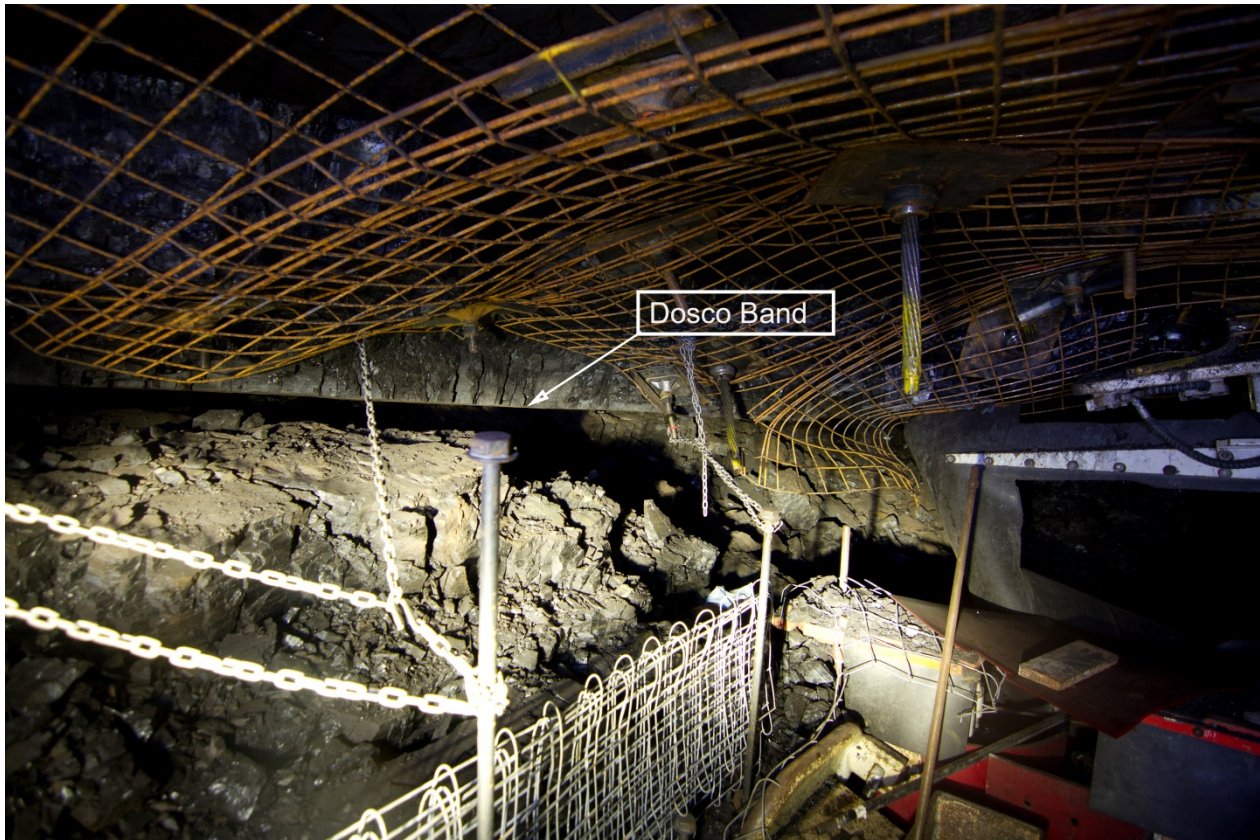
Figure 13 Incident scene showing the left-hand side of continuous miner after recovery of Mr Grant and Mr Mitchell.

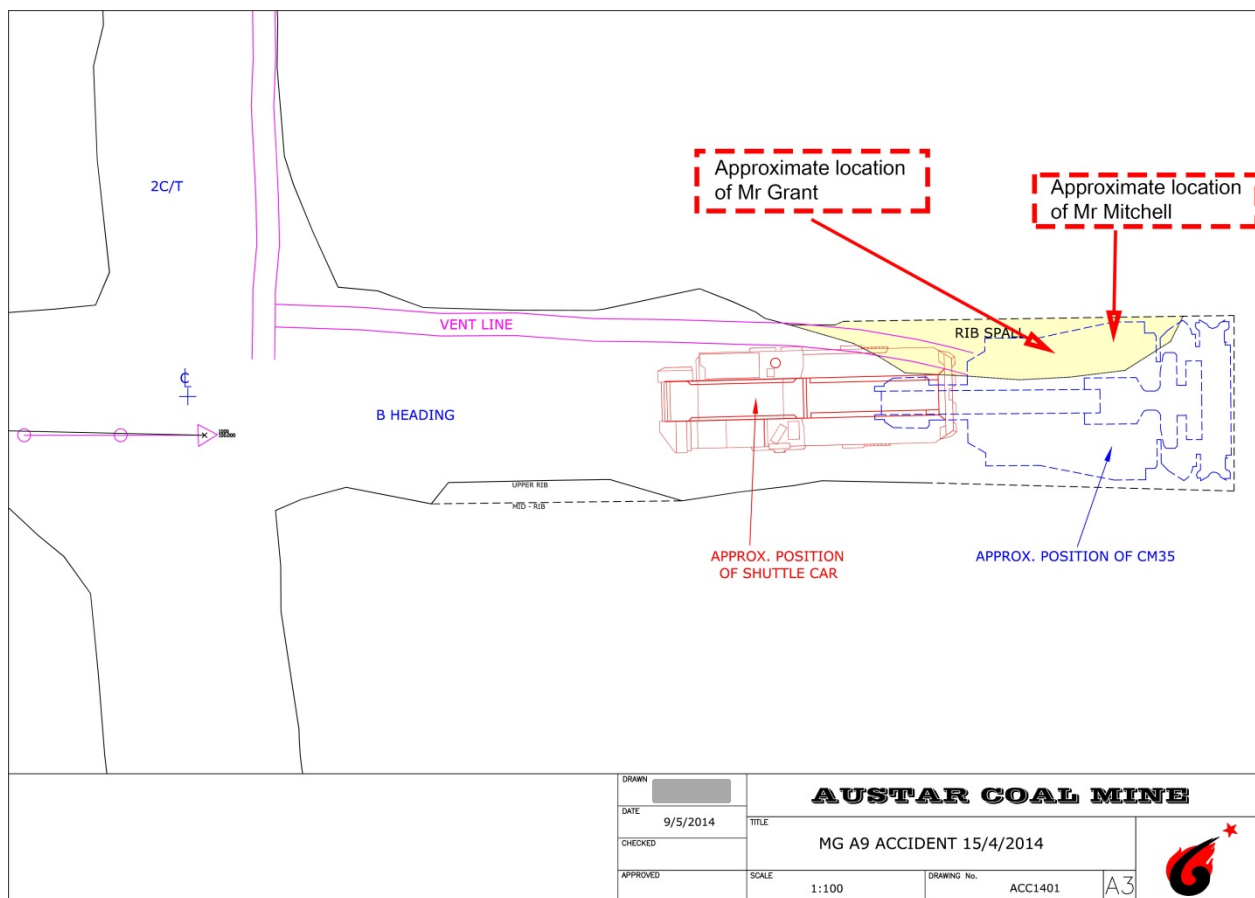
Mr Mitchell and Mr Grant were both at the point where the rib burst occurred and were buried as a result of the burst. Figures 11 above and 14 below show CM 35 and the shuttle car in B Heading immediately after the incident.

Figure 14: Plan of the incident.<sup>49</sup>

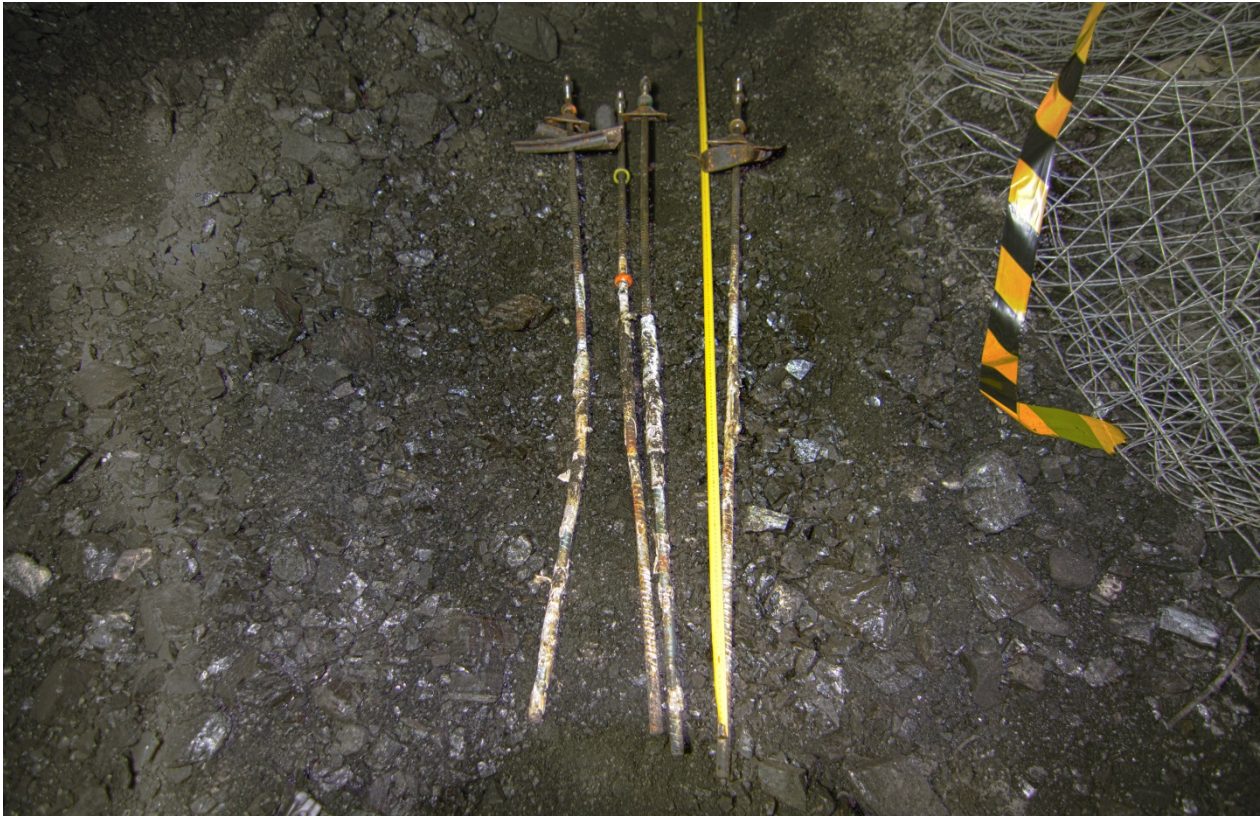
All witnesses spoken to after the incident that had observed the scene confirmed the view that the rib supports they had observed among the debris after the incident had no sign of mechanical failure of either the bolts or the plates. They also confirmed the view that the point of failure in the rib was at a point well beyond the effect of the rib bolts.<sup>78</sup>

**Figure 23** The chemical anchor bolts removed from the incident scene. Note each bolt appears to have full encapsulation of chemical resin.

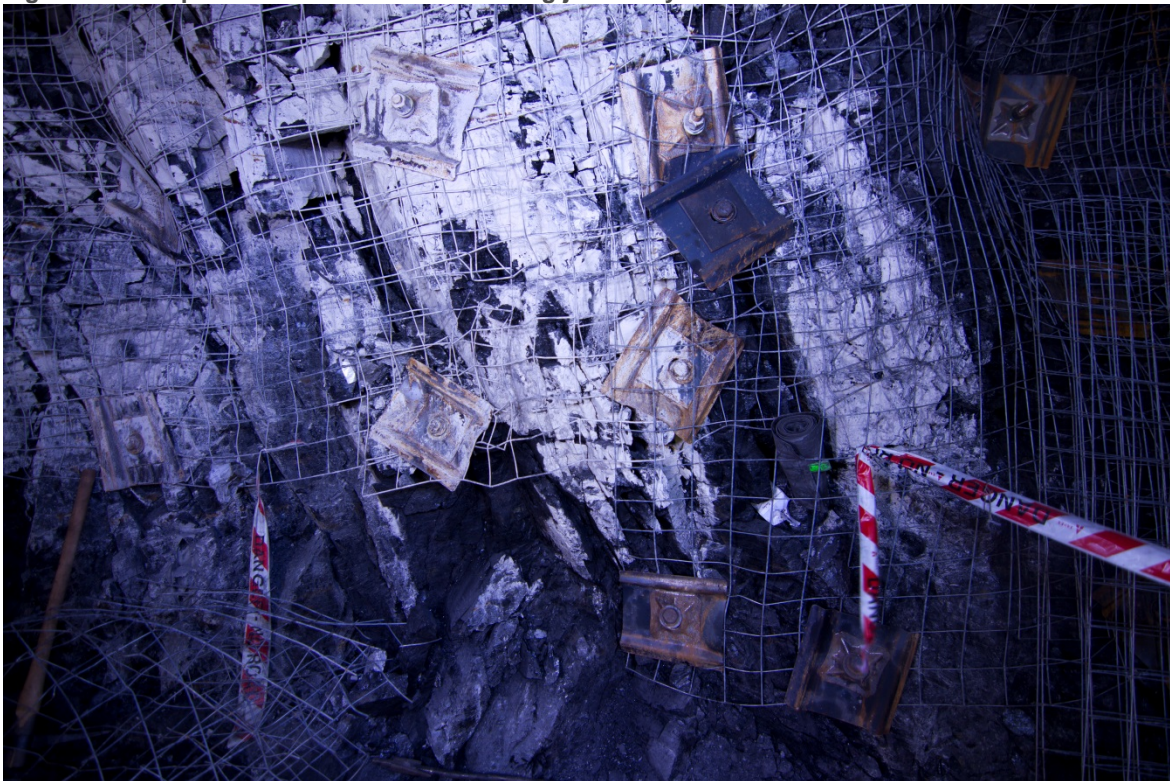
Due to the soft broken nature of the ribs at Austar it was common for the operators of the bolting rigs to encounter problems when setting the rib supports. All operators spoken to insisted that if a chemical or mechanical anchor was not properly secured, a new bolt would be installed next to it. This contention is supported by observation of the support outbye of the incident as demonstrated in Figure 24 below.

Figure 25 Example of rib bolts LHS of B Heading just outbye of the incident.

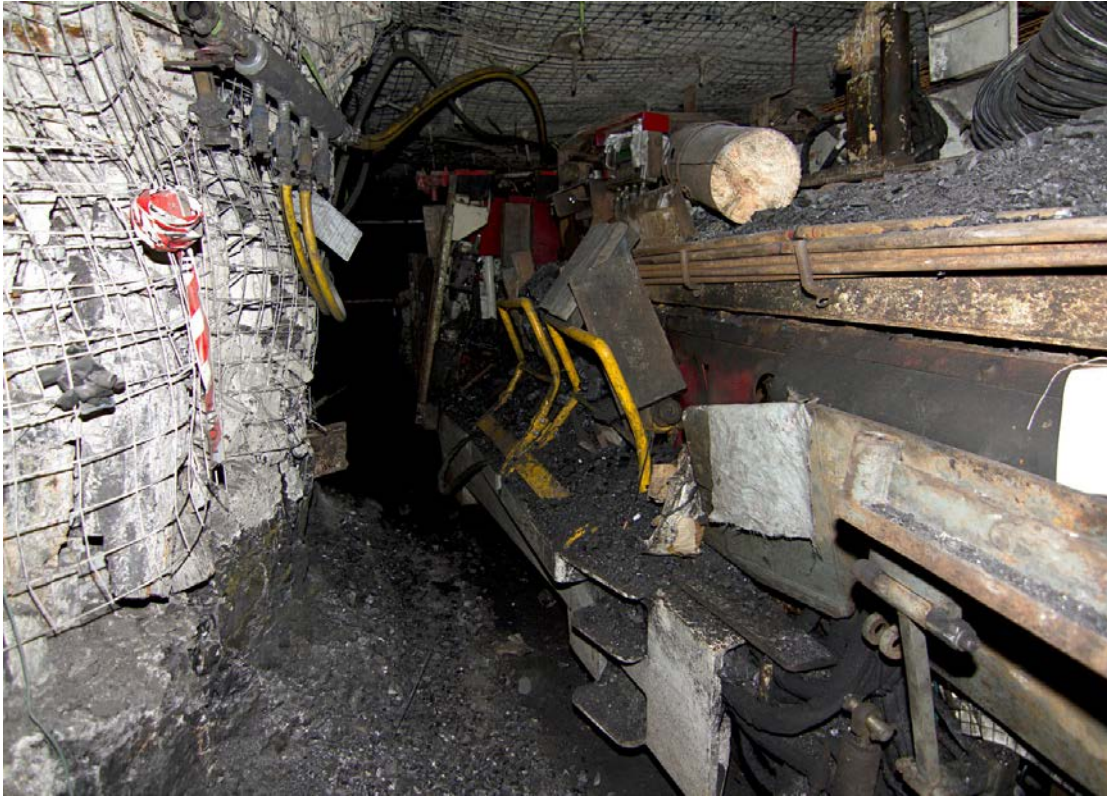
Figure 28 CM 35 post incident; note the bent handrails and rib guard.

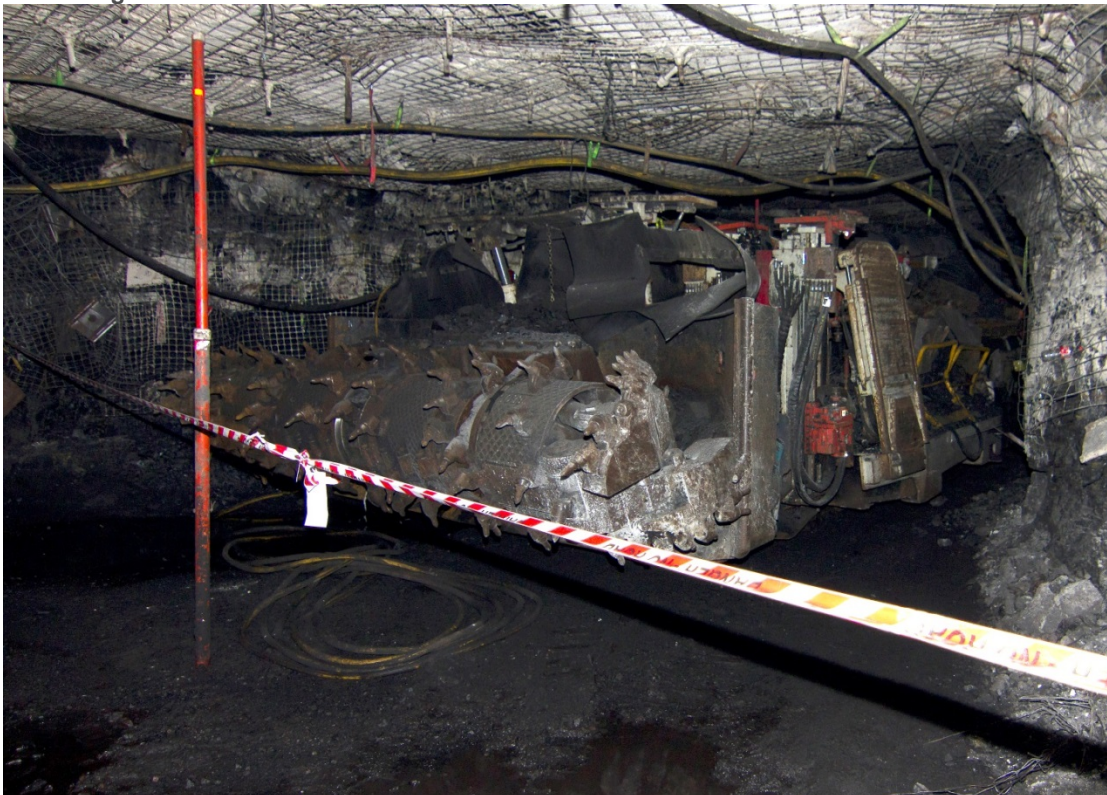
Figure 29 CM 35 after being moved from the incident; note rib guard is bent into the machine, the inflection measuring 110 mm.<sup>82</sup>
