**NSW  
Resources  
Regulator**

**INVESTIGATION REPORT**

# **MAULES CREEK MINE TRUCK COLLISION**

Maules Creek Mine 21 April 2018

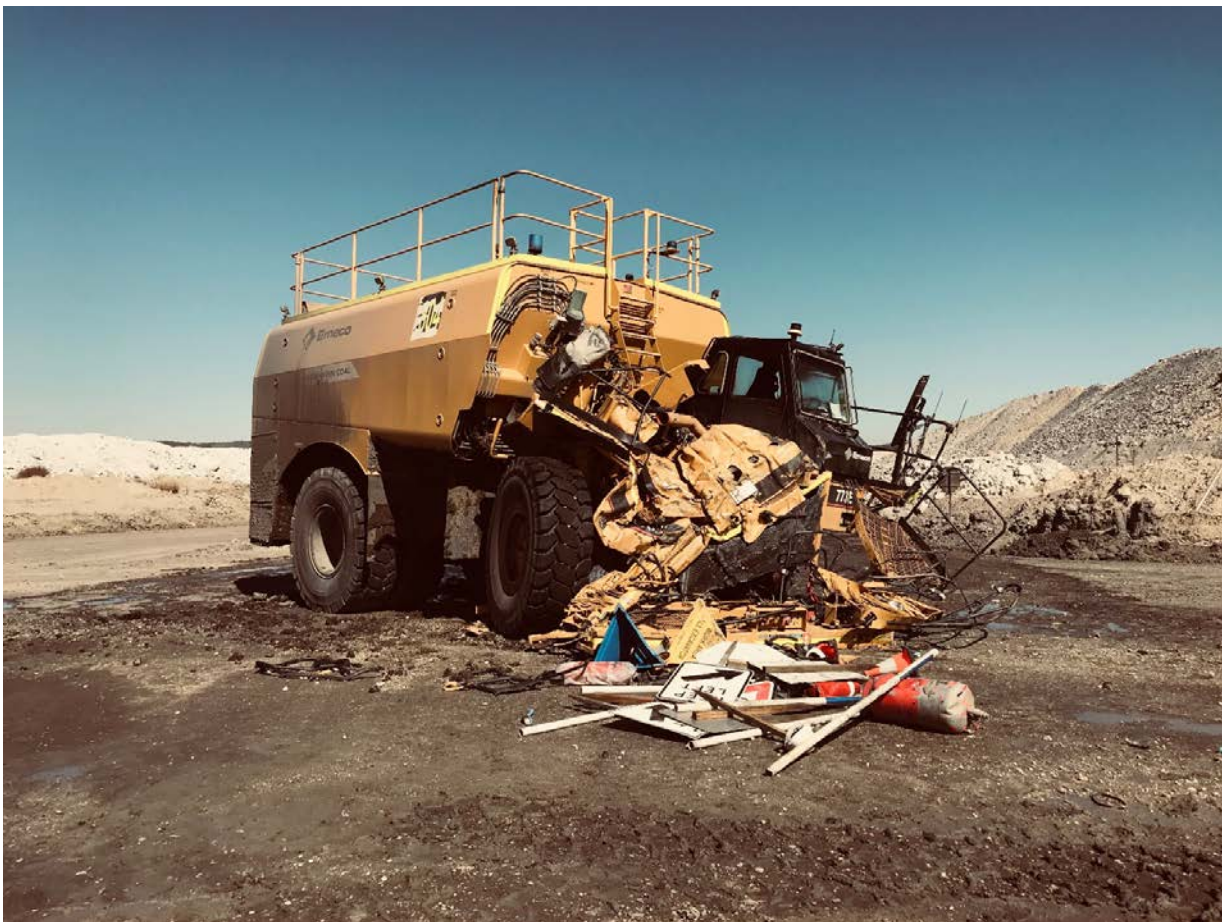
*Figure 1 Damaged front end of service truck*

As the two vehicles entered the intersection, both drivers realised a collision was imminent and attempted to take evasive action. The 100-tonne service truck collided with the side of the 500-tonne haul truck, resulting in catastrophic damage to the service truck. The haul truck stopped about 100 metres past the impact point.

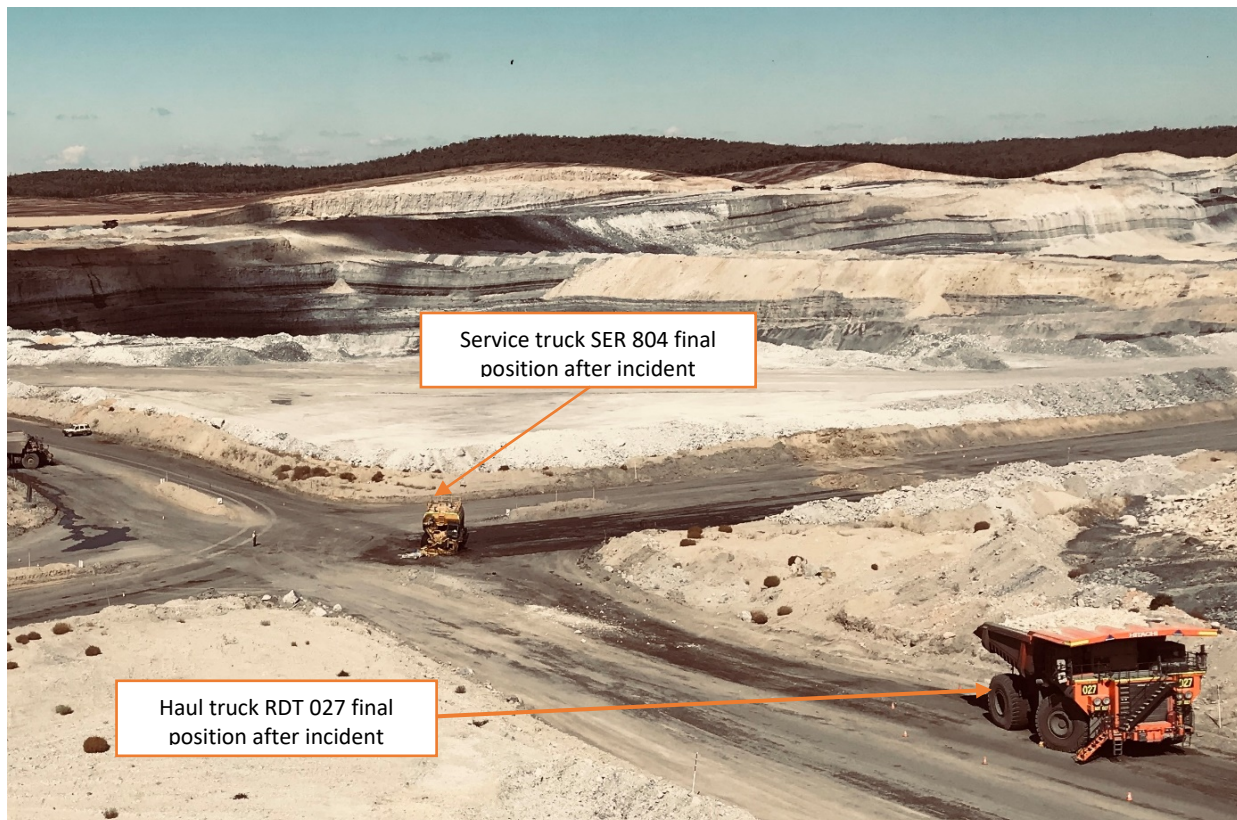
The final location of both vehicles immediately after the incident is shown in figure 2.

*Figure 2 Four-way haul road intersection showing trucks involved in the collision*

The haul truck operator told investigators that the windrows were high and impeded his view as he approached the intersection. The service truck suddenly appeared at the last minute to his left. He tried to accelerate in an attempt to avoid the collision, however the service truck collided with the rear of his truck, pushing his truck toward the median strip.

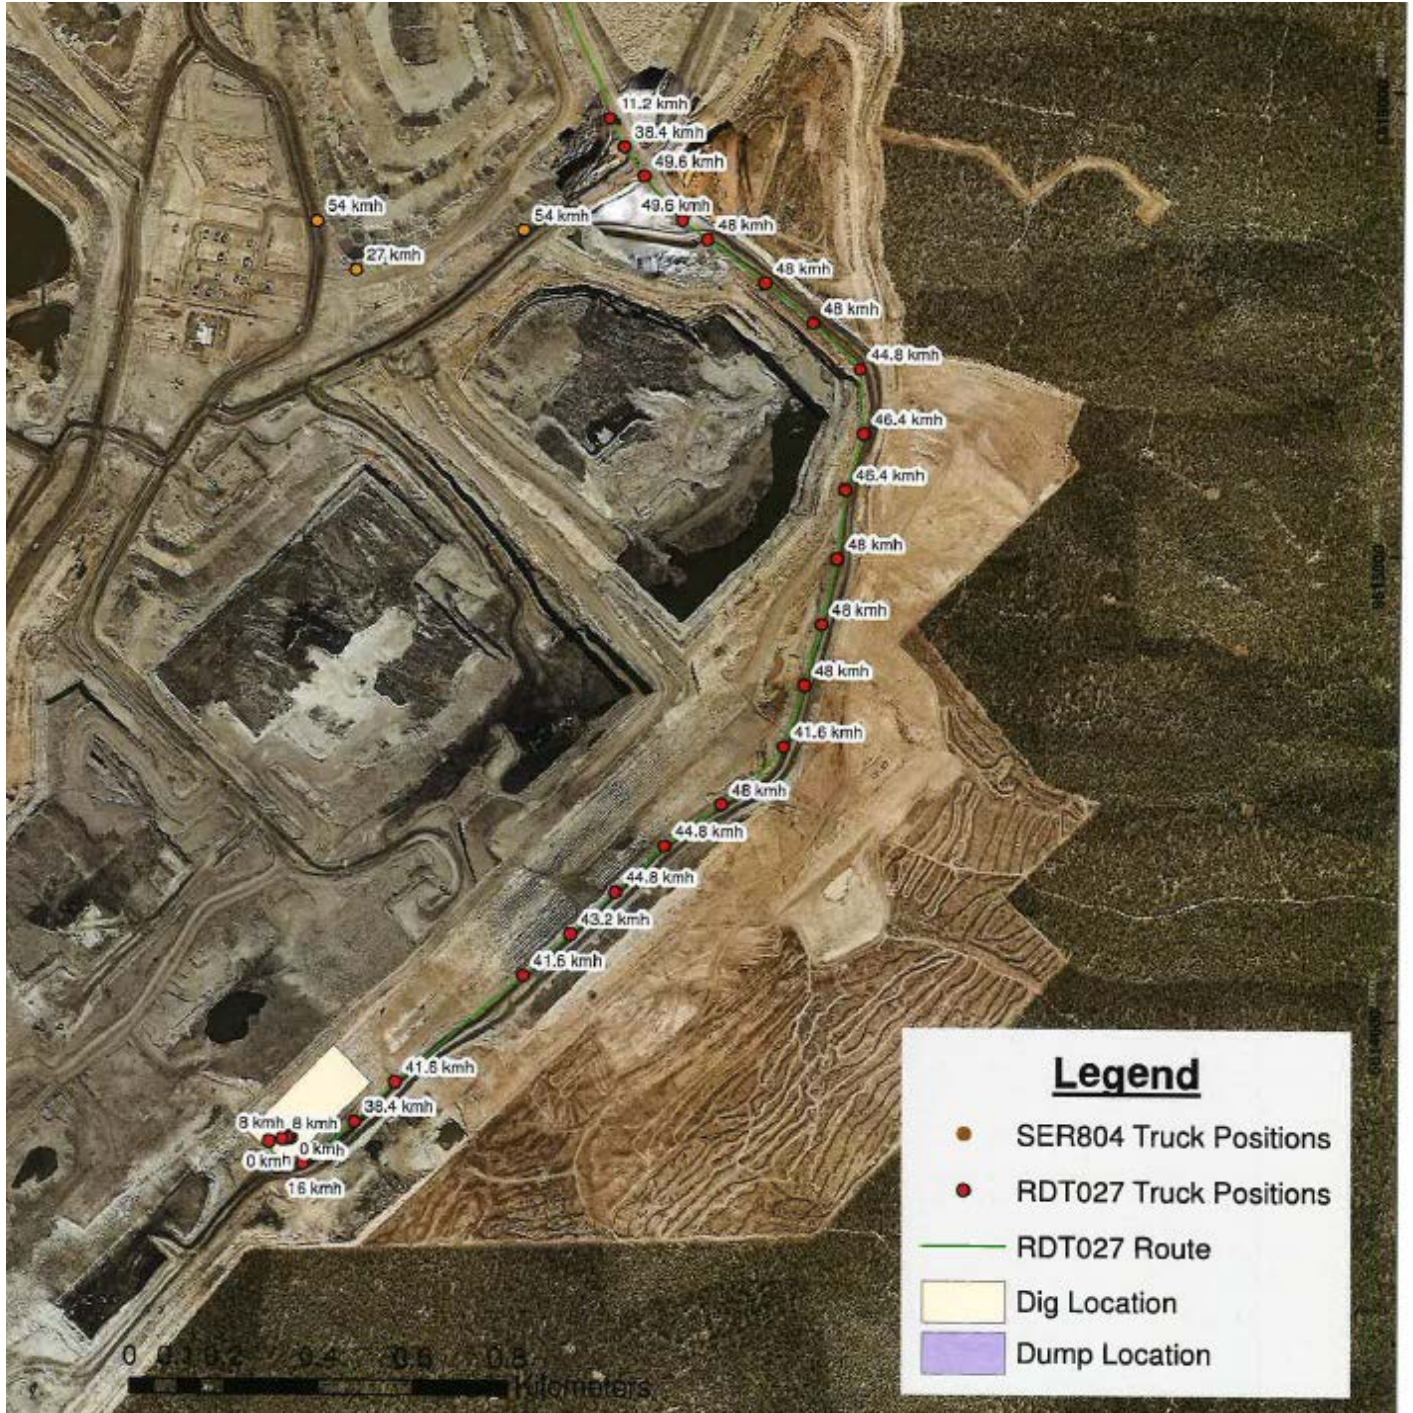
In the plan below, the movements of the haul truck are shown with the red dots and the movements of the service truck with brown dots. The tracking of the haul truck was quite constant, whereas the positioning of the service truck was infrequent and random.

The haul truck was travelling at 48.6 km/h at time of impact and the service truck was travelling at 54 km/h toward the intersection. According to the mine's safety management system, the maximum speed limit in the mine was 60 km/h. It appears that both vehicles were travelling at speeds that would indicate that they were not intending to slow or stop at the intersection. However, the speed of both trucks at the time of the collision is not known as both operators attempted to take evasive action immediately before the collision.

Figure 3 Maules Creek Coal Mine haul truck RDT027 and service truck SER804 speed tracking
