Investigation report

Incident involving exposure to risk while
operating a dozer at Mount Thorley
Warkworth on 15 May, 2011

Extract of report prepared by the
NSW Mine Safety Investigation Unit

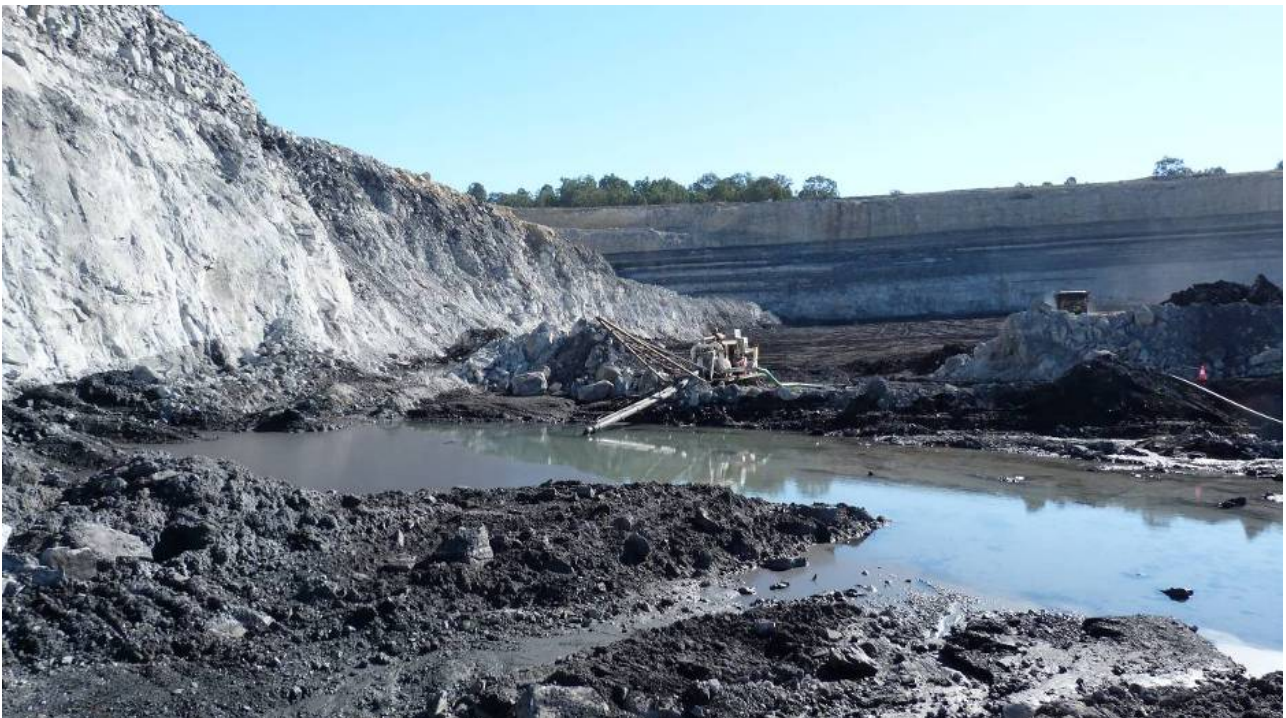
Sometime between 9 May and 13 May the sign was moved about 150 m north on the coal bench to a location near the end of the expanse of water where a pump was to be used to drain water from the bench (see Photographs 3 and 4). There was no record kept on the open cut examiner reports or anywhere else of the relocation of the sign or who had moved the sign.

Photograph 3: Pump at the northern end of the expanse of water.

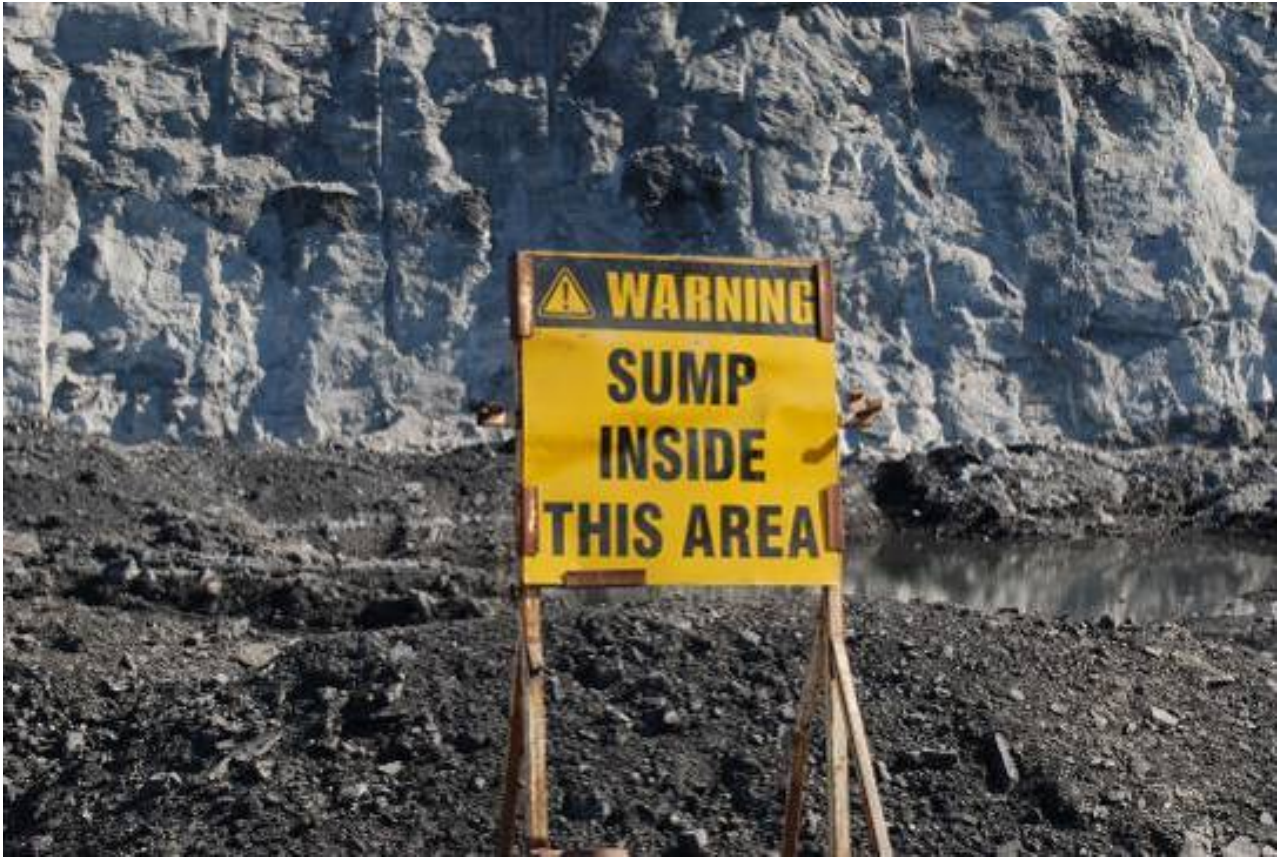
Photograph 4: Sign in front of the area where the pump was located at the northern end of the bench.

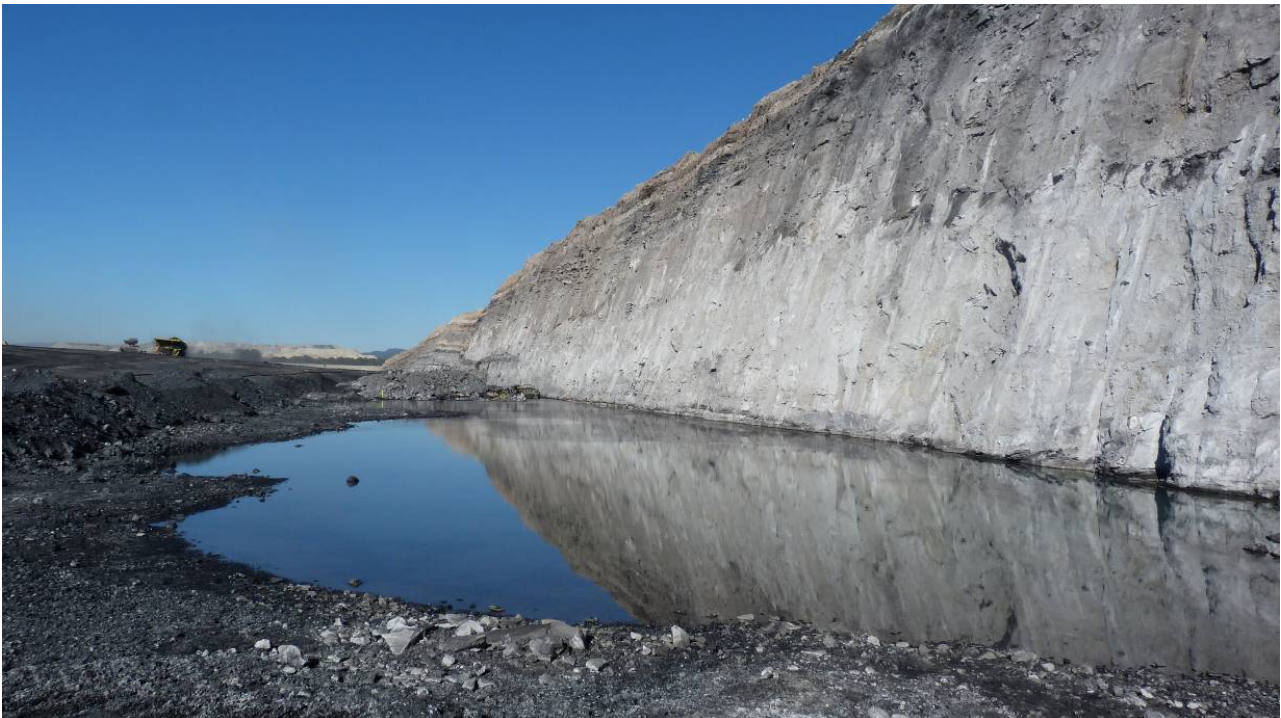
Regardless of whether the sump warning sign was at the correct location before its move the northern end of the bench, no attempt was made to identify that there was a sump within that area. No signs, barricades or anything else was left at the southern end of the expanse of water to denote that there was a sump (Photograph 5).

Photograph 5: Water spread across the coal bench at Moorlands Pit (view looking south).

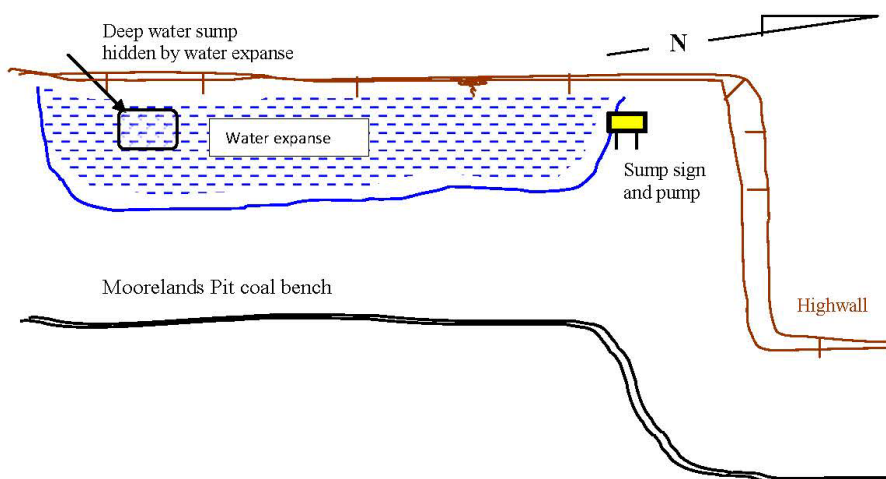
Figure 2: Moorelands Pit coal bench

Figure 2 shows the expanse of water on the coal bench, the location of the deep water sump at the southern end, and the location of the water pump and sump warning sign at the northern end.

The pump and the sign at the northern end identified that this was the location of the only sump in the coal bench.

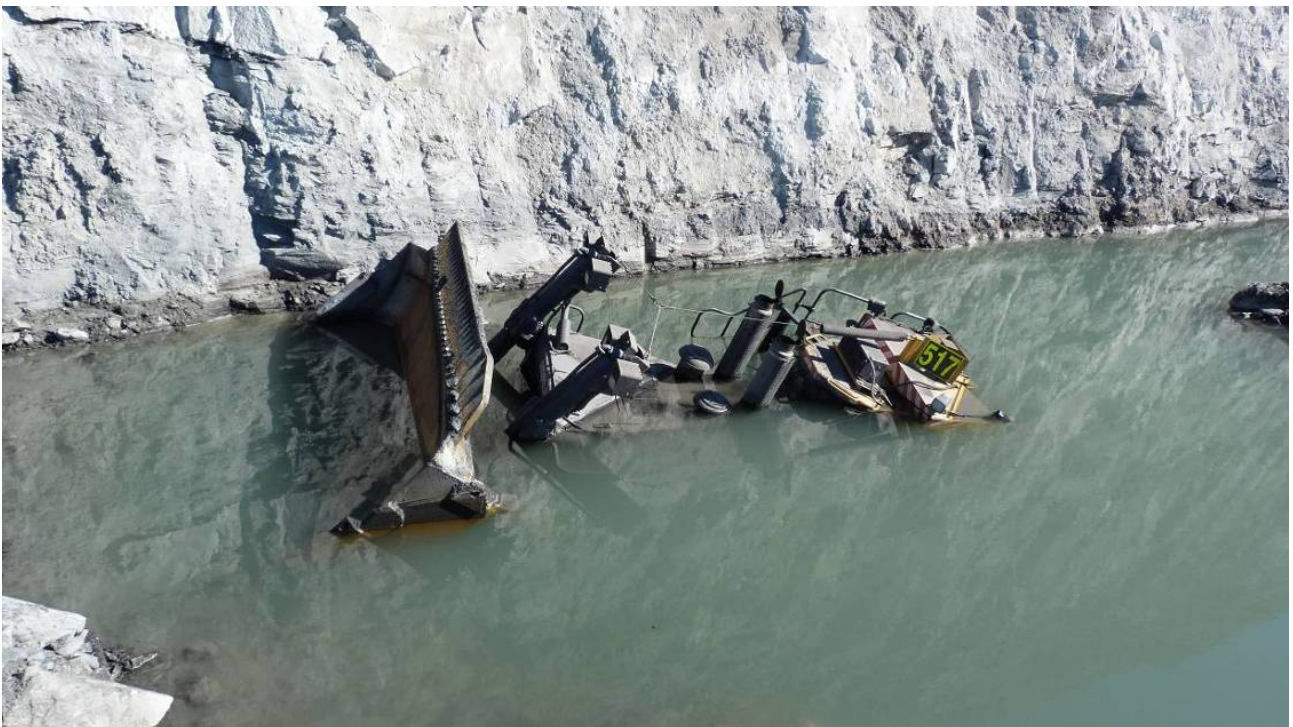
At 7.30am the dozer operator reversed over the pile of partings and felt the dozer sliding into deeper water. He attempted to drive the dozer out of the water but could not get enough traction and began to sink. The dozer sank into the deep water sump (Photograph 6).

Photograph 6: CAT D11T dozer submerged in the sump.

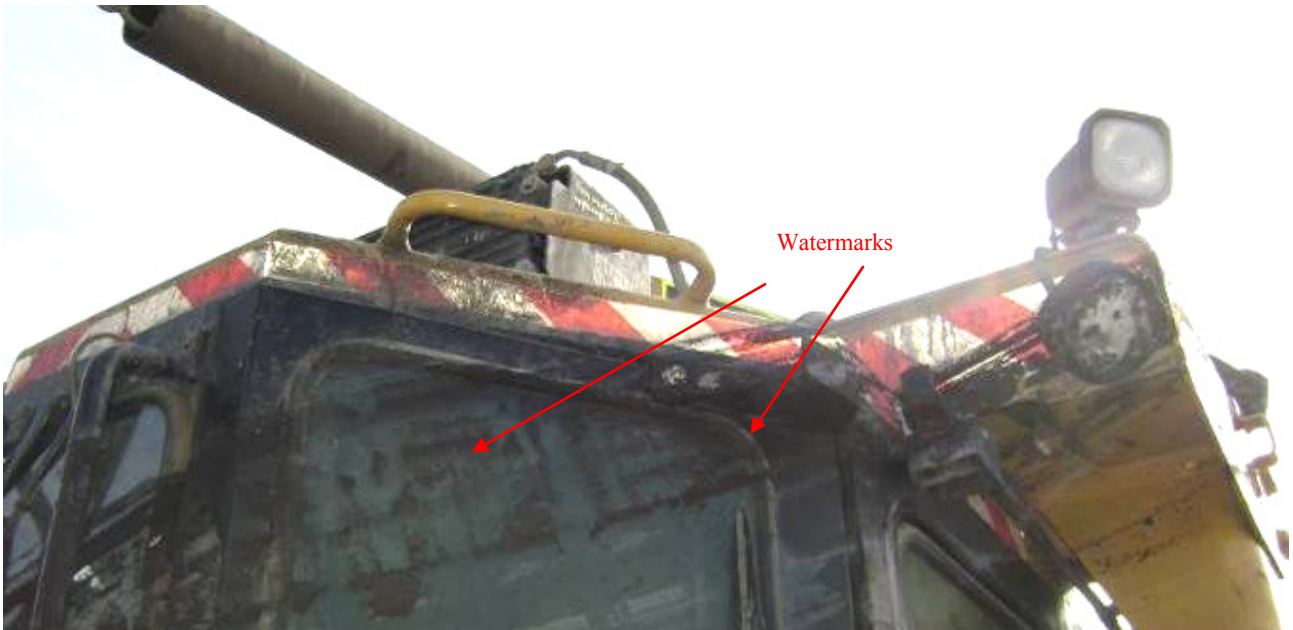
Photograph 7: Water mark at the top of the external part of the cabin of the dozer⁴.

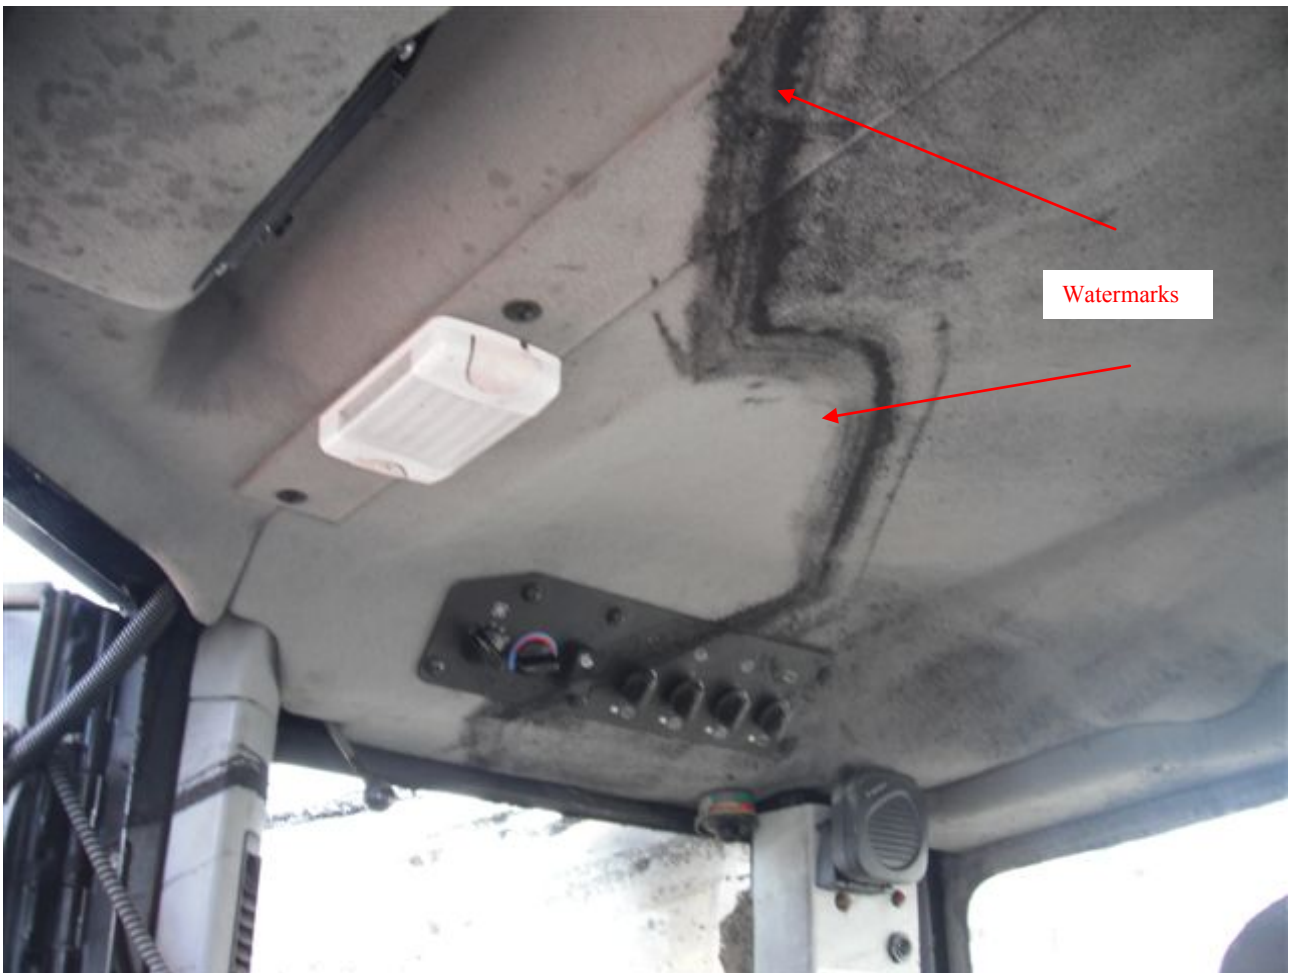
Photograph 8: Inside the cabin of CAT D11T dozer showing water mark on the ceiling⁵.

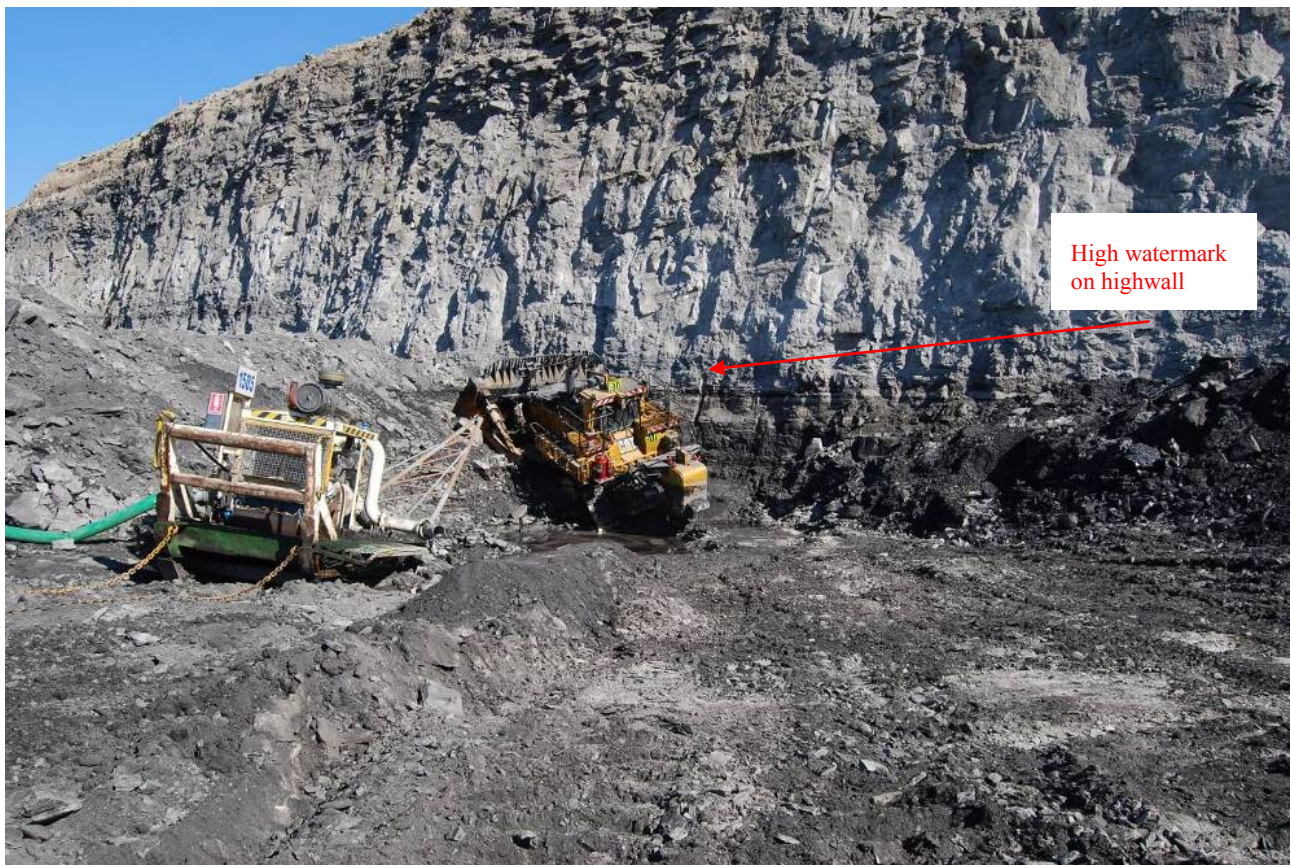
Photograph 9: CAT D11T dozer in the sump after water was pumped out.
