Investigation report

Cause and circumstances of fatal injury to
Peter Thomas Jones at Chain Valley Colliery
on 3 June 2011

Extract of report prepared by the
NSW Mine Safety Investigation Unit

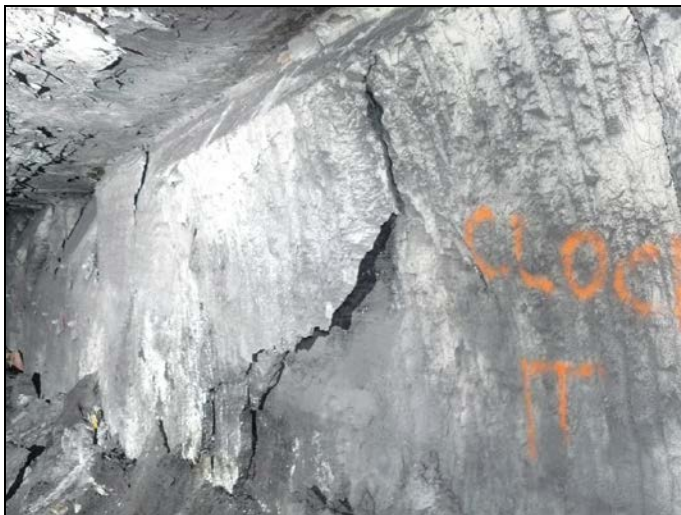
Investigators identified that a 15 metre working section of rib at B Heading 5 cut-through (just outbye the incident scene) was not bolted. Investigators identified significant rib deformation within this unsupported zone. It was noted that an unknown person had painted the words "CLOCK IT" on the unbolted rib side. (A clockit is a device that is placed in the roof as an early warning system of roof failure.)

Photograph 1 Looking at 5 cut-through of the left hand rib noting that significant deformation and failure in the rib side and that the rib does not contain any rib bolts. Also note that a person has painted the words "CLOCK IT" on the rib to identify the placement of a roof monitoring device.

Photographs 1 and 21 identify the unbolted section of rib at 5 cut-through B Heading West 6 Panel. It can be seen in Photograph 1 that the unsupported section as significant rib slabbing and appears ready to fall in similar circumstances to the slab that crushed Mr Jones. It also appears that a person had spray painted the words "CLOCK IT" on the rib side indicating that a clockit is to be installed in the roof.

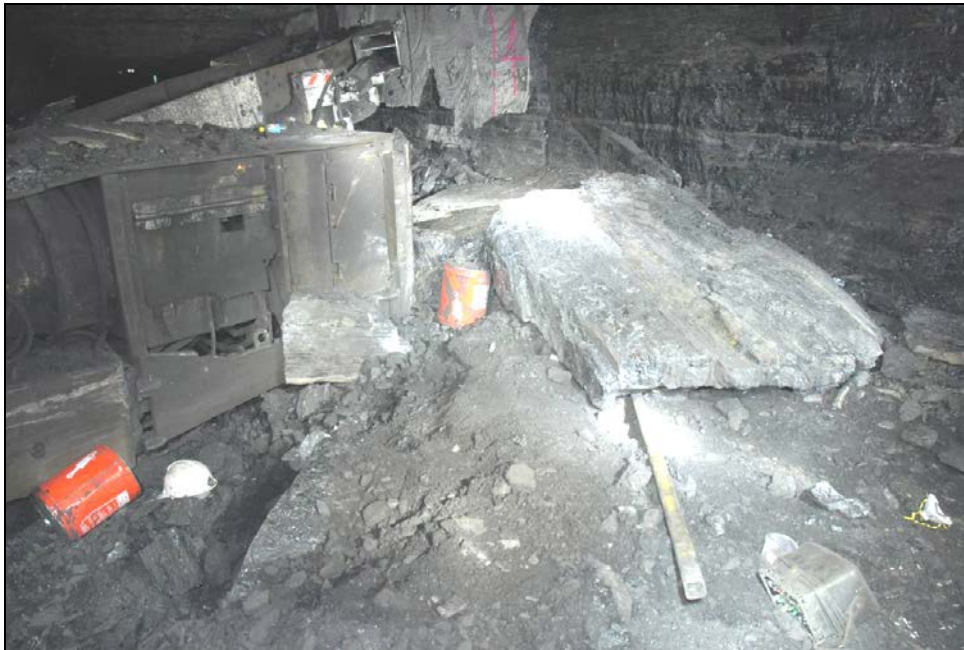
Photograph 2 Incident scene photographed by NSW Police Forensics on 3 June 2011.

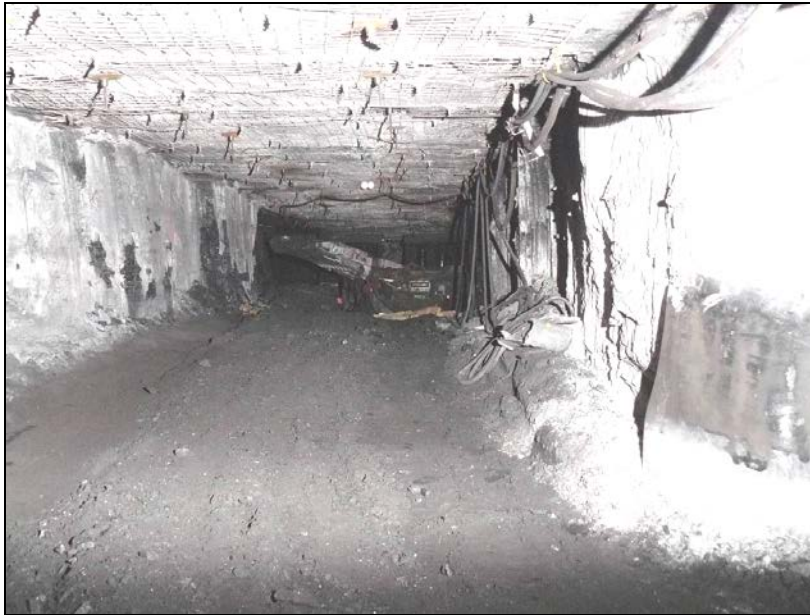
Photograph 3 Looking inbye of B Heading from 5 cut-through towards continuous miner and incident scene.

Photograph 3 shows the roadway is stone dusted (white areas to prevent a coal dust explosion in the event of a methane gas ignition). Black areas in the rib side after the stone dust application shows where rib has fallen. Note on the right hand rib that a rubber bumper was installed to protect shuttle car cables rubbing against the rib side.

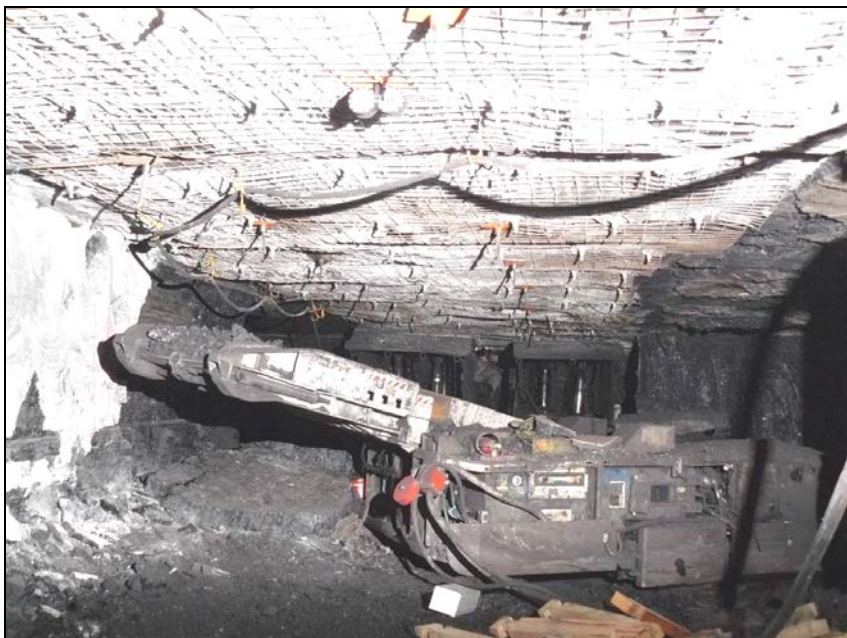
Photograph 4 Looking inbye of the continuous miner in the right hand side pocket and the fallen rib coal inbye of the continuous miner boom.

On the left hand side of Photograph 4 the fallen rib side involved in the incident is evident. The boundary is clearly defined by the white rib to black rib contrasts. The roof is supported with mesh and roof bolts. A roof monitoring "clockit" device can be seen at the top of the picture.

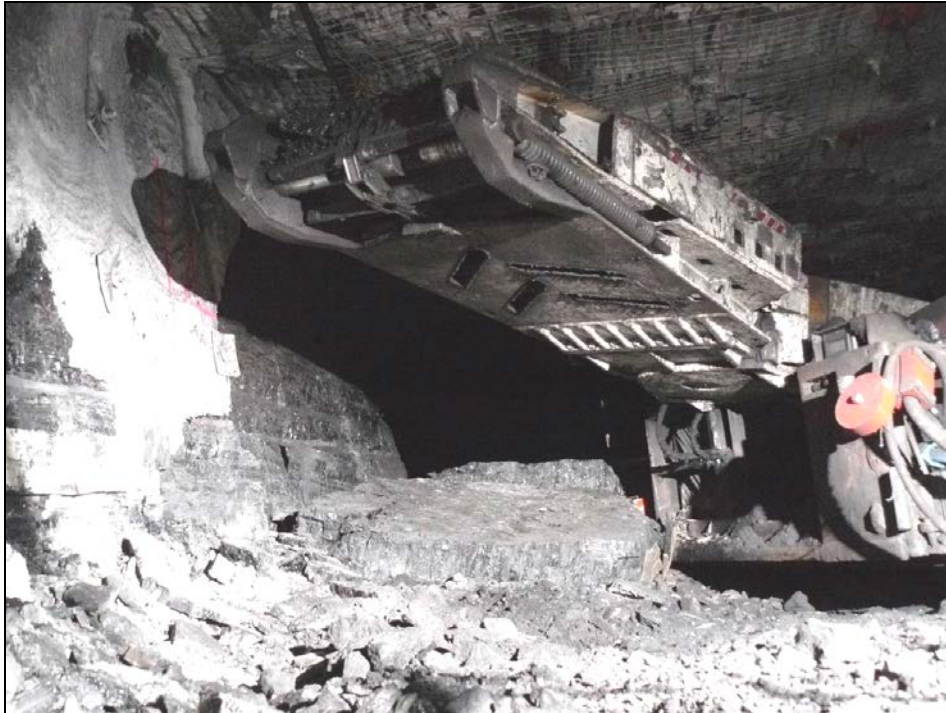
Photograph 5 Looking inbye of the fallen slab inbye of the continuous miner boom.

Photograph 5 shows the fallen rib slab adjacent to the left hand side of the continuous miner. Rib bolts and plates are evident in the still standing rib side.

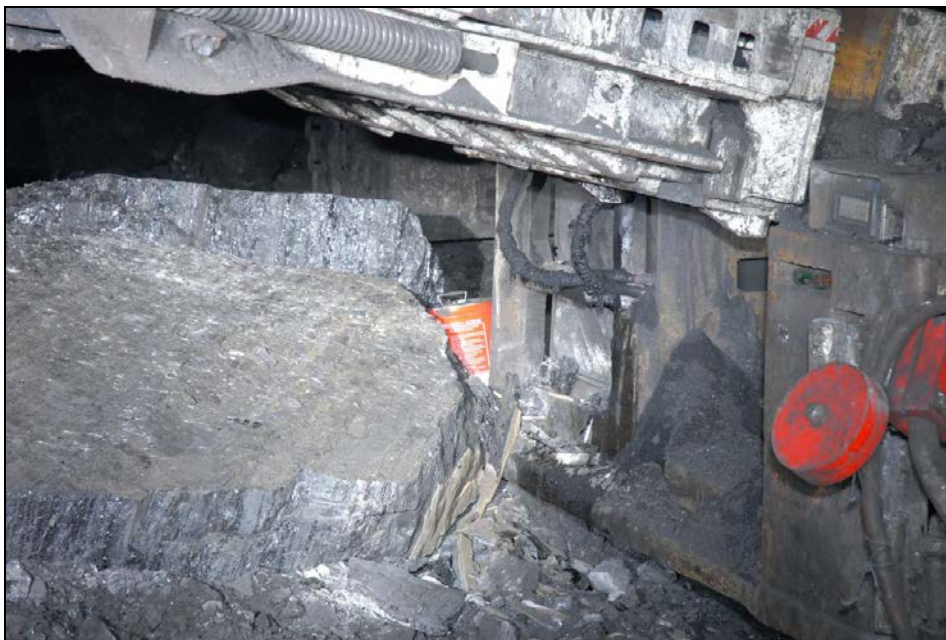
Photograph 6 Looking inbye of the fallen slab underneath the continuous miner boom.

Photograph 6 shows the fallen rib slab adjacent to the rear of the continuous miner and the red oil drum.

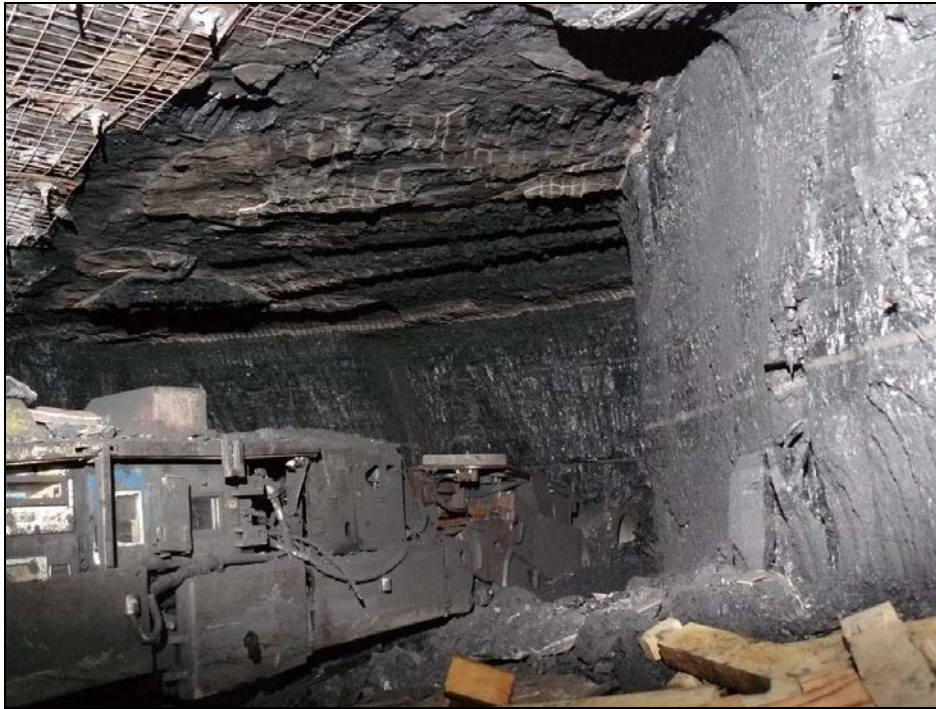
Photograph 7 Looking inbye of the continuous miner positioned in the first right hand pocket in B Heading 5 to 6 cut-through.

Photograph 7 shows the exposed roof and rib in the right hand side pocket. The rib is not bolted in this area because it was freshly cut by Mr Jones and not required to be bolted.

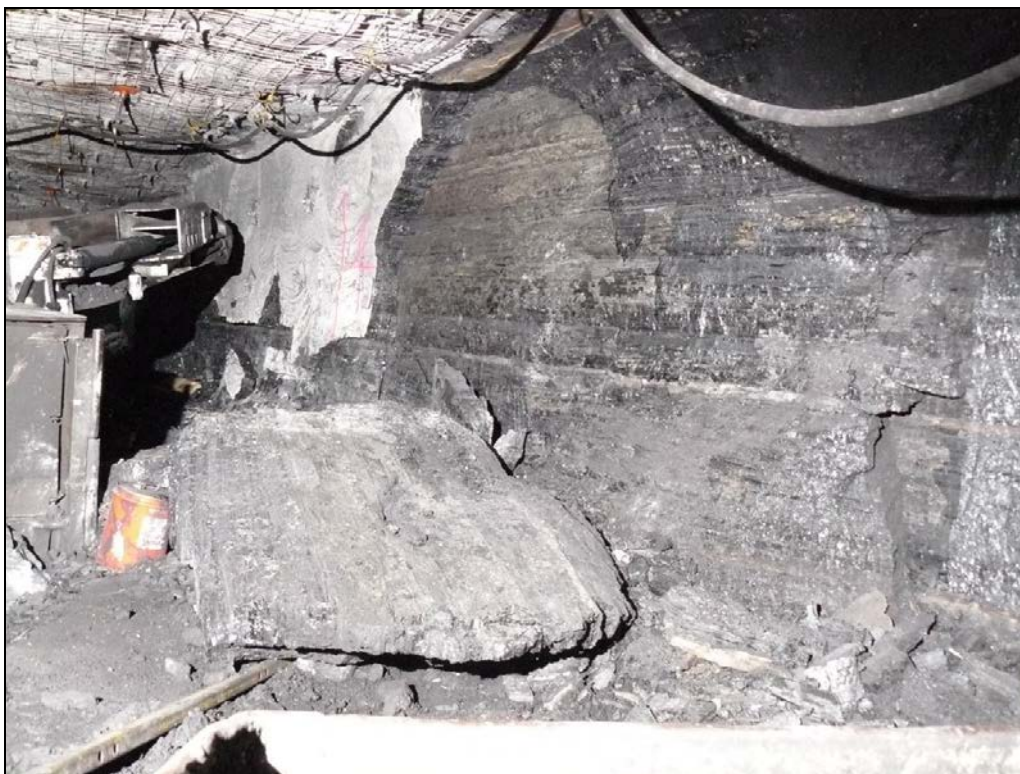
Photograph 8 View of the incident scene on Saturday 4 June 2011 looking towards the area of rib slabbing and rib slab on ground. Photograph taken inbye of the continuous miner. Note the red oil drum and steel belt clamp used in the rescue of Mr Jones.

Photograph 8 shows the scene on Saturday 4 June 2011. Note the red number four painted on the remaining rib side adjacent to the continuous miner. This is the numbered position of left hand side pocket number four, as yet unmined.

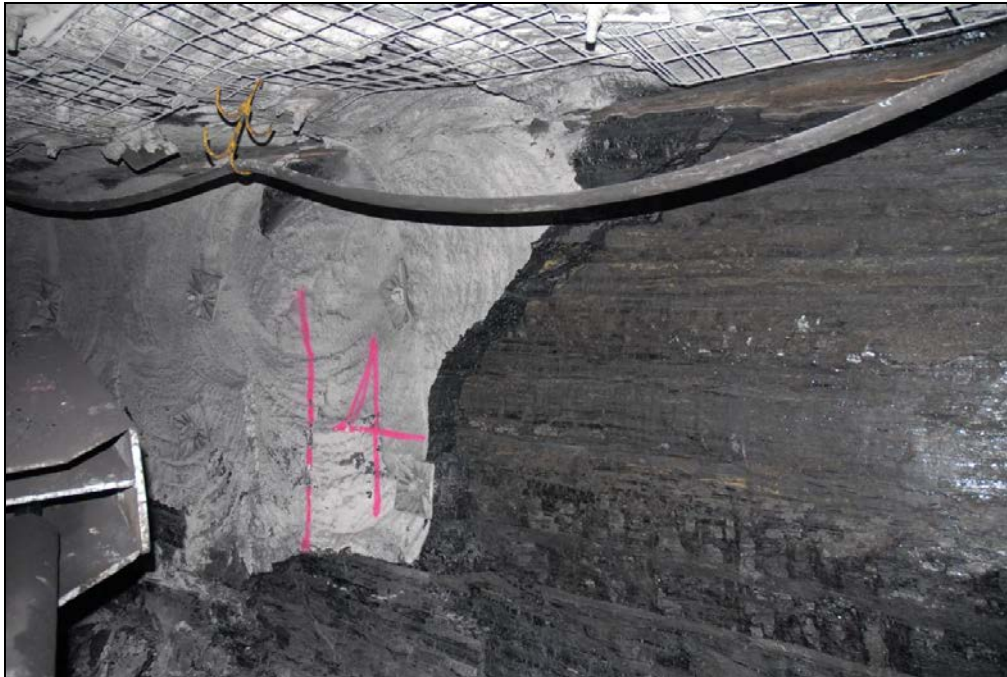
Photograph 9 View rib showing the two bolt and plates in the white stone dusted area prior to the fallen area.

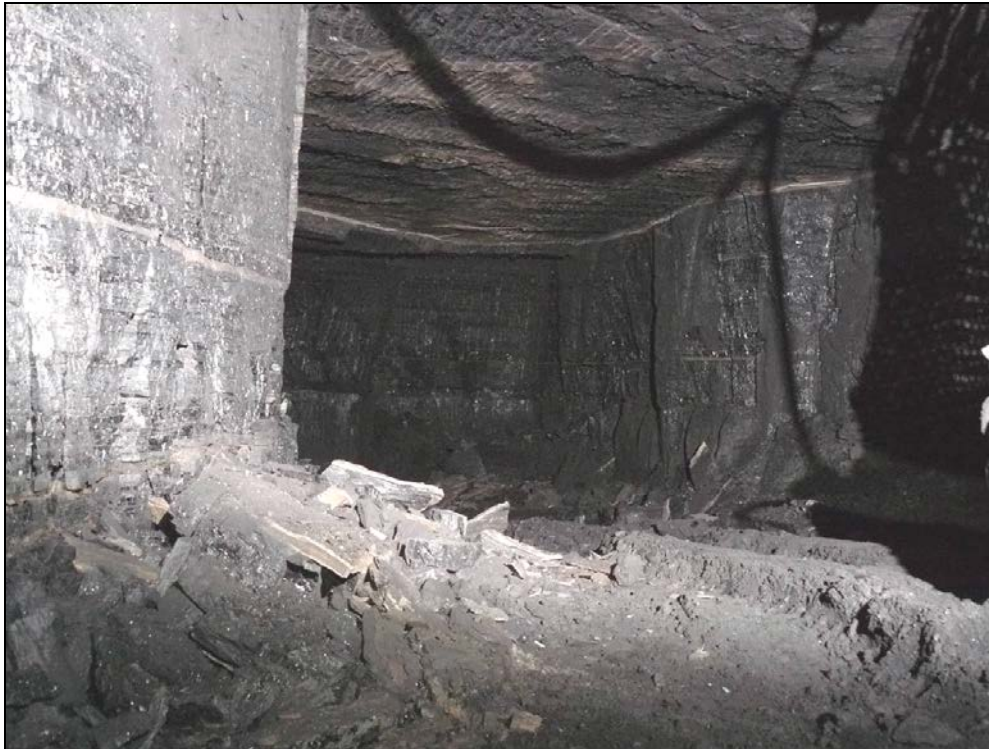
Photograph 13 Looking into the left hand rib pocket that had been extracted by Mr Jones before extracting the right hand pocket. First left hand pocket in B Heading between 5 and 6 cut-through.

The roof and ribs in the left hand rib pocket show no major deformation. In the foreground there appears to be fallen roof rock material.

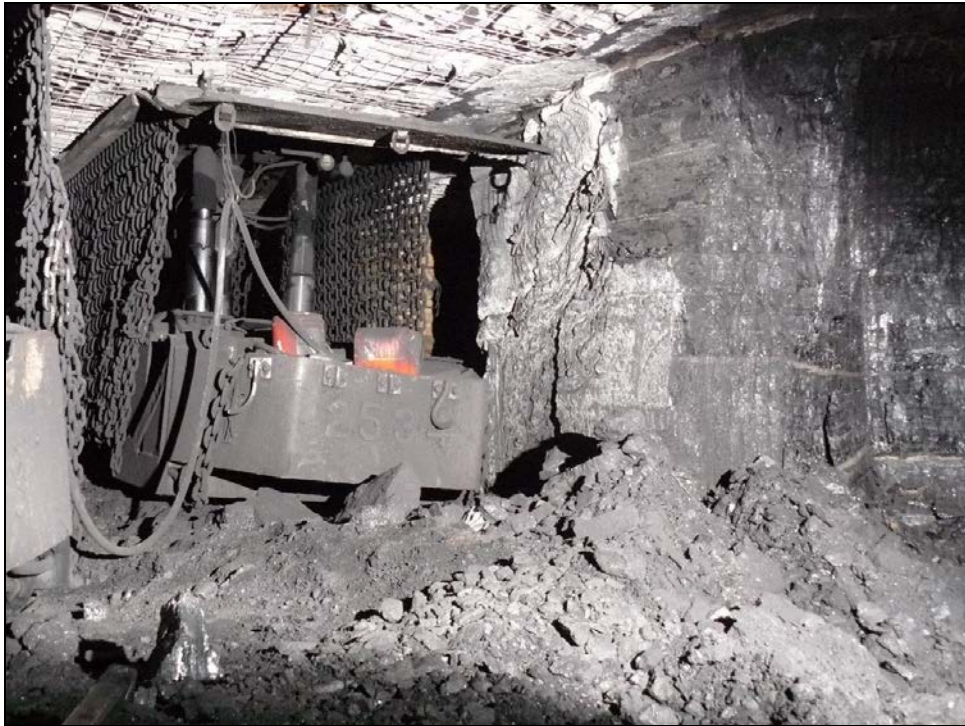
Photograph 16 Looking inbye of the right hand side breaker line support in relation to the start of the right hand side rib pocket.

Photograph 16 shows the floor material in front of the right hand side breaker line support.

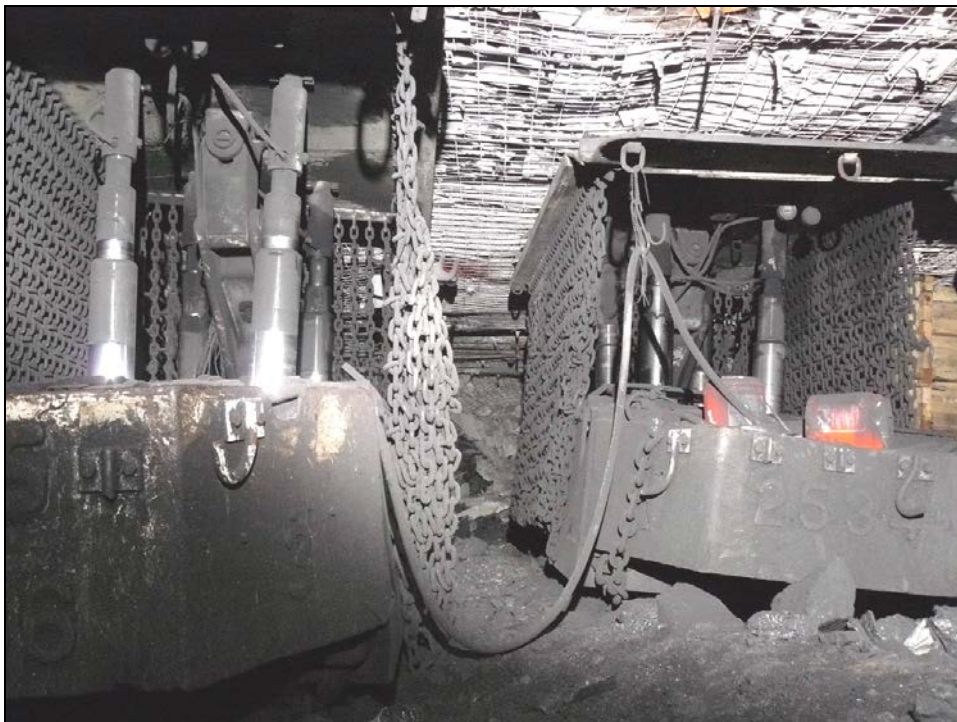
Photograph 17 Looking inbye of the position of the two breaker line supports towards the goaf edge.

Photograph 17 shows the area behind the supports was open up to the roof fall in the last extracted left hand side pocket in 6 to 7 cut-through.

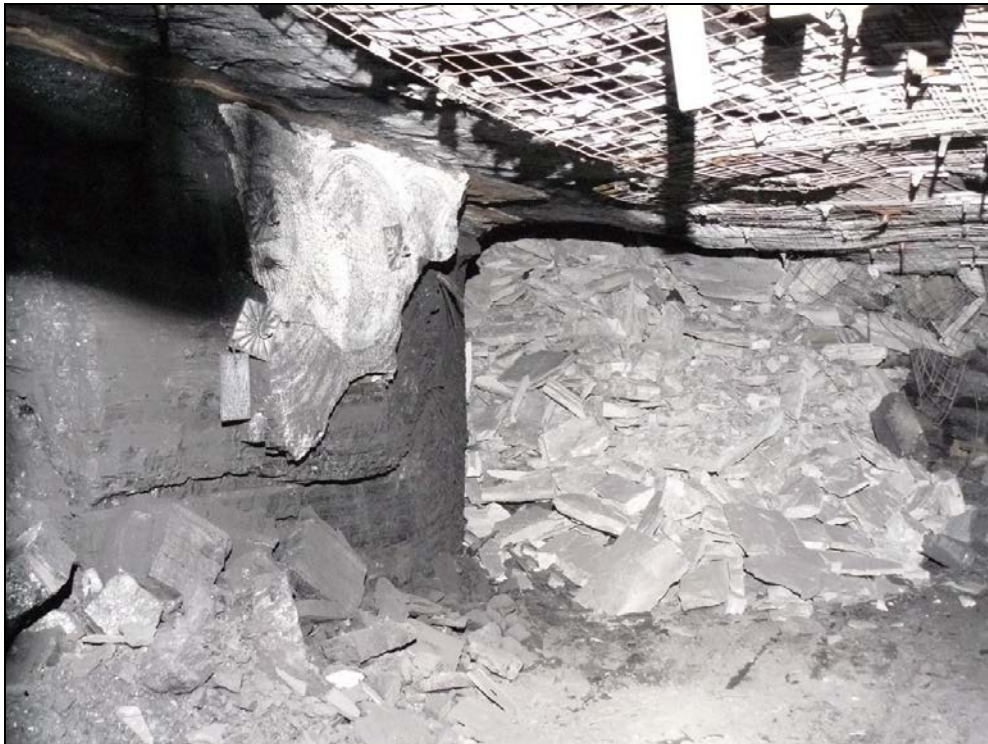
Photograph 18 View looking inbye of 6 cut-through inbye the breaker line support position showing rib support in left hand side rib and goaf edge at 6 cut-through in B Heading.

Photograph 18 shows the rib support effectively holding the white stone dusted rib side piece in place.

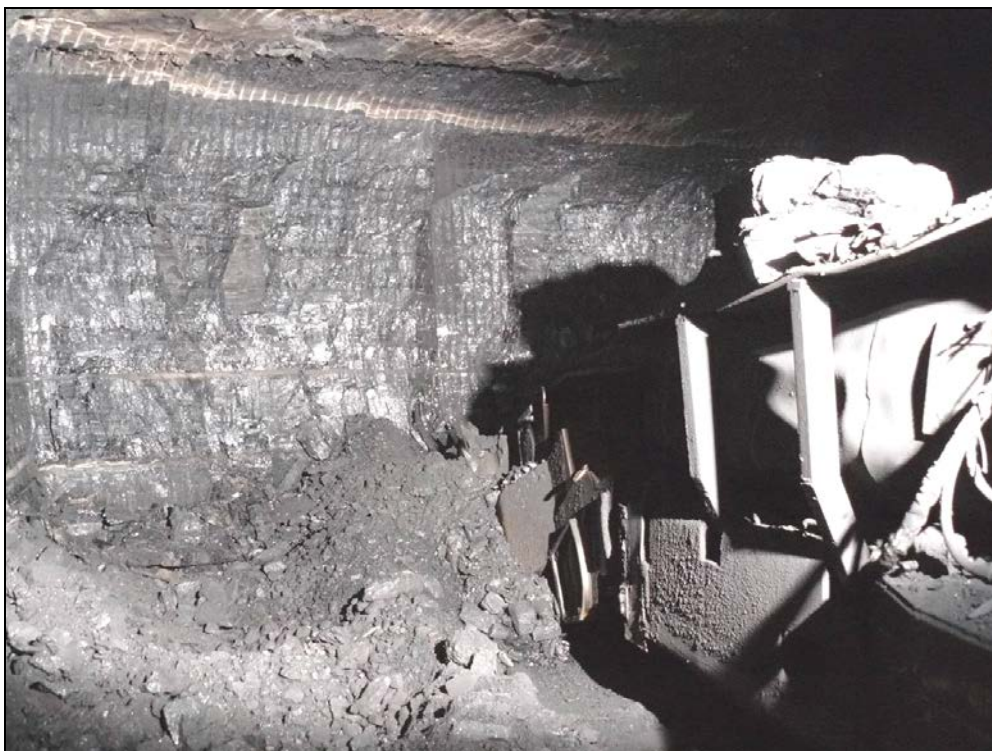
Photograph 19 Looking into the first right hand rib pocket showing the extent of over width extracted against the continuous miner.

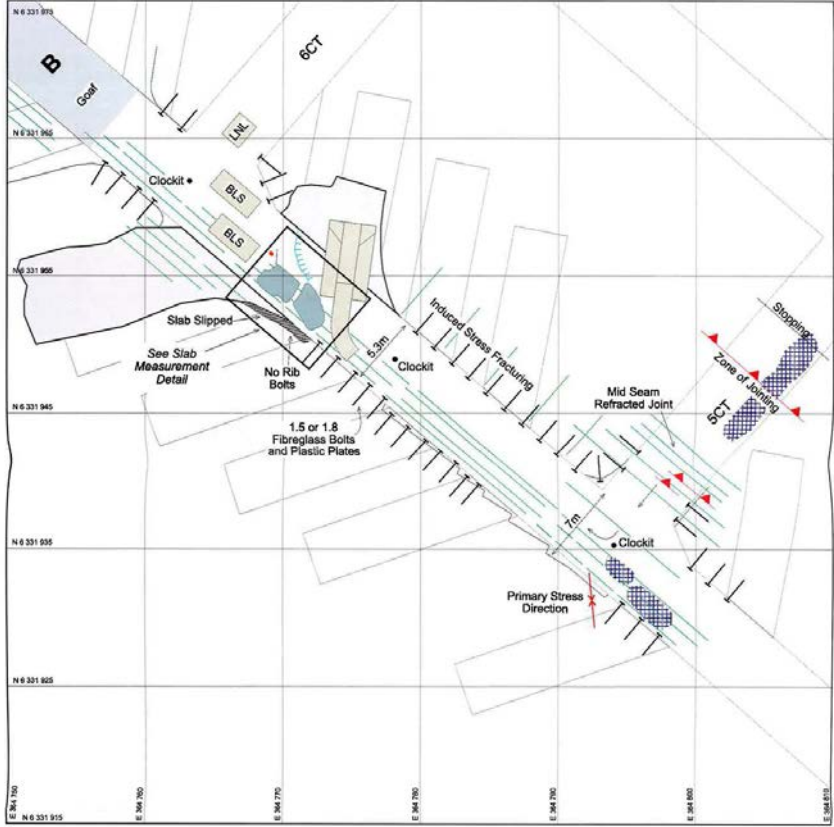
Figure 3 SCT Report Figure 2 Surveyed Incident scene.

SCT Operations' report (Figure 3) is a plan of the surveyed incident scene. It shows the left hand lift proposed position and the actual mined position. The actual mined left hand pocket was about 2.5 metres inbye of the design location. The right hand side rib pocket was oversized to the design. The plan also shows the position of the mobile roof supports and the rib support. An extract from the report has been included below. It explains the probable causal factors and mode of failure at the scene of the incident:

The rib side is considered to have toppled over as a single block which broke into two main fragments weighing approximately 1.3 tonne and 1.9 tonne respectively. The entire slab toppled over while the miner Mr Jones was operating (an Eimco Dash 3 miner) directly adjacent the area of failure. The failed slab was bounded by joint planes, both vertical and inclined, forming a wedge shape. The inbye side of the slab has the previous lift forming another parting surface. The C clay band forms the upper boundary. The entire slab was supported on a thin 10 cm thick column of coal as defined by the intersection of the joints. The only additional support came from a row of rib bolts but the remaining 4.8 metres of slab had no rib bolt support.

The final impetus causing the rib failure, while Mr Jones was present, is to be considered to be vibration and loosening of the heaved floor coal by the machine, destabilising the thin column of coal supporting the slab.

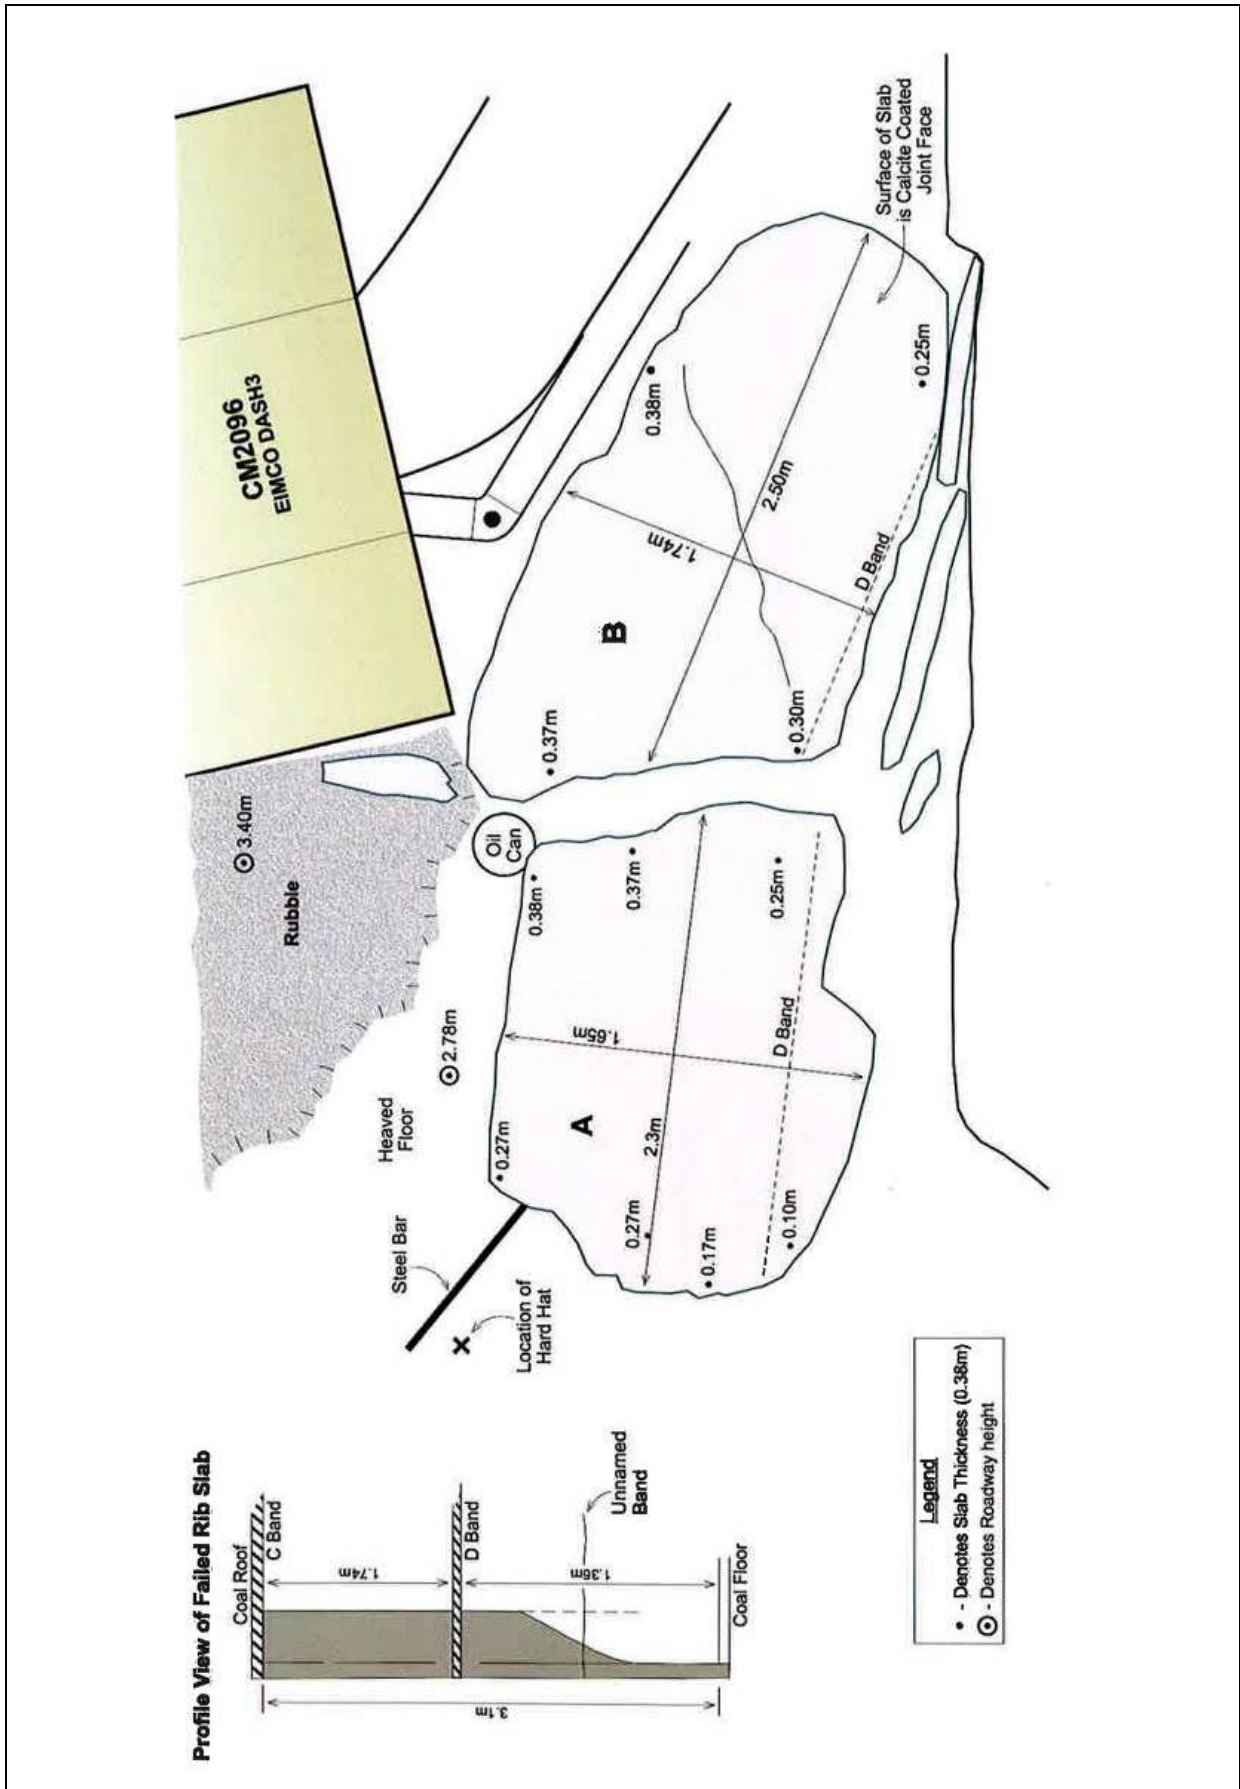
Figure 4 SCT Report Detailed slab measurements

SCT personnel also included in their report a plan depicting the dimensions of the slab that crushed Mr Jones. Incorporated into this plan is a profile view of the left hand rib depicting the wedge shape described above. The plan also shows the relative size of the slab compared to the continuous miner and the roadway.

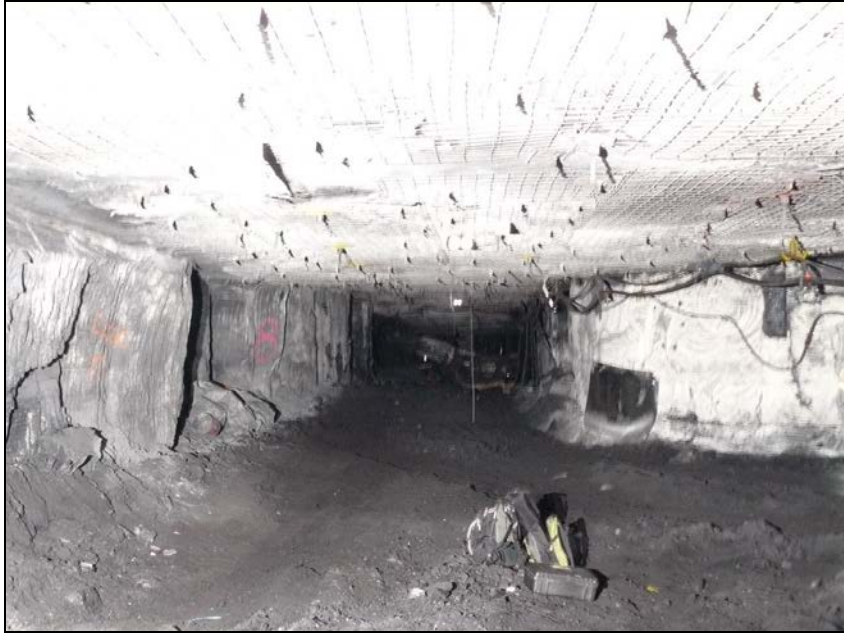
Photograph 21 Looking inbye at 5 cut-through of the left hand rib noting that a significant distance of rib does not contain any rib bolts.

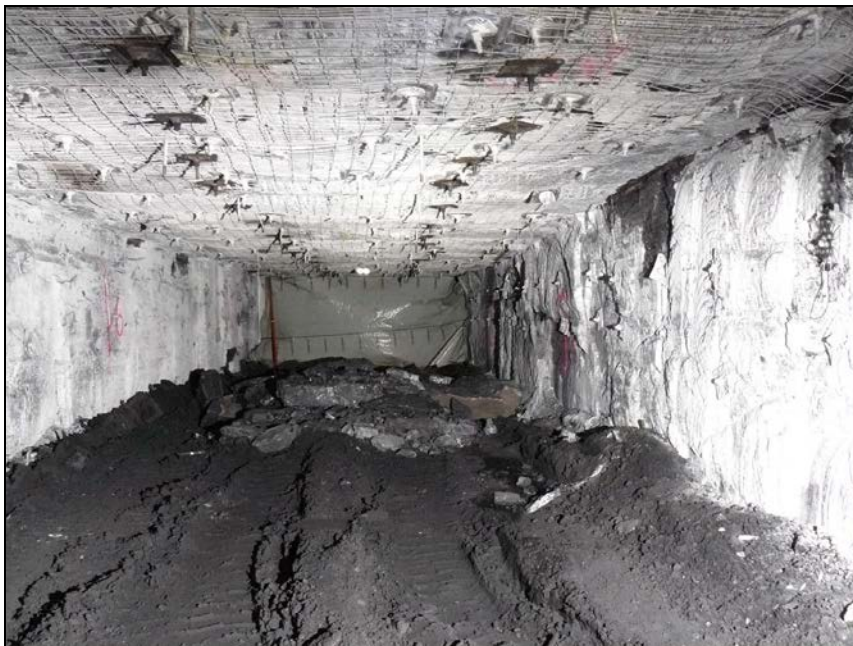
Photograph 22 Looking inbye in D Heading showing a large rib slab on the floor in the centre of the photo, which appears to have come from the removal of a rib slab on the night shift before the incident.

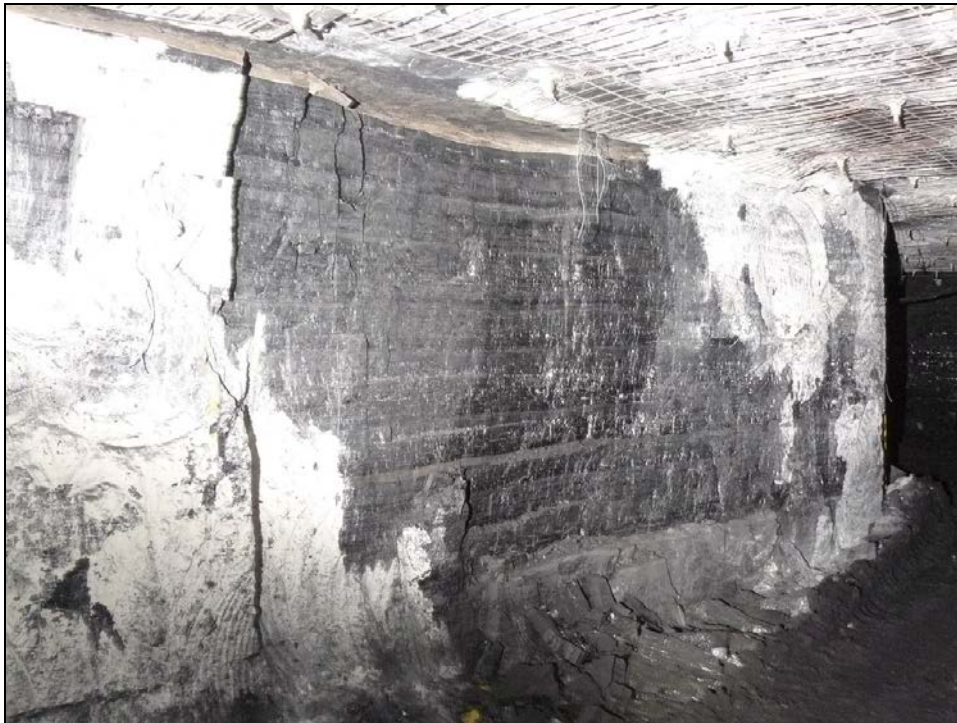
Photograph 23 Looking inbye in D Heading showing a large unsupported area of rib side in a shuttle car wheeling road.

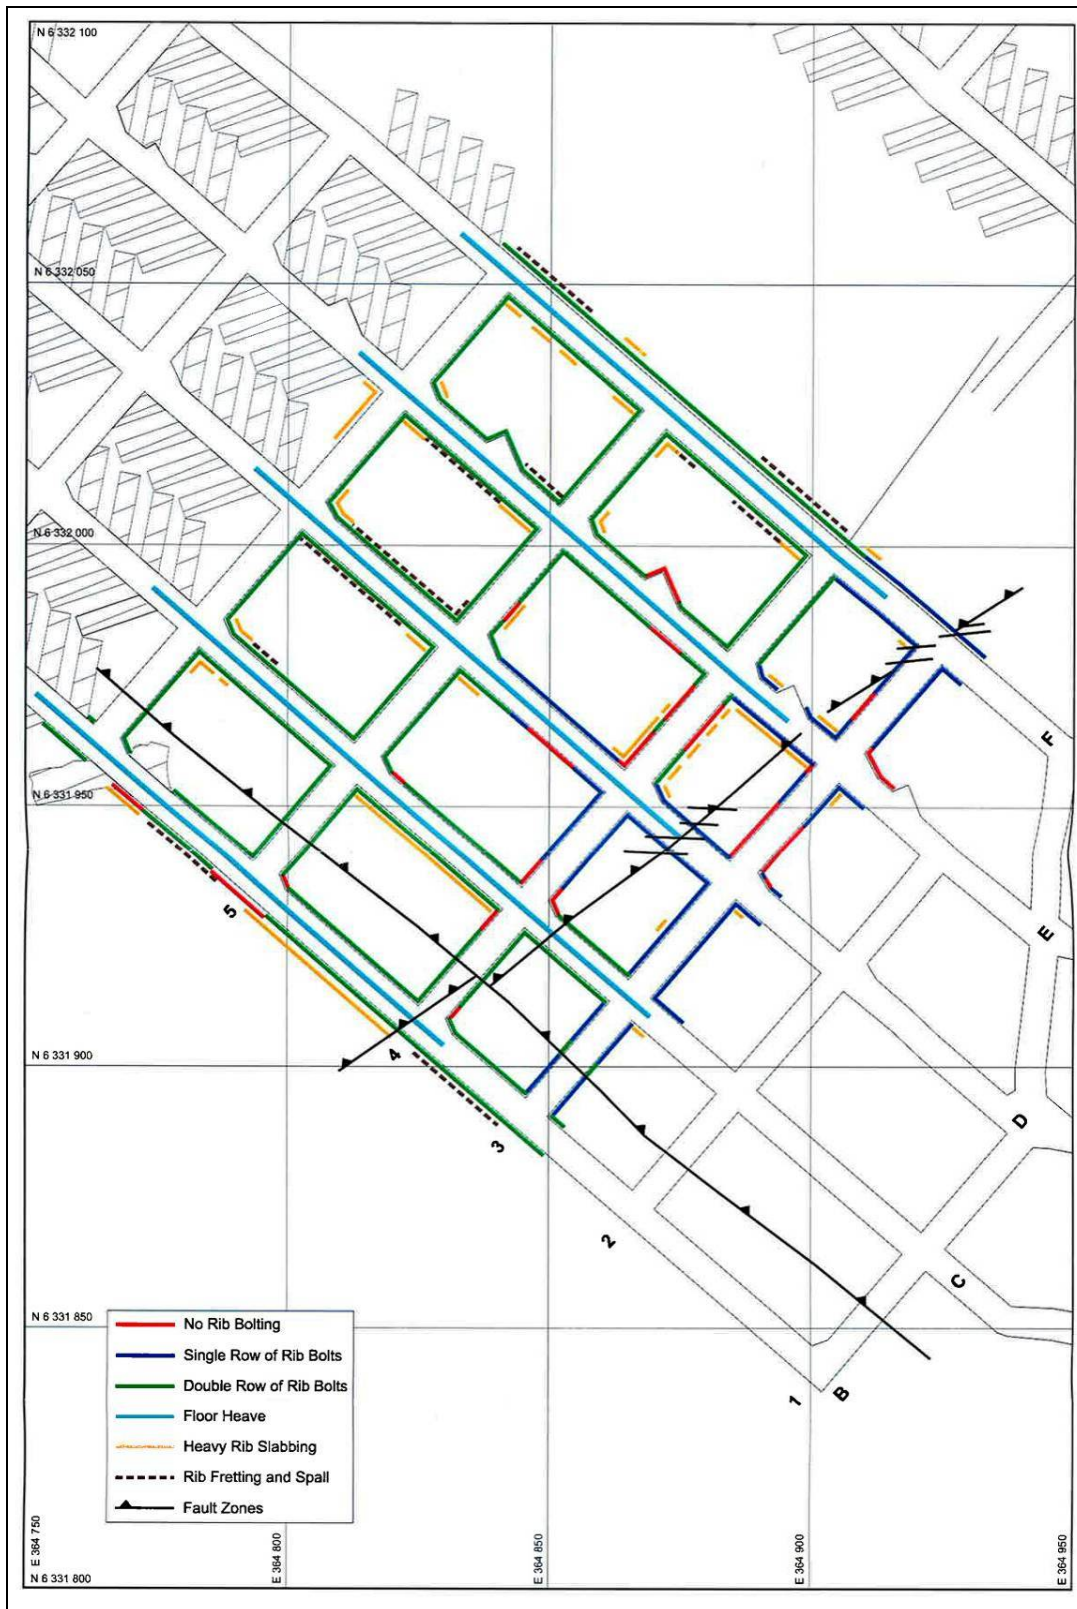
Figure 11 SCT Figure 3 Mine plan showing mapping undertaken by SCT Operations.

Mapping conducted by SCT focussed on recording the distribution of geotechnical condition and installed rib support present between 3 cut-through and 6 cut-through on all headings. Figure 3 shows the distribution and density of rib bolting within the panel together with the presence of rib slabbing, location of floor heave, presence of rib fretting and spall. Roof condition was noted to be very good and no change in roof condition was noted apart from the roof cavities and gutters noted in the Chain Valley Colliery Geotechnical Plan.

All headings in West 6 Panel (B–F) had significant levels of floor heave. This is mainly caused by abutment pressures experienced during pillar extraction. Rib bolting and strata failure presenting as rib spall are also mapped. Below is an extract from the report describing the West 6 installed support and rib failure rate:
