# REHABILITATION INFORMATION RELEASE

**DATE:** 25 June 2021

## Rehabilitation of Western Emplacement Area at Ravensworth Operations

**Location:** Ravensworth Operations open cut coal mine, Ravensworth, Hunter Valley, NSW.

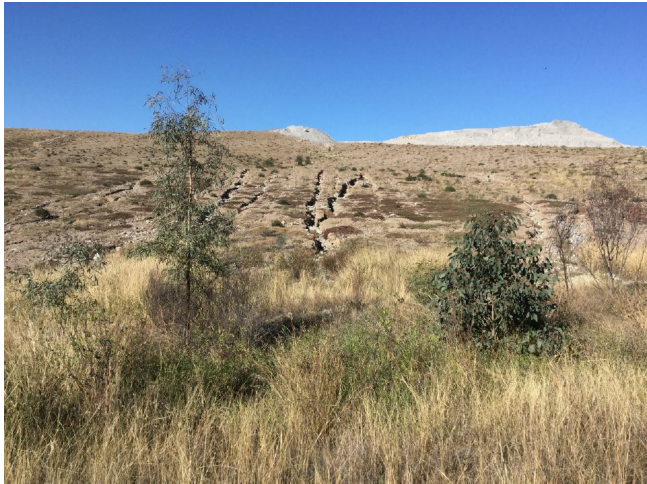
- Incomplete implementation of controls to remediate and mitigate erosion on the lower slopes of rehabilitated WEA.
- A number of soil erosion features on the lower slopes of the WEA northern batter faces, including scours and gully features (refer to Figures 1, 3 and 5).

Figure 1 **Before** - Active scouring on the Northern batter of the WEA

- soil sampling and analysis by a soil scientist of topsoil and treatments of rehabilitation works
- backfilling and reshaping of gullies and scours across approximately 40 hectares of the lower northern, eastern, and western batters of the WEA

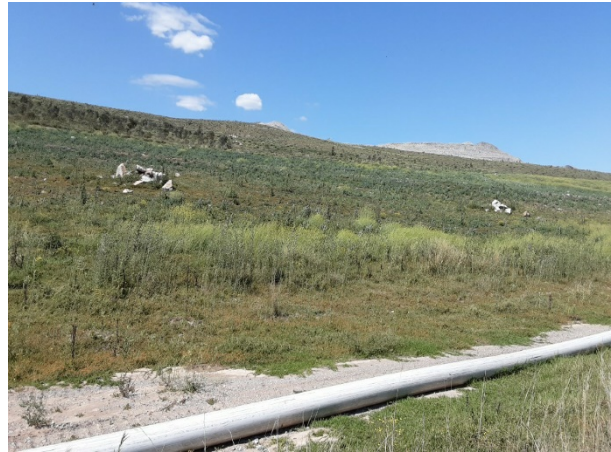
Figure 2 **After** - Remediated scouring and gullies with habitat features and vegetation

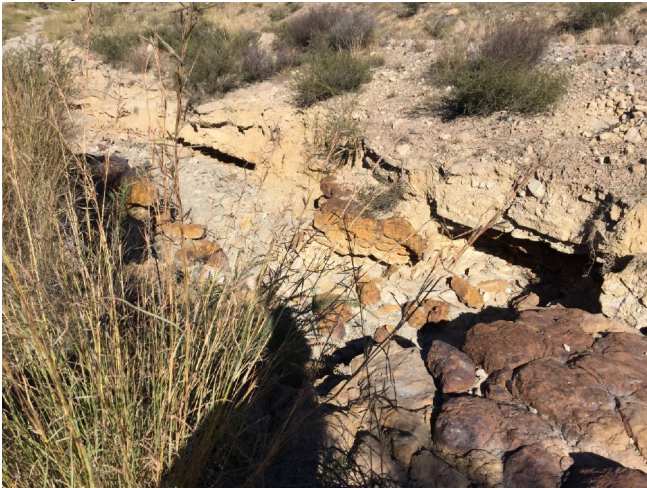
Figure 3 **Before** - Deep eroded toe drain at the base of the Northern batter of the WEA

- de-silting of the toe drain along the perimeter of the WEA
- installation of erosion and sediment controls, including contour drainage
- repairing minor contour banks and constructing drainage lines utilising geomorphic principles on the western WEA

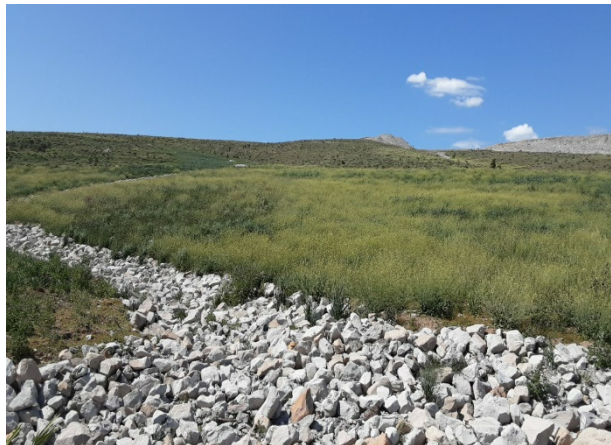
Figure 4 **After** - Armoured drainage channel and vegetation tied into to micro-relief landscape

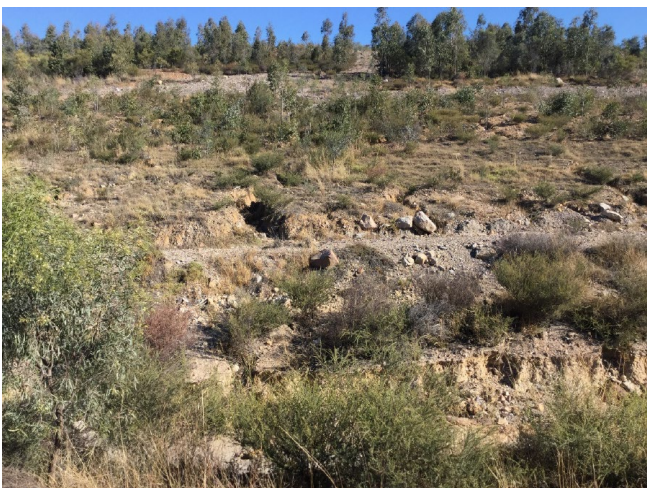
Figure 5 **Before** - Erosion rilling, gullies and bare patches in established rehabilitation

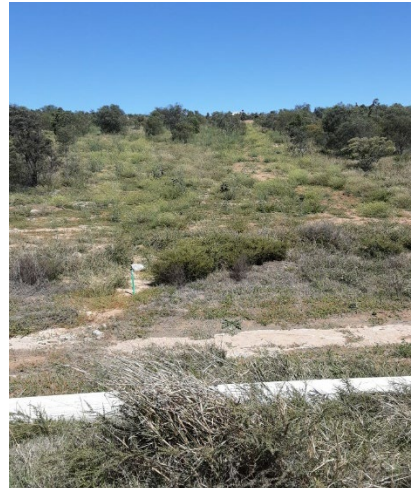
Figure 6 **After** - Backfilling of gullies and rills. Vegetation establishing on previous identified bare patches

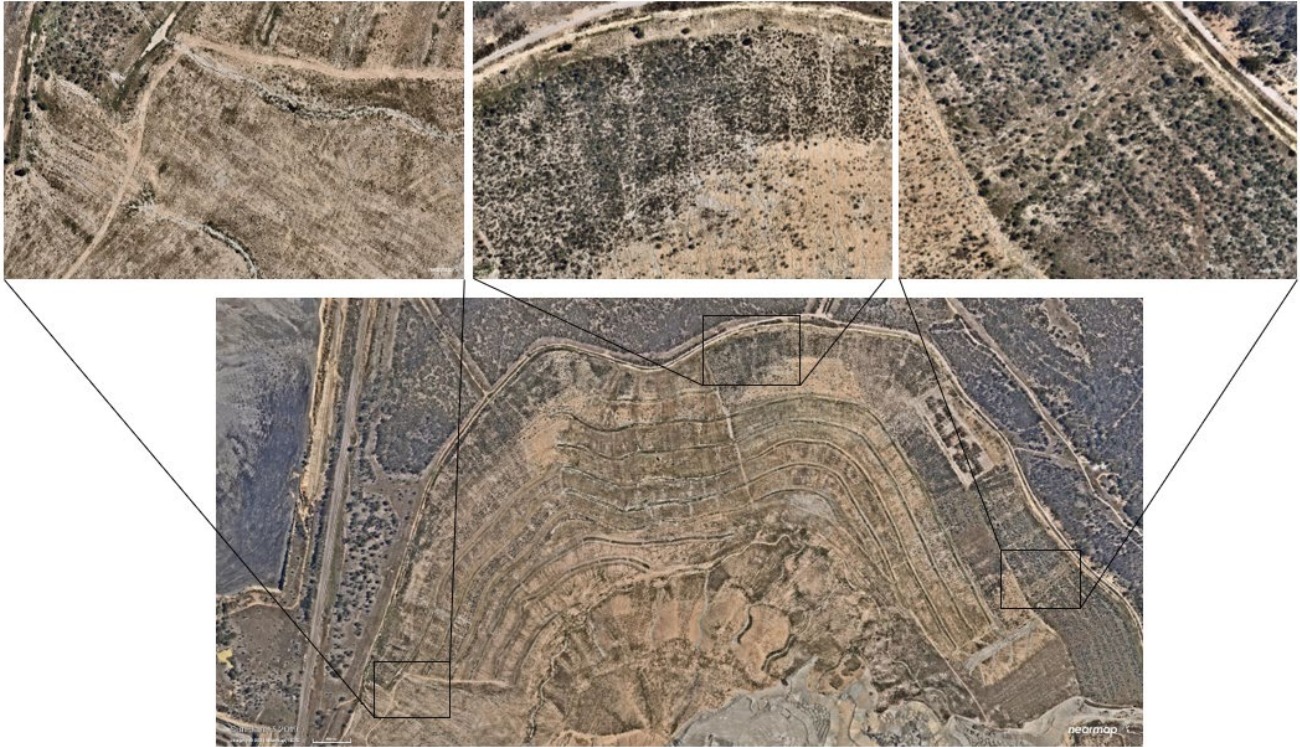
Figure 7 **Before** – WEA January 2019 (source: nearmap)

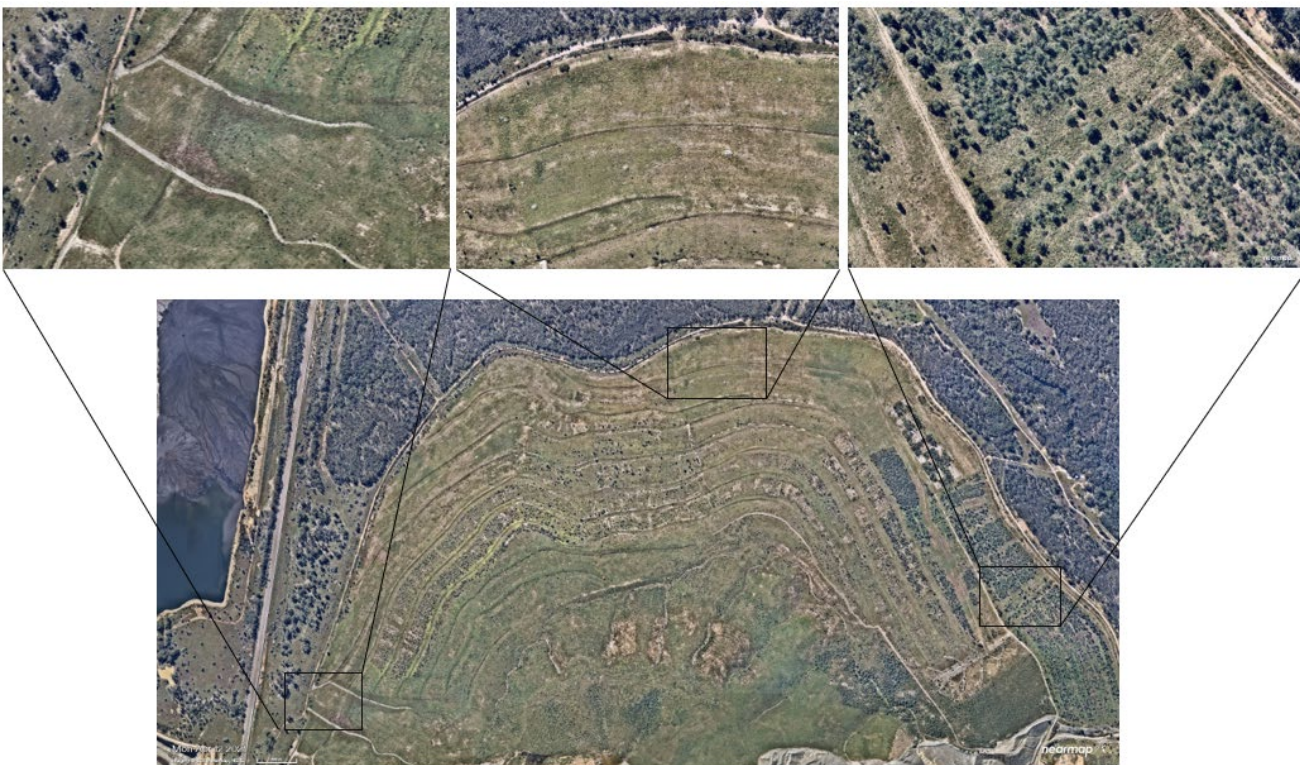
Figure 8 **After** – WEA April 2021 (source: nearmap)
