# SAFETY ALERT

## Park-brake malfunction leads to crush injuries

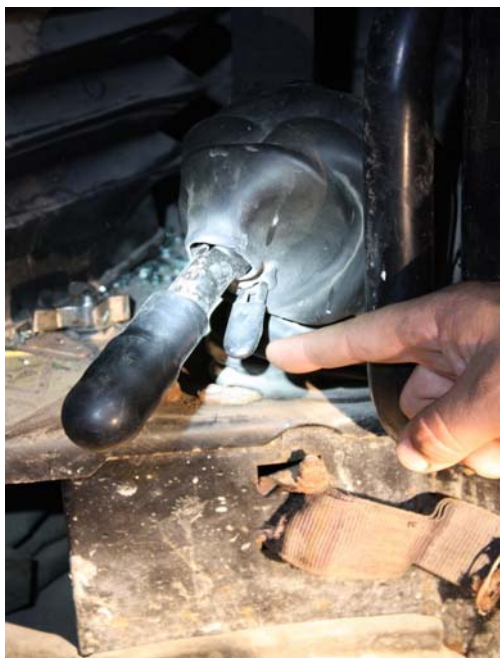
Photo 1.

The telehandler park brake is applied by a lever located to the left of the driver's seat. The park brake is applied when the lever is raised and a tee bar locks the park brake on. A trigger on the lever is used to disengage the tee bar and release the park brake. The park brake assembly is contained within a protective rubber boot (Refer Photo 1).

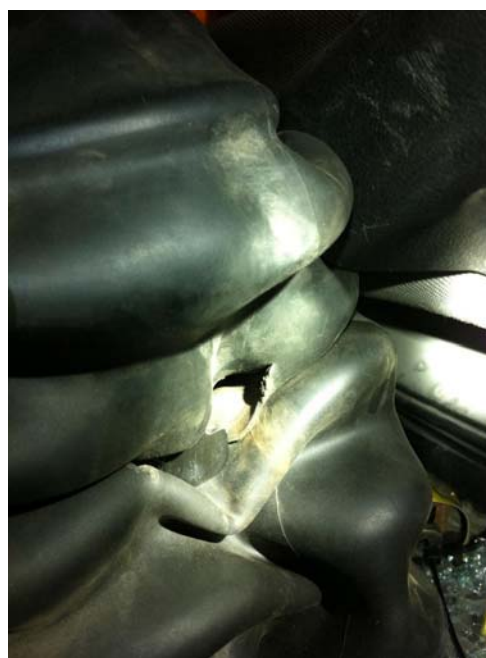
Photo 2.

The investigation determined that the tee bar had worn a hole in the rubber boot (refer Photo 2) and was projecting through the hole when the park brake was applied. The tee bar was prevented from engaging correctly by the torn rubber and while the park brake appeared to be applied it would release if the lever was knocked.

The park brake released when the lever was struck by the driver's self rescuer as he stepped from the cabin of the telehandler.

Mines operating telehandlers or any other mobile plant with park brake mechanisms similar to that described above should immediately inspect and test the park brake for correct operation. If faults are discovered they should be reported to the original equipment manufacturer and should be repaired in accordance with the original equipment manufacturer's recommendations.
