# SAFETY ALERT

## Winder balance rope failure

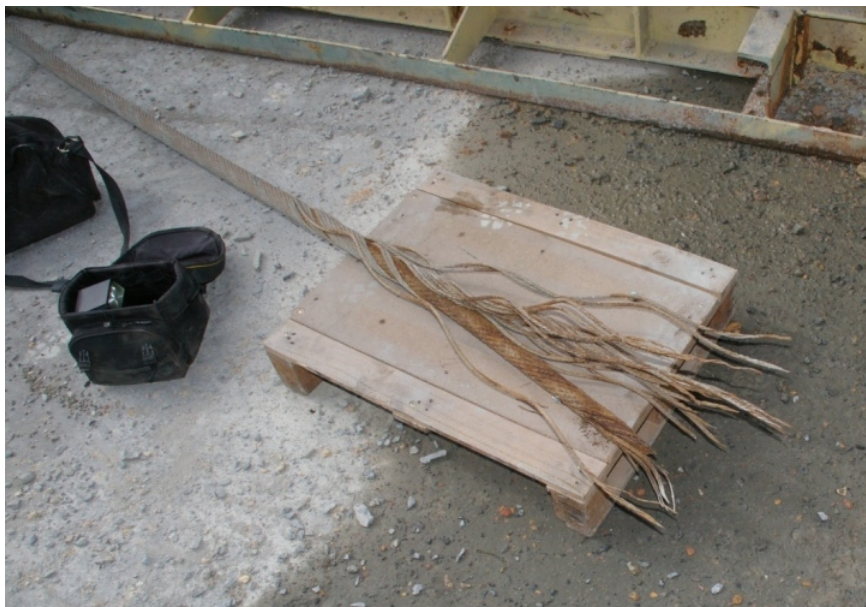
The 25m portion of the broken balance rope that remained suspended below the cage after the incident was recovered (see photographs). The rope was severely corroded immediately adjacent to the break. It appears the reduction in cross sectional area due to corrosion combined with the self weight of the rope caused the failure. This corroded section of the rope formed the tail loop at the shaft bottom when the skip over cage was at the loading stage. This section of rope was most exposed to spillage during loading, and hence to the corrosion and wear that would result from the entry of fine particles of sulphide ore into the rope structure.

The testing did not include the point at which the failure occurred. This was the section that was most prone to corrosion and was the most highly stressed part of the balance rope.

*Photo 1 - Broken end of balance rope.*

1. Safe systems of work for the inspection and testing of all winder ropes.
2. Periodic non destructive testing and visual inspections covering the full length of the rope.

3. Particular attention being given to inspection and testing of high risk areas, such as the tail loop area on balance ropes.
4. The provision of fit-for-purpose infrastructure in shafts to provide safe access to winder ropes for inspection and testing,

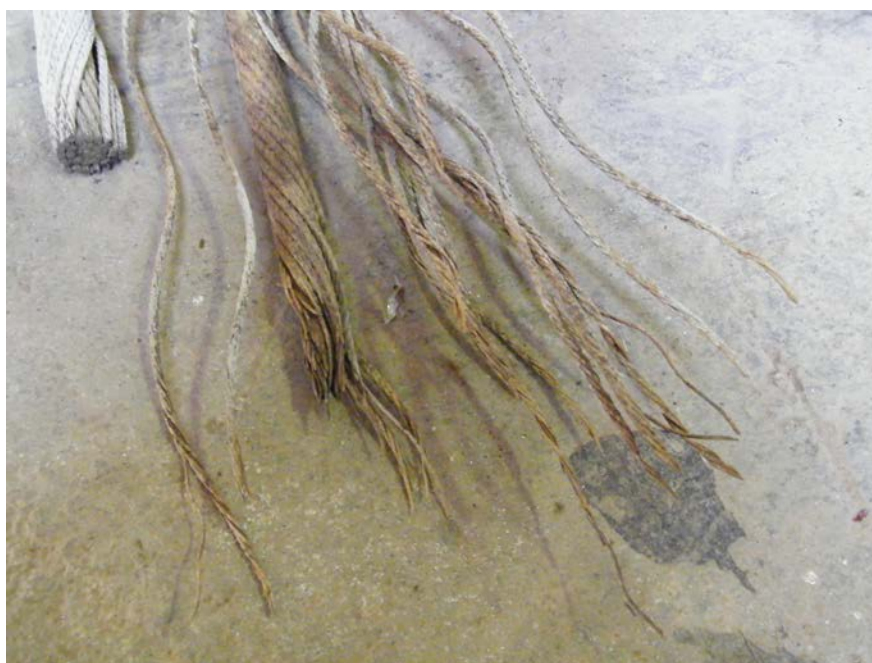
*Photo 2 – Close-up of corroded rope.*
