SAFETY ALERT

Fire in 33kV XLPE cable splice

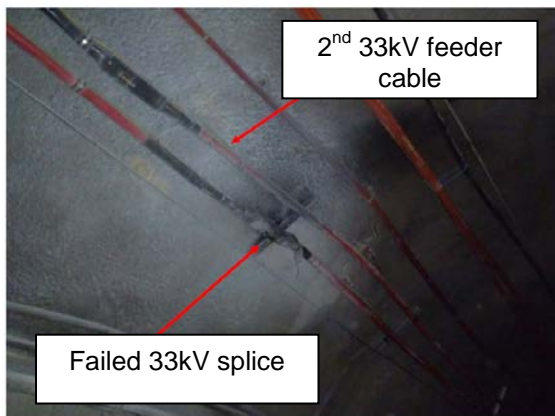
Figure 1: The burnt out cable splice as seen from the floor of the mine.

- The 33kV splice fire was not discovered until 36 minutes after the initial fault. The splice is believed to have burnt for about two hours, periodically dropping burning insulation material onto the roadway. The XLPE cable on either side of the splice did not burn. The situation was compounded when another electrician resetting power to the mine, failed to identify that the 33kV underground feeder involved had tripped on an earth fault, and reset power to the effected cable. This happened about 55 minutes after the initial failure and subsequent fire.

- The cable splice was of a tape and heat shrink construction. Such joints do not fully preclude air from getting inside the completed splice. The manufacturer has confirmed that this may make such joints more vulnerable to fire.

4. Set the fault current limitation on HV IT networks to the minimum level required for reliable system stability.
5. A risk assessment should be carried out to determine the suitability for use of the various types of HV splice kits available for use in an underground mine. Considerations should include, but not be limited to:

- the availability of suitable testing equipment and regimes for these installations
 - the impact of a splice failure in an underground mine
 - whether epoxy-filled HV cable splices would be more appropriate in the underground portion of the mine - considerations should include initial installation issues and the life of the mine, including maintenance.

- whether fire rated HV cable splices would be more appropriate in the underground portion of the mine
6. Mine emergency response plans need to consider:

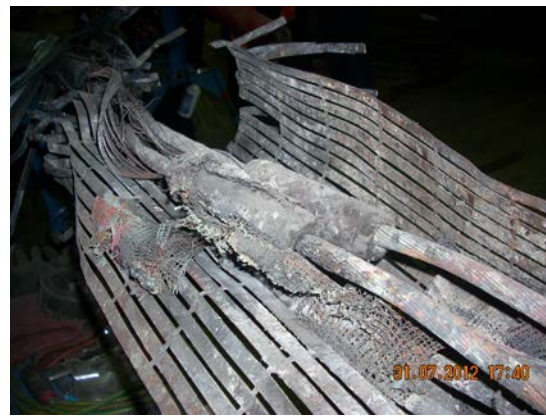
Figure 2: What remained inside the cable splice cage.

faults failed to cause tripping of the relevant earth leakage protection relays. Investigations following the power trip identified a flashover at a separate 33kV recloser on the surface and the insulation failure and subsequent fire on the underground 33kV feeder cable splice.
