SAFETY ALERT

Electrician injured after making contact with live high voltage conductor

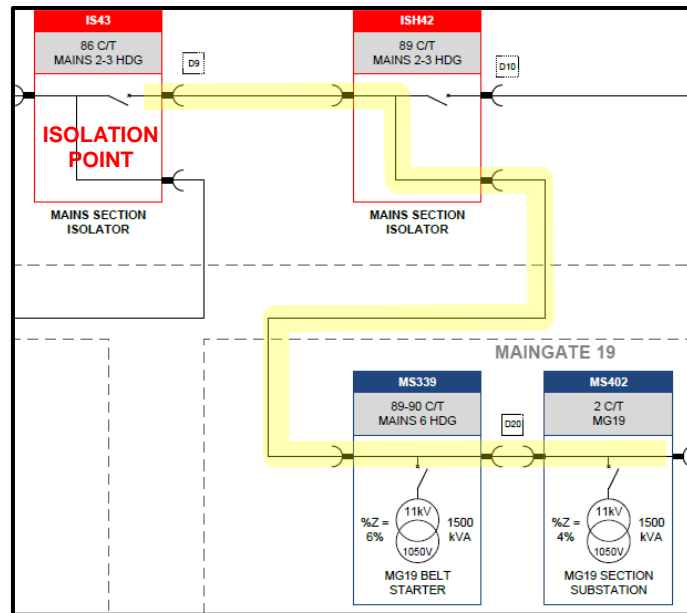
Figure 1: Portion of single line diagram. Highlighted line indicates section of HV system to be tested.

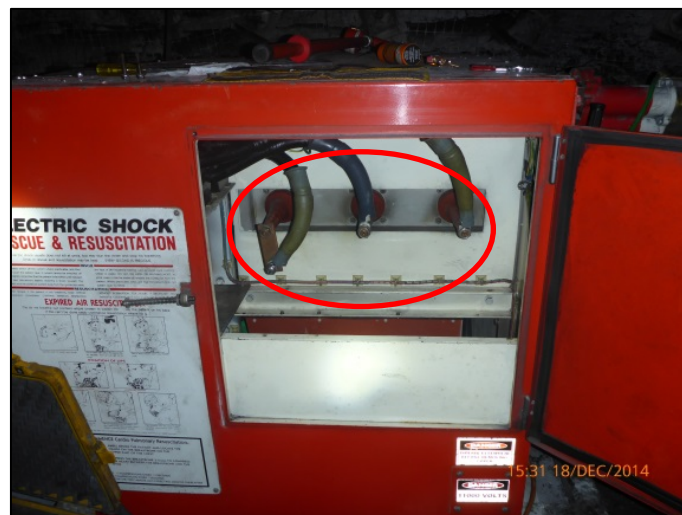
Figure 2: Opened test compartment on IS43. Test points circled

The electrician and the work team supervisor then verified the test points (refer to figure 2) were de-energised in accordance with site procedures.

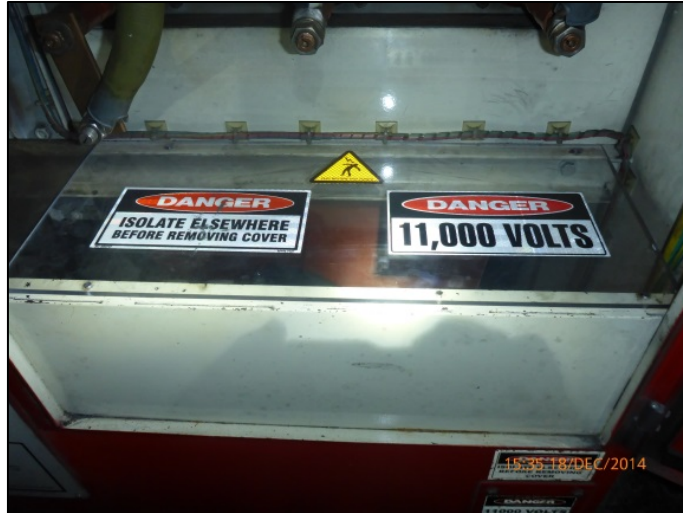
Figure 3: Test compartment with Lexan cover above 11000V/110V control transformer installed.

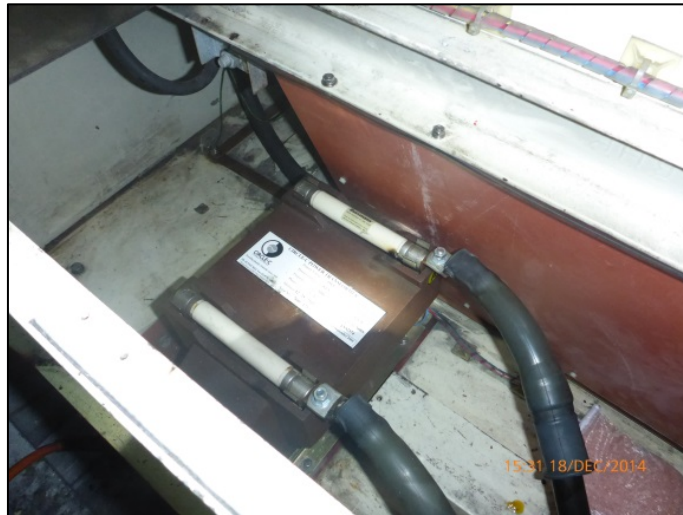
This required gaining access to a purpose-designed test compartment within the section isolator. After gaining access, the electrician removed a cover from a control transformer that was not included in the isolation so was still energised.

Figure 4: 11000V/110V Control transformer located in bottom of test compartment. Lexan cover removed, as found after the incident.

6. Mine operators should consider the implementation of engineering controls, such as door and cover interlocks designed to remove power, or devices warning that equipment is energised, where reasonably practicable to do so, and that under a functional safety approach such controls would be considered a safety function (Refer to Section 7.6 of Australian Standard HB 242-2007 *High Voltage Mining Equipment for Underground Use*).
7. Mine operators should review electric shock protocols for their sites, in consideration of issues relating to the specific outcomes of a person being subjected to an electric shock from a high-voltage source.

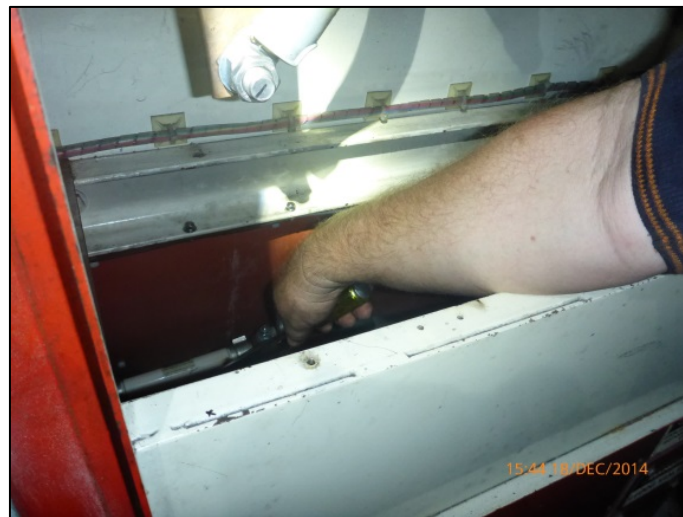
At this point, the electrician proceeded to remove the Lexan cover protecting him from the energised control transformer in the bottom of the compartment. He removed the cover and placed it on top of the section isolator, then used a large through-tang screwdriver in an attempt to lever out one of the fuses from the top of the energised control transformer (refer to figure 5).

Figure 5: Re-enactment of the event, based on witness statements, position of burn marks on equipment and the arm of the electrician involved in the incident.
