DATE: JULY 2018

Near miss between light vehicle and haul truck

This safety alert provides safety advice for the NSW mining industry.

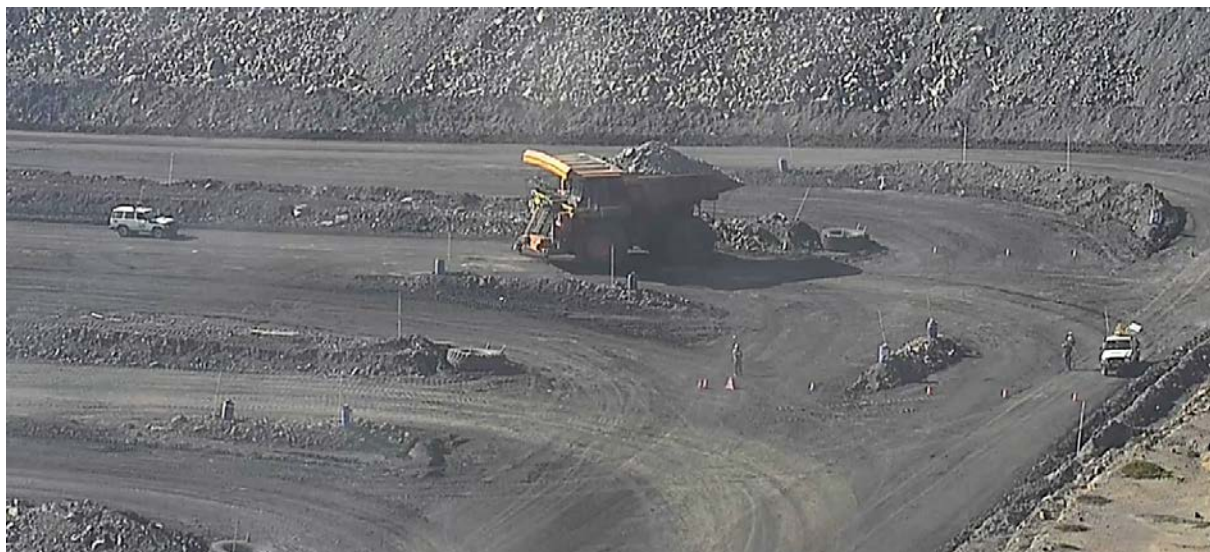
Figure 1: Photo of area. Photo courtesy of the mine.

The light vehicle was stationary and waiting to proceed through an intersection. The driver of an approaching haul truck incorrectly identified the roadway he intended to travel and turned into the roadway where the light vehicle had stopped. When reviewing the wheel marks, the vehicles would have made heavy contact.

1. Review complex intersections and consider operator error, visibility and flow.
2. Review site standards for signs and audit signs that have been installed.
3. When designing haul roads, consider the tendency for operator error and visibility constraints because of weather and equipment design.
4. Increase monitoring of inexperienced operators during periods of adverse weather.

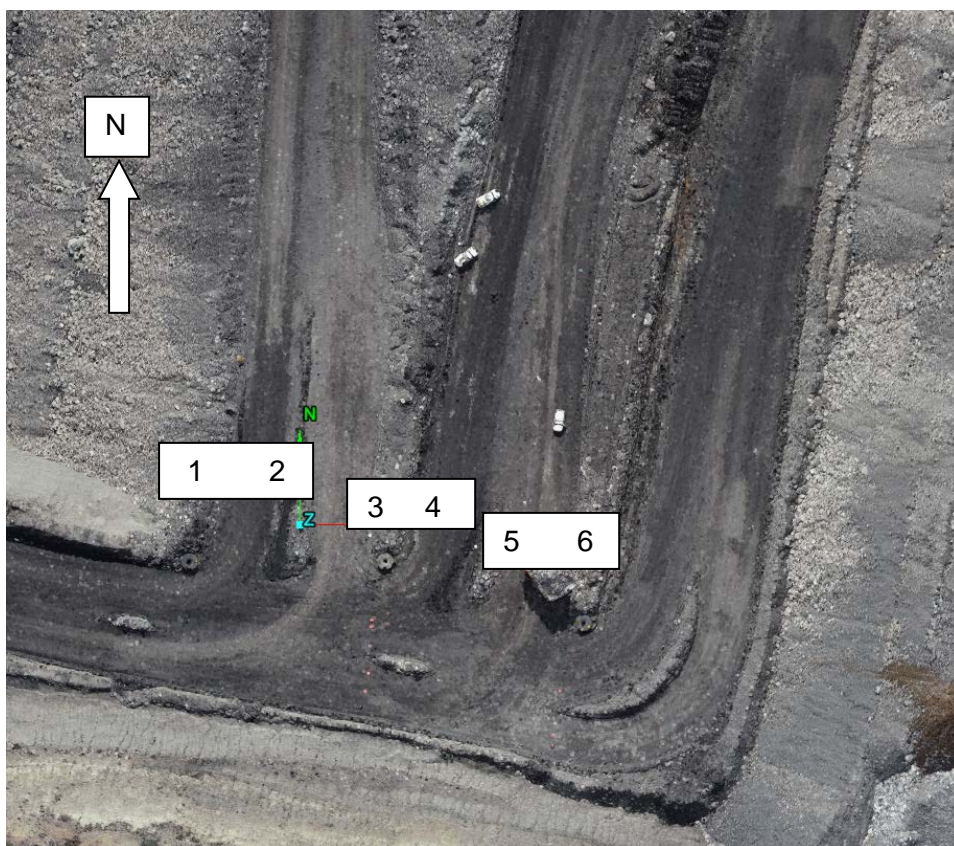
An east/west haul road intersects three other haul roads, all in a north/south orientation. All three roads were segregated, resulting in six individual roads. Refer to figure 2 below.

- the visibility due to the fog had been varying from 50 to 100 metres during the shift
- the haul truck driver drove onto the wrong side of the road
- the travel direction on each road was segregated so there were six separate roadways in the intersection
- complex intersection design resulted in all three travel paths being in the same direction
- some road signs had not been installed in accordance with site standards
- some road signs were poorly maintained
- the point where the light vehicle was visible through the fog was in the blind spot created by the A pillar of the cabin
- the light vehicle was white, however its flag and yellow flashing light were operational
- the mine had a policy in place where workers could stop at any time when concerns existed
- the haul truck driver was a trainee and had minimum experience in challenging weather conditions.
