DATE: DECEMBER 2018

Opal miner injured in shaft fall

This safety alert provides safety advice for the NSW mining industry.

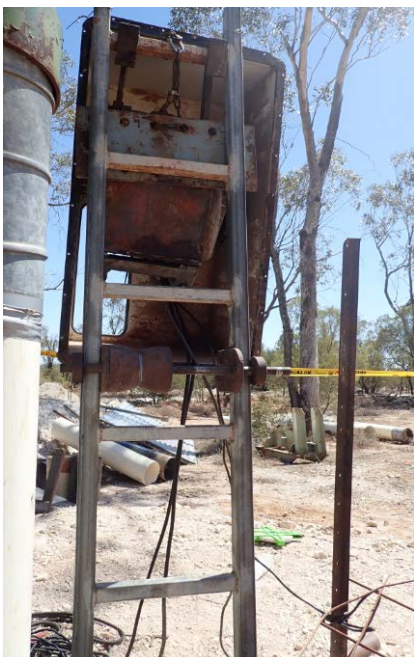
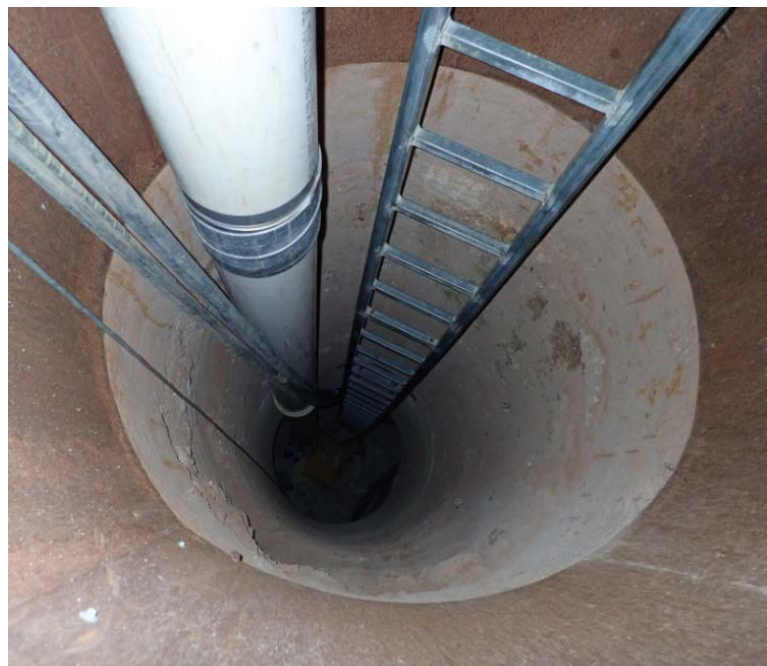
Photographs 1 and 2: View from the top of the shaft showing the access ladder arrangement. (Photographs by Resources Regulator)

- **There were no fall from height controls while using the access ladder.** The access ladder was also used to support a winch for a platform that the miner lowered to the shaft base. The winch rope had been raised back to the surface before the incident.
- **There were no means to raise an emergency response from the shaft.** The opal miner was working alone at a remote mine site. There were no means of communicating to the surface from the shaft.

1. The [Model code of practice - Managing the risk of falls at workplaces. \(see figure 25 at right\)](#)
2. Include the provision for training and instruction in fit-for-purpose equipment in falling from height protocols to ensure it is properly used, stored, tested, maintained and discarded where appropriate.
3. If a ladder is used for access, it must be fit-for-purpose and regularly inspected.
4. Developing a working-at-heights plan that considers self rescue and emergency management.
5. Reviewing the effectiveness of emergency communication systems.

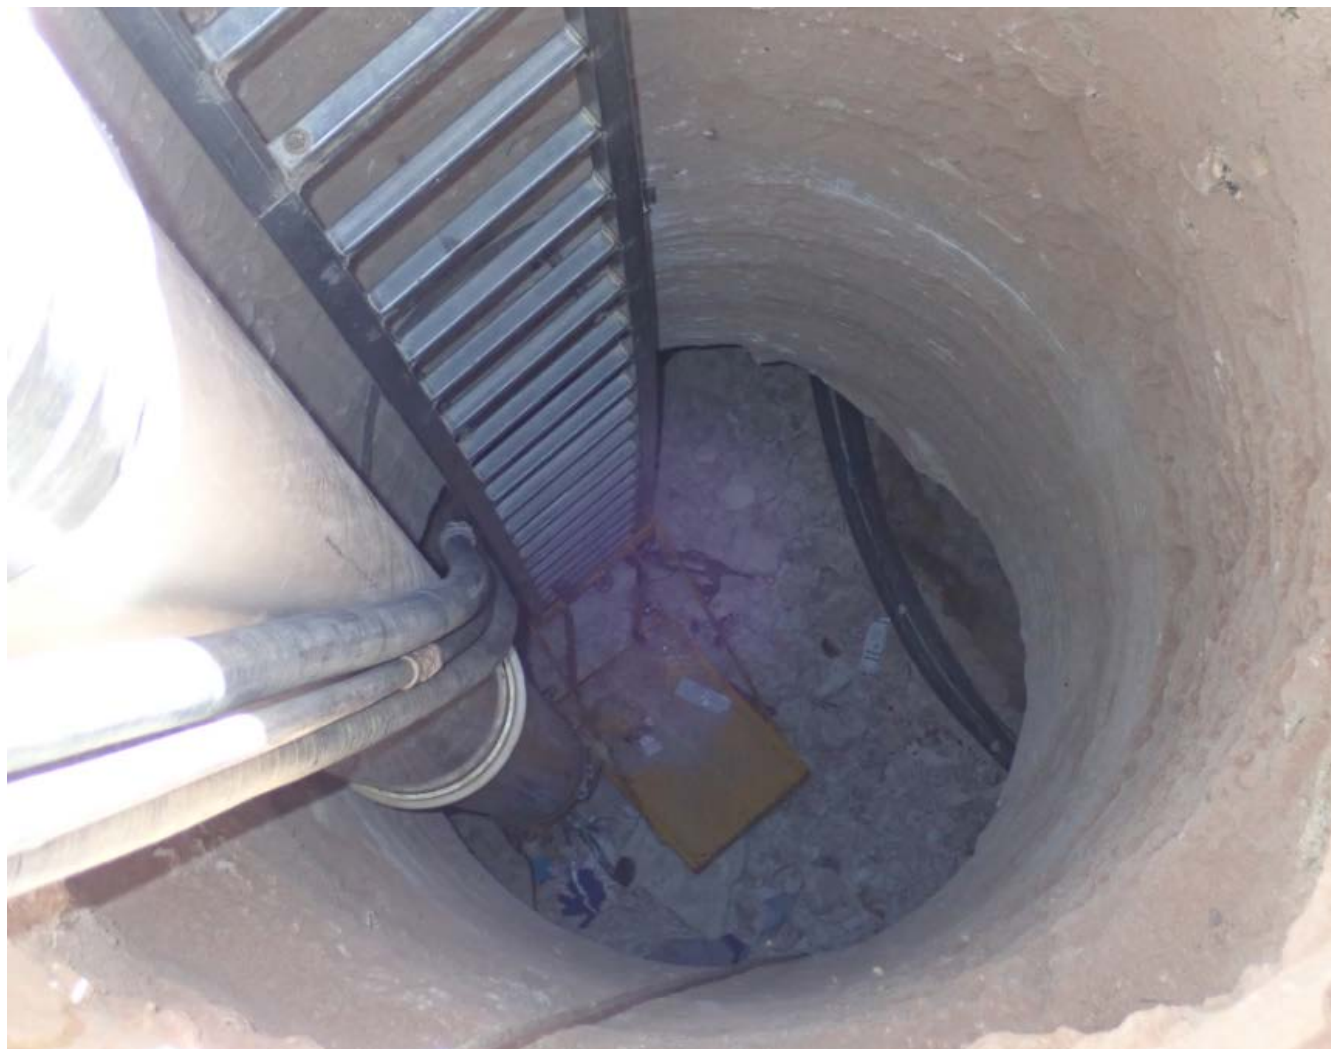
After completing maintenance work at the surface, an opal miner climbed down a nine-metre shaft using a vertical access ladder. During the descent, the miner stopped about two metres from the bottom of the shaft to look downwards. The miner lost balance and slipped from the ladder to the shaft bottom. The miner suffered a compound fracture of his lower right leg and a broken lower left leg. The miner was not using fall prevention equipment.

Photograph 3: View of the base of the shaft showing the access ladder and where the opal miner fell. (Photograph by Resources Regulator)
