SAFETY ALERT

DATE: 9 June 2020

QDS pods fall off dolly car flat top and slide down drift

CM9 reference	DOC20/426910
Mine safety reference	SA20-06
Date published	09 June 2020
Authorised by	Chief Inspector Office of the Chief Inspector

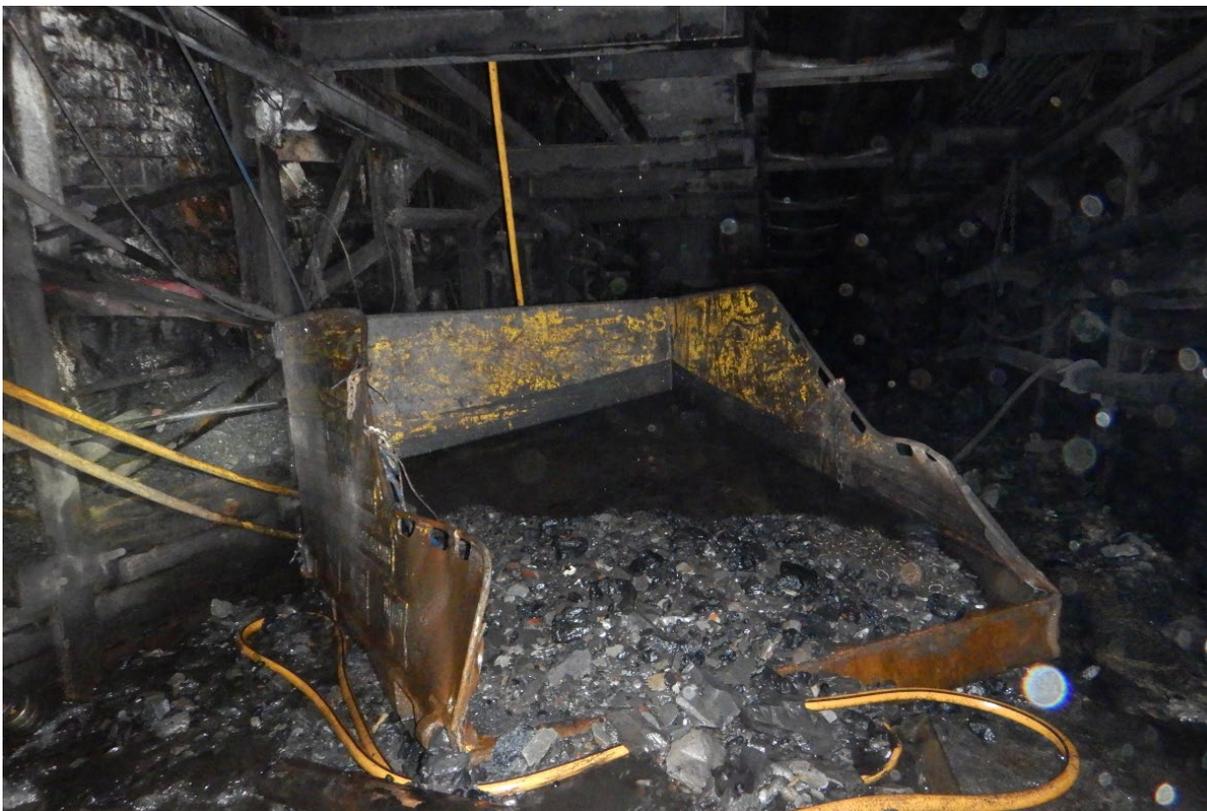
Whilst transporting three QDS pods (ducksbills) into the mine on a rail flat top attached to the dolly car two of the pods detached and slid uncontrolled down the drift. There was no one in the drift at the time of the incident and no one was harmed.

Figure 1 QDS pod arrested by spillage near drift bottom. It had travelled past the pit bottom shunt

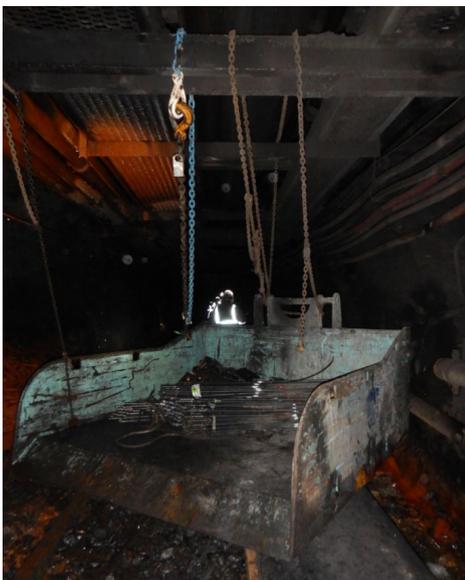
When the dolly car braked to a stop the middle pod also slipped off the flat top and slid down the drift to 32 man hole, where it hit the right hand rib and separated a main water pipe at a joint. The dolly car driver contacted the pit bottom shunt on the radio and advised that they had lost a load in the drift, and then walked down to the pod at 32 man hole.

Figure 2 middle pod had separated water pipe at connector when it wedged against right hand rib at 32 man hole

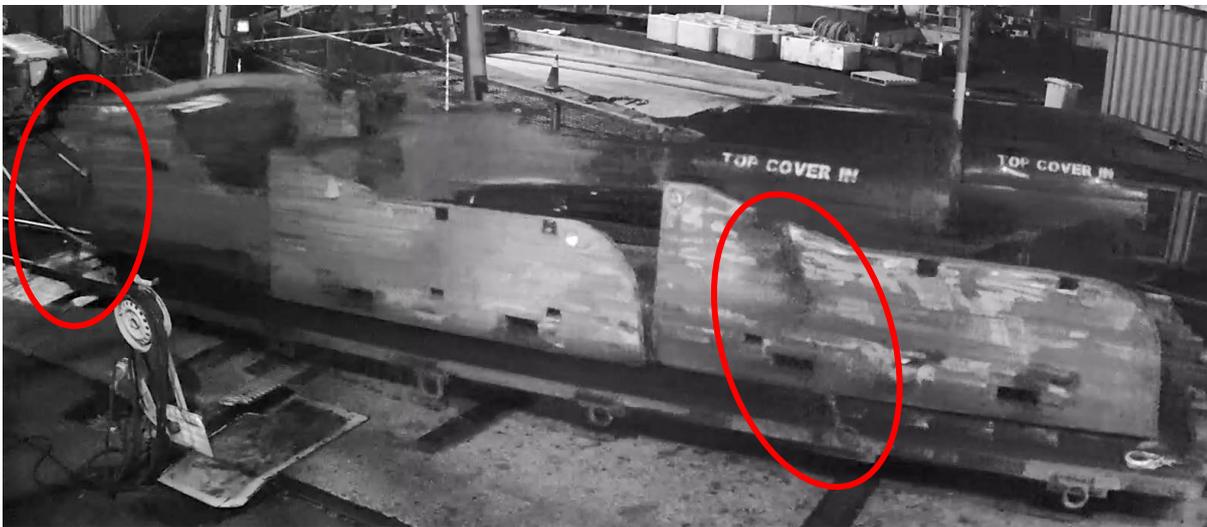
Figure 3 video footage confirmed the inbye and outbye QDS pods were chained, the middle pod was not.

- The inbye pod had damaged rib mesh, water pipes, conveyor access ladder, walkway support beams, conveyor support beams, turning sheave at pit bottom, a concrete wall, and approximately 40 dolly car rope rollers
- The pod at 32 man hole had damaged the main water pipe
- A lever action chain binder (dog) found approximately 8 metres inbye 28 man hole, shown in Figure 4, appeared to be in a useable condition, and had not come undone as the rope securing the lever to the body of the binder was intact
- The chain securing the inbye pod to the flat top was still attached to the left side of the flat top, but the grab hook for the right hand side was missing its spring safety latch. It is not known if this occurred during the incident
- There was no securing chain placed on the middle QDS pod, and it was seen to slide off the flat top once the dolly car brakes were applied

- Both the dolly car driver and the surface yard person had completed a sling awareness training course within the previous twelve months
- The procedure for securing loads to the flat top:
 - was unclear about the requirements for a headboard on the flat top,
 - had no specific requirements for securing multiple loads
 - did not identify who is responsible for checking the load security
- Witness statements provided conflicting accounts of who secured the inbye pod

- It is the dolly car operator's responsibility to check the security of the load before operating the dolly car
- The use of secondary methods of securing loads should a securing mechanism fail,
- Adequately securing all items of plant and equipment
- The use of head boards on the inbye end of rail flat tops to minimise the potential for equipment dislodging from the flat top and sliding down the drift
- Procedures for securing loads are clear, and include securing requirements for transporting multiple loads on a flat top

- Training competence packages that address securing loads operating on steep grades
- Retraining frequency for workers directly involved in securing loads on equipment operating at steep grades.

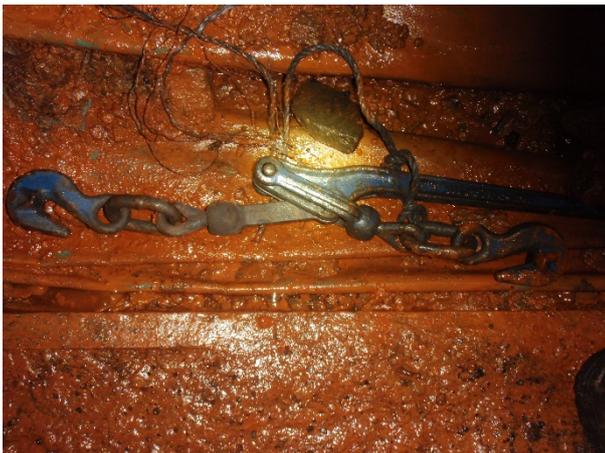
Figure 4 chain dog found 8m inbye 28 man hole
