SAFETY ALERT

DUMP TRUCK TRAYS HIT OVERHEAD STRUCTURES

Report No: SA 04 03

Date: 16 January 2004

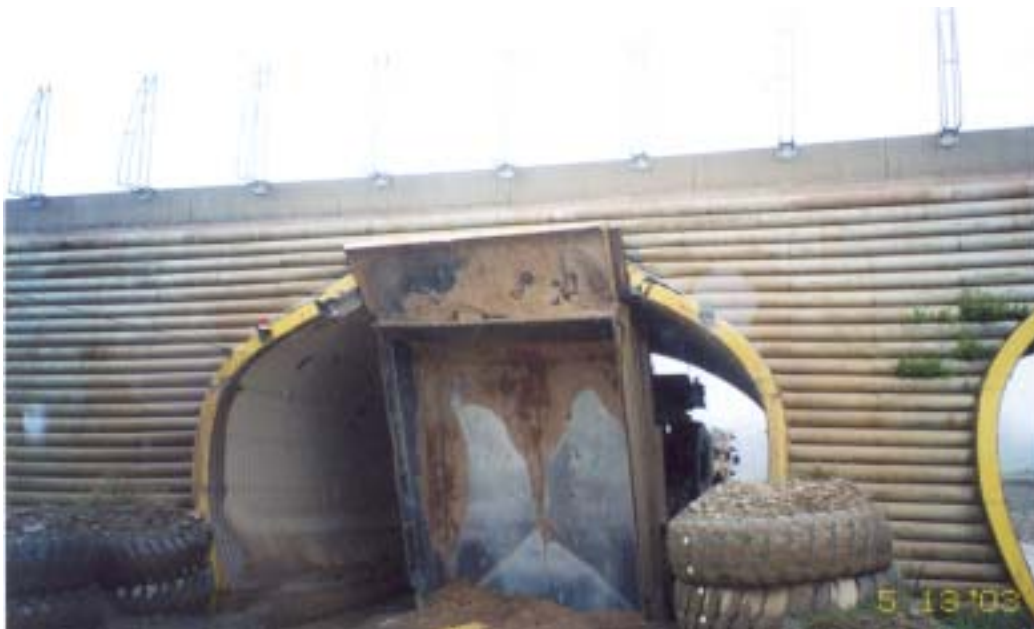
1st Incident

In the first incident the tray hit a public road underpass and threw the driver towards the top of the cabin; in the second incident the tray hit an overhead conveyor jamming it between the driver's cabin and the tray.

- Truck tray jammed in underpass
- Truck wheels off ground

1. Conduct a site specific risk assessment to identify and control the potential for mobile equipment to hit overhead structures, including power lines, anywhere on the mine site. Consider the increased probability of a truck rolling over if it is driven with the tray up for anything more than a short distance at low speed.
Ensure the appropriate hierarchy of controls is utilised.
2. Consider installing a suspended or lightly supported clearance frame before any major structure or power lines. The clearance frame should not result in a hazard if it is hit.

3. Fit a device which will automatically stop or inhibit the movement of the truck whilst ever the tray is raised. Refer to MDG15, Guidelines for Mobile and Transportable Equipment For Use at Mines.
4. Ensure that every time there is a change in work area that the change in risks is re-assessed before work recommences.
5. Implement a system of monitoring to ensure that all personnel wear seat belts. Wearing of seat belts is called up in Australian Standard AS2294.
6. Ensure the training of operators and drivers and the management of contractors are adequate to prevent dangerous incidents.
7. Use pre start check lists which ensure that the functionality of audible and or visible tray up warning devices are operational and also ensure that tray up truck movement inhibitor systems are operational.

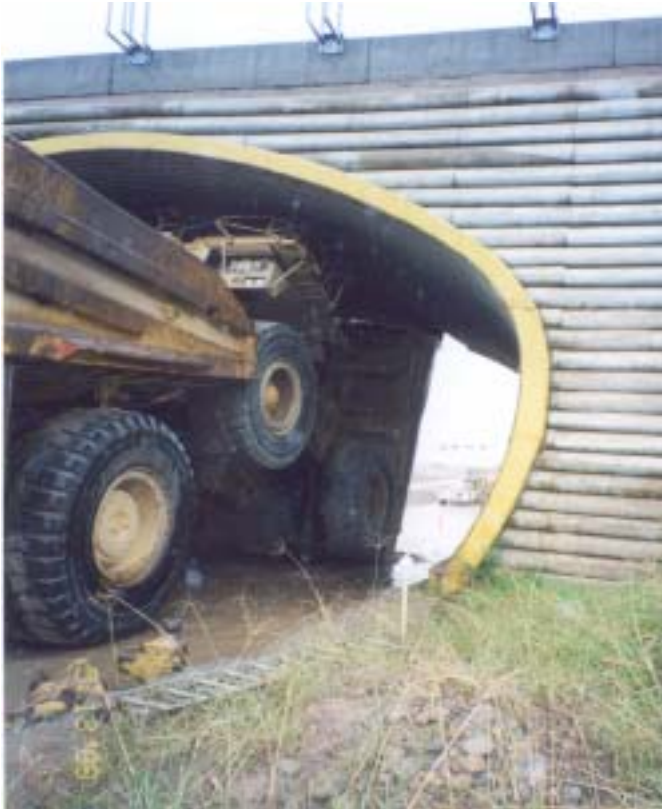
1st Incident

1. Neither of the trucks were fitted with anything to automatically prevent or inhibit movement of the truck whilst its tray was raised.
2. In the first incident the driver roll over protection structure was so badly impact damaged that it could not be repaired.
3. In the second incident some of the conveyor gantry had to be replaced.
The raised tray warning light had intermittently not been operating for a considerable period.

- Drivers cab jammed against underpass
- Crushed handrails
- 2nd truck used to stabilise elevated truck

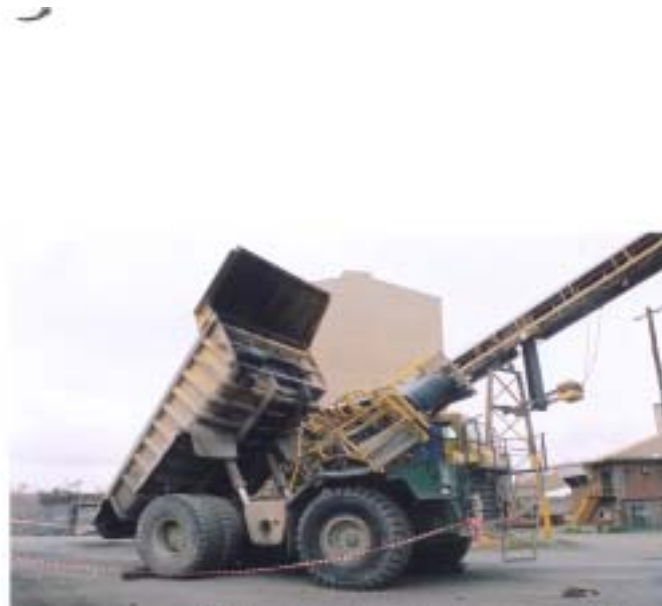
2nd incident

- Conveyor gantry jammed between drivers cab and truck tray
- Damaged conveyor, truck hand railing and fire suppression system
