# SAFETY ALERT

## NEAR MISS INVOLVING CONTINUOUS MINER POD

Report No: SA 04 - 17  
Comet ID 1065001  
Date: 16<sup>th</sup> September 2004  
Prepared by: Paul Healey  
Phone (02) 6572 1899

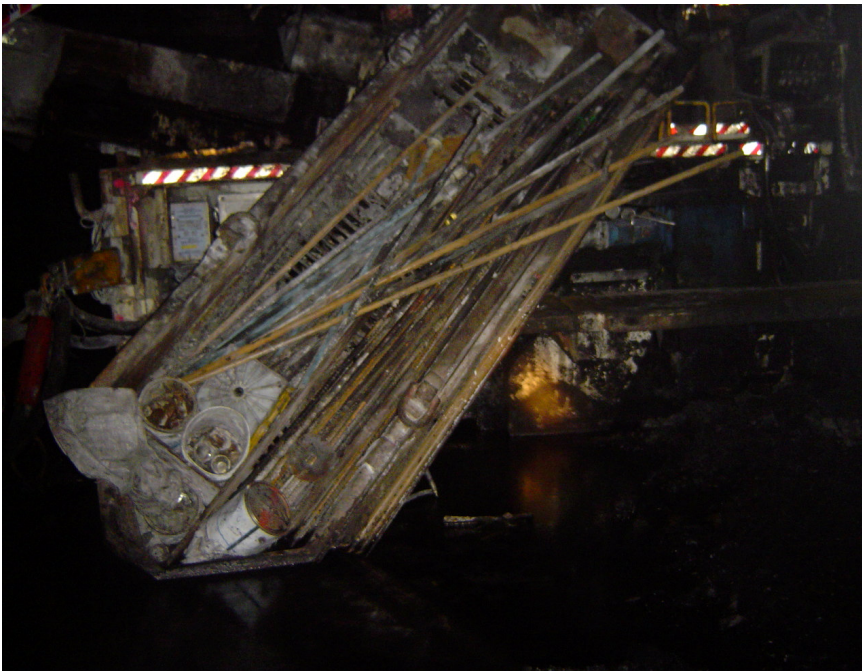
While operating a 12CM12 bolter miner a piece of roof stone being conveyed up the centre chain contacted a one tonne materials pod on the side of the machine and lifted it off the location lugs and caused it to fall off one end of the machine.

The pod was not adequately retained

- Mines should review the design and construction of miner material pods.
- Mines should review procedures for loading and unloading miner material pods.
- Mines should review their procedures for identifying and controlling safe work zones around continuous miners.
