SAFETY ALERT

WORKERS INJURED AFTER FALL FROM ELEVATED WORK PLATFORM (EWP)

Report No:	SA 04 – 25
Comet ID	317517642001
Date:	22/12/2004
Prepared by:	Robert Jay
Phone	(02) 63926337

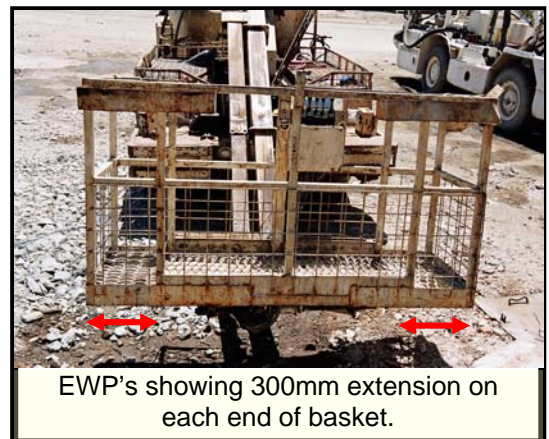
The two operators were working in an underground mine installing services from a basket on an EWP. The basket tipped over and the two operators fell to the ground. The basket was approximately two metres above the ground when they fell.

1. The size of the basket had been enlarged 300mm on each end during recent maintenance.
2. The rated capacity of the EWP may have been exceeded (number of occupants).
3. The two operators were not wearing safety harnesses.
4. The manufacturer's manuals for the use and maintenance of the EWP were not available at the mine.

- Review Risk Assessments and Safe Work Procedures for the operation and maintenance of EWP's;
- Ensure EWP's are operated and maintained to the manufacturer's specifications ;
- Review Relevant Australian Standards – in particular AS 1418.10 and AS 2550.10 for EWP's;

- Ensure EWP's are fit for purpose;
- Ensure that every time a modification is undertaken on equipment or machinery a risk assessment is completed;
- Ensure that any modification is carried out without a reduction in safety and in compliance with relevant legislation; and
- Ensure persons operating and maintaining EWP's are competent.
